ASSESSING THE CRACKS DEVELOPED IN DEMATAMAL VIHARAYA, BUTTHALA

Department of Civil Engineering, University of Moratuwa

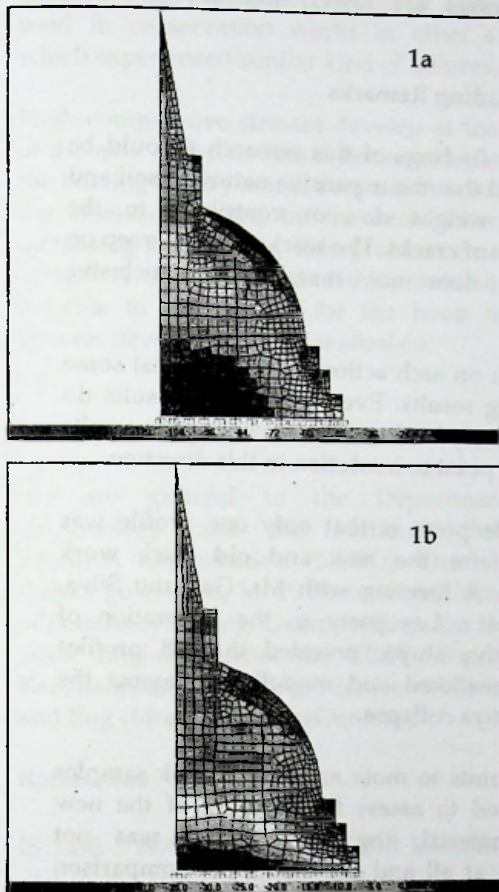
Figure 1: Vertical (a) and Hoop (b) Stresses due to self-weight of the stupa modelled with modern brick properties

Figure 1 shows the vertical and hoop stresses in the stupa. The vertical stresses are wholly compressive in the range of 0.156Nmm⁻² to 0.003Nmm⁻² and steadily increase from top to bottom. Maximum Compressive stresses can be noticed at the base. Hoop stress is mainly compressive and has a variation similar to the vertical stress, but tensile stresses also can be seen at the outer surface of the dome and in the edge of the pesawalalus but they are less than 0.01 Nmm⁻² and approximately one fifth of the tensile strength of the modern bricks. So it

can be concluded that the self weight had not been the reason for the cracks.

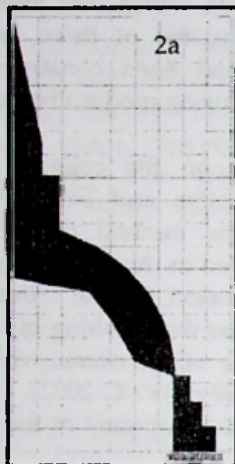
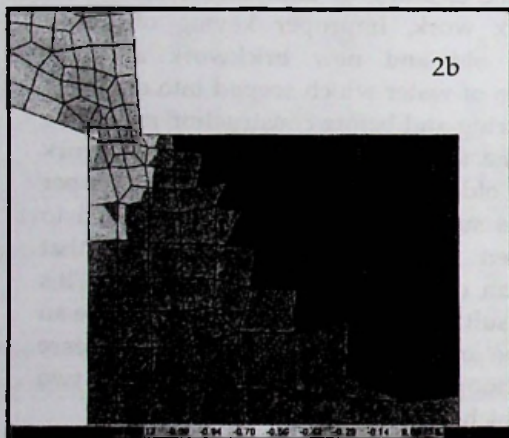
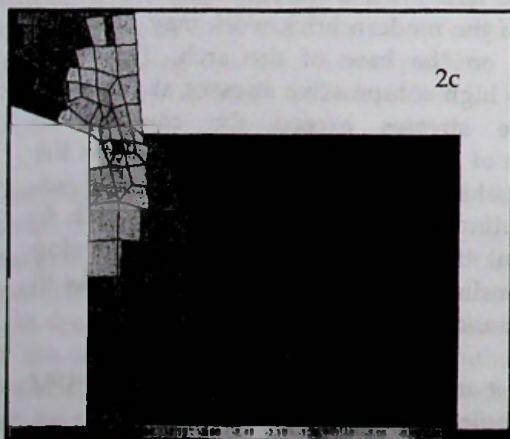
Figure 2: (a) Model used to analyse arch action (b) Hoop stresses at the base of the arch (c) Vertical stresses at the base of the arch

It can be clearly noted that an increase in stress occurs at the base, whether it be vertical, or hoop. In the case of vertical stress, the increase compared to the self weight model with both materials is 30 times higher. The model also shows the development of high hoop tensile stresses in the *pesawalalu* edges thus proving the second part of the hypothesis to be true. The general range of the hoop stress at the *pesawalalus* is $0.14-0.28 \text{ Nmm}^{-2}$, an increase of 250 times compared to the self weight model. But these stresses are lower than the material strength.

High compressive stresses develop at the base of the new material. This is because the area of the bearing is very small, thus not able to carry the stresses induced by the arch action. By increasing the bearing this problem could be solved. A tie beam around the *pesawalalu* will be able to compensate for the hoop tensile stresses developing at the *pesawalalu*.
