FAILURE ANALYSIS OF A DBST ROAD USING MECHANISTIC EMPIRICAL METHOD

Abstract: The objective of this research is to analyze a failure of a DBST road section using a Mechanistic – Empirical method. For this analysis, failure of A15- Trincomalee-Batticaloe road was selected. This particular road section was rehabilitated recently by extending the width of the initial road section from both the sides and soon, a large amount pot holes appeared in the newly constructed areas. Empirical methods alone failed to identify the reason behind this failure and therefore a Mechanistic – Empirical approach was used along with the KENLAYER software to analyze the section. Mechanistic approach to pavement design seeks to explain phenomena only by reference to physical causes. Thus it uses stresses, strains and deflections within a pavement structure to analyze the loads and material properties of the pavement. This study would help future engineers to identify the reason behind the failure of road sections. This will promote mechanistic softwares like KENLAYER and increase the usage of it. These softwares will make life easy for road designers and consultants and this may turn a new chapter in road

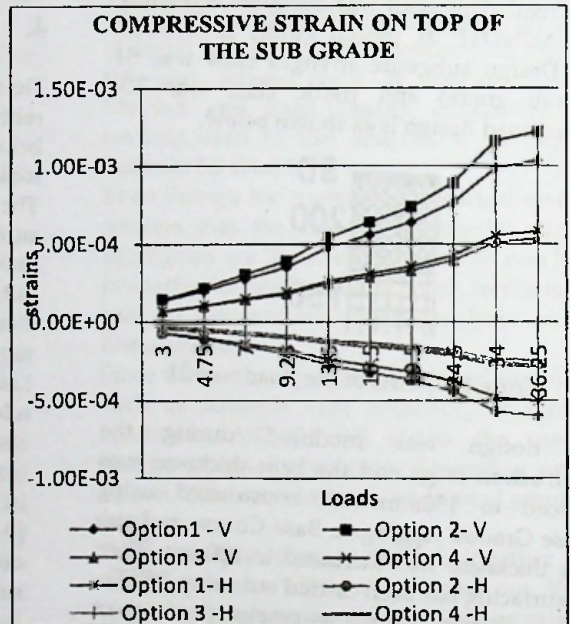
Figure 3 : Compressive Strain on Top of Subgrade

As shown above in figure 3, with the help of KENLAYER vertical compressive strain and horizontal compressive strain on top of the subgrade was plotted and this shows that there is very small vertical compressive strain on the top of the subgrade of the failed location when compared to other stresses (Option 3).

Failure has not penetrated beyond the subgrade. It was proven through the site investigations and it was further confirmed by Figure 3 shown above. Subgrades' vertical compressive strain has not been very significant in the failed location according to it. It can be concluded that failure has taken place above the subgrade and there is no connection between subgrade and the failure. This type of failure can be identified as a "Rutting Failure". Vertical compressive stress plays a higher role in determining design life and damaged ratio in rutting failures.

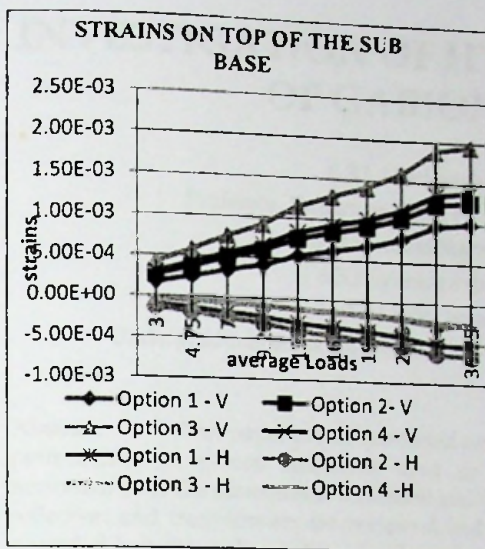
Figure 4 : Strains on Top of Subbase

The same analysis was done for the subbase layer using KENLAYER as shown in figure 4. Higher vertical stresses were shown on the failed location (option 3). Subbase has become critical at the failed location.

The subbase has displayed a higher vertical compressive stain at the failed location. A subbase condition at the failed location had been the reason for the failure. Low subbase CBR value of 5% has ended up resulting in higher vertical stress on the subbase which had lead to a failure in the subbase.

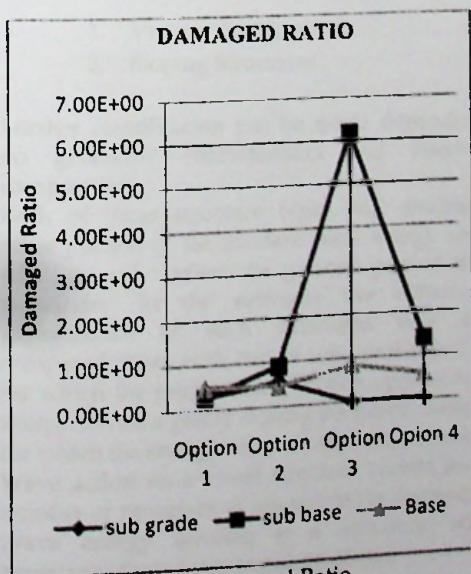
Figure 5 : Damaged Ratio

KENLAYER has the facility to perform a damage analysis, where it interprets damage ratio for each load group and finally the cumulative damage ratio for each group. A graph was plotted for the cumulative damage ratio verses the four options as shown in figure 5.

Highest cumulative damage ratio is visible in the Option 3 on the subbase and it shows a significant deviation from the rest of the graphs.

Damaged ratio has become very high in option 3 and on the subbase layer. The above statement is further justified by the damaged ratio for each options as plotted in the figure 5.

According to figure 5, subbase damaged ratio for option 4 is little higher than the option 1 and 2 and it concludes that sub base in the partially failed location has also got affected. Subgrade of option 3 and 4 shows very insignificant damaged ratio which tells that the subgrade has not failed and that is due to the high CBR of 40% and subgrade has got failed due to it's poor material properties. Failed locations' subbase has failed severely due subbase properties being worst on the failed location (Option 3) than partially failed location (Option 4).
