# Structural Mitigation for Stabilizing Rock Slope Failure at Peradeniya on Colombo-Kandy Main Road; Geotechnical and Constructional Aspects

**Abstract:** Rock slope failure at Kandy -Colombo highway near Peradeniya town has been identified as a major threat to the highway as well as the people and properties of the vicinity. This study proposes a permanent mitigation plan for the rock slope failures at this site. Study was initiated with the analysis of similar case studies and field studies on the site area and mitigation options. Two level surveys were carried out to collect topographical data for preparation of a 3D model of the slope. Material identification was done by using particle size analysis and plasticity tests; direct shear tests were carried out to determine the friction angle, cohesion and density of the material. Mitigation plan was designed according to the site conditions. The design was analysed for nine sections on the slope for its stability with the test results by using Geo-studio 2004 software. Reinforcements were proposed to improve the stability whenever needed. An appropriate drainage system was also designed having analysed the past rain fall data of t

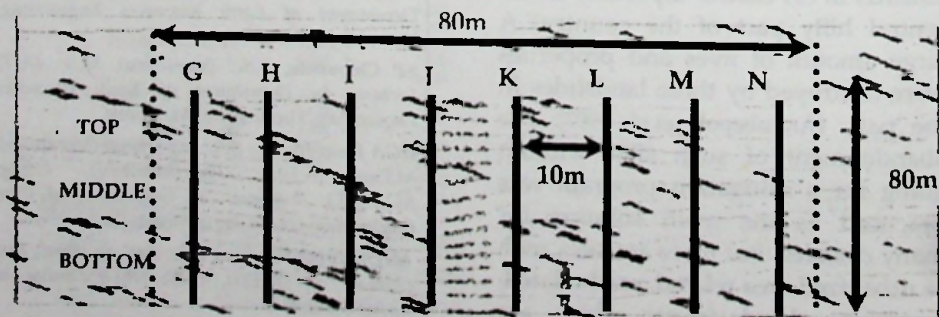
Figure 1 Section plan of the site

Well representative samples were collected from four sections (H, J, L & N) (Fig. 1) of the slope and their particle size distribution & the plasticity were analysed.

The most vulnerable sections of the slope (section G to N in Fig. 1) were selected and their stability levels were checked with Geo-slope 2004 by means of the factor of safety (FOS). A

Stability of the slope was analysed as sections (G to N) (Fig. 1) with the aid of 3D model, Geo-studio 2004 software and direct shear test results (Table 2). The results showed that all the sections were in critical region ( $FOS \approx 1$ ) due to steep slope and higher head weight. The situation becomes worse ( $FOS < 1$ ) at the adverse conditions where materials are heavily saturated (Table 3).

FOSs of sections G to N (existing slope conditions) are in near critical range (1.1-1.2). FOSs for the adverse conditions are even worse and they were in the range of (0.8-0.9), well below the

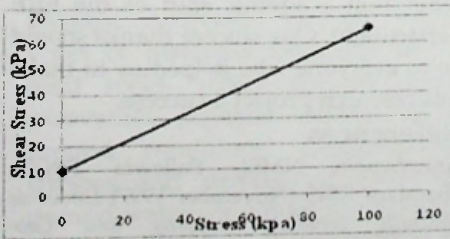
**Figure 2 - Direct shear test results**

Cohesion (c)	10kPa
Friction angle ( $\phi$ )	29°
Material Density (r)	15.1kN/m <sup>3</sup>
