Incident of Ground Collapse up to Daylight and Recovery Actions Taken in Shallow Ranwediya Tunnel in Sri Lanka

*Perumal¹ M, Wanigasekara¹ WADID, Isuranga¹ SNAMTK and Narangoda¹ SRAIB
¹Program Management, Design & Supervision Consultants (PMDSC), for Mahaweli Water Security Investment Program (MWSIP), Dambulla, Sri Lanka

Abstract

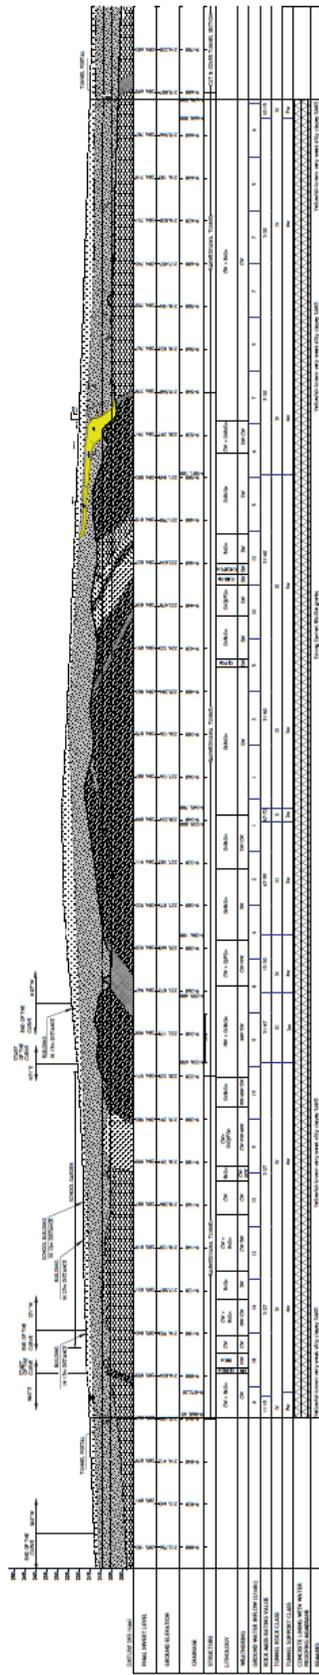
The actual geological condition faced while driving the tunnel is detailed in Table 2 and shown in Figure 4.

Figure 4 Actual geological long section of the Ranwedyawa tunnel after excavation

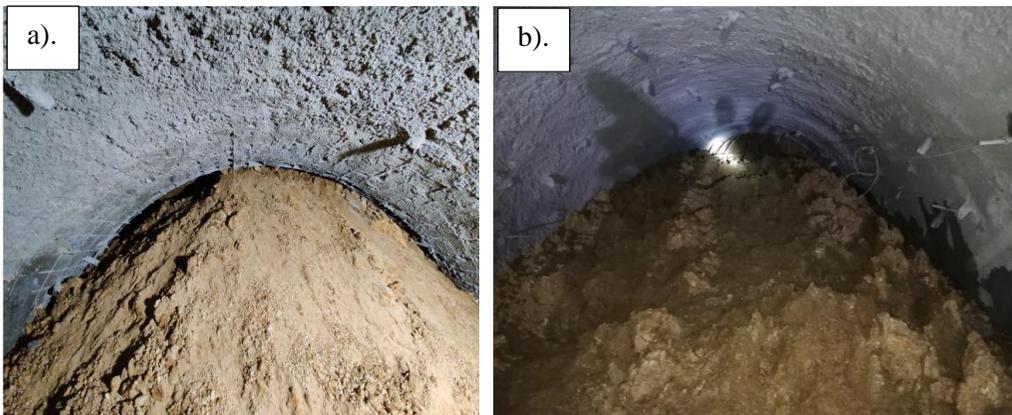
The tunnel drive was reached on 7th June 2021 the chainage of 9+535.9 after excavation of 142.6 m length as the tunnel started at 9+678 after the portal excavation which was varied due to the initial survey error at the start of portal excavation and the weak ground at the portal too. After the completion of the previous round of support works, a set of 3.5 m pipes was installed into the ground as the fore-polling pre-excitation umbrella support for the next set of rounds of tunnel excavation. Then the second round was completed after an excavation of 1.2 m on 9th June 2021 at the end of the day shift followed by the first round of 0.7 m excavation. The tunnel started a small collapse from the tunnel face of 9+534 and an unsupported roof of about 0.4 m from the last supported lattice girder, which requires the drilling space for the fore-polling while marking the positions and cleaning. This collapse continued for some extended time and it created a huge cavity in front of the tunnel face, the fallen material was somewhat dry condition while falling however it was fully wetted after mixing with water that was coming from the last tunnel face as shown in Figure 5. At the time of this occurrence the absence of an experienced tunnel team with the Contractor at the tunnel face, it was left the tunnel to continue the collapse.

Figure 5 Ranwediya tunnel face collapse at 9+534, photos on a) 10 June 2021 and b) 12 June 2021

The initial collapse happened by bending the 50 mm diameter pipes in the previous fore-polling support set due to the force of the loosed sandy material's weight. This happened due to the failure of the pre-excavation investigation in the correct location of the face continually as decided by the tunnel team geologists due to the absence of the correct probe drilling equipment. This tunnel construction was started with the minimum resources available to the Contractor due to the spreading of COVID-19 around the world and it was not possible to get any special equipment promptly. This has resulted in delays in arranging the equipment and delays in the rectification too.

After the incident, the Contractor failed to propose a mitigation procedure the Engineer issued an instruction which includes the below-mentioned items to follow at the tunnel site after 12 June 2021.

1. Make a sandbag or any other suitable barrier to stop the flow of the collapsed material along the tunnel, as it was observed the collapsed material flowed along the already excavated tunnel due to increasing water.
2. Drill a few hand-arguer holes above the collapsed location to identify the size of the created cavity.
3. Fixing monitoring points at the surface above the cavity and nearby areas to identify any active movement of the area.
4. Identify the laboratory testing to identify the properties of the collapsed and arguer hole material.

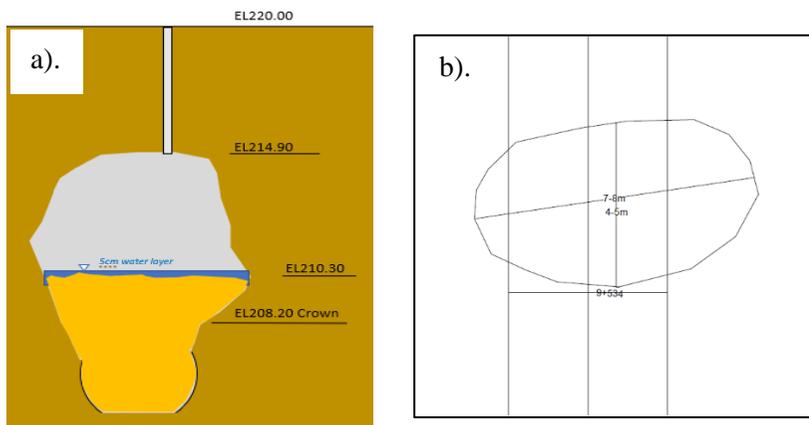
As per the initial arguer hole investigation on 13th June 2024, it was identified a cavity of over 150m³ in size, which is shown below in Figure 6. At the same time an agreed procedure the cavity was started to be filled with 165 m³ of C15 concrete on 14th and 15th June 2024, while

Figure 6 Identified the size of the cavity after initial investigation. a) section view of the cavity at 9+531 and b) plan view of the cavity

The concrete filling continued for two days and two steel pipes were fixed in the concrete body through the arguer holes to monitor any movement of the filled concrete block due to its weight. Also, another 52m³ cement mortar was filled on 17th June 2024 and the sinking of this concrete was monitored after the initial setting of the mortar continuously and those were stable for 12 hours until the sandbag removal for the next agreed procedure on 19th June 2024

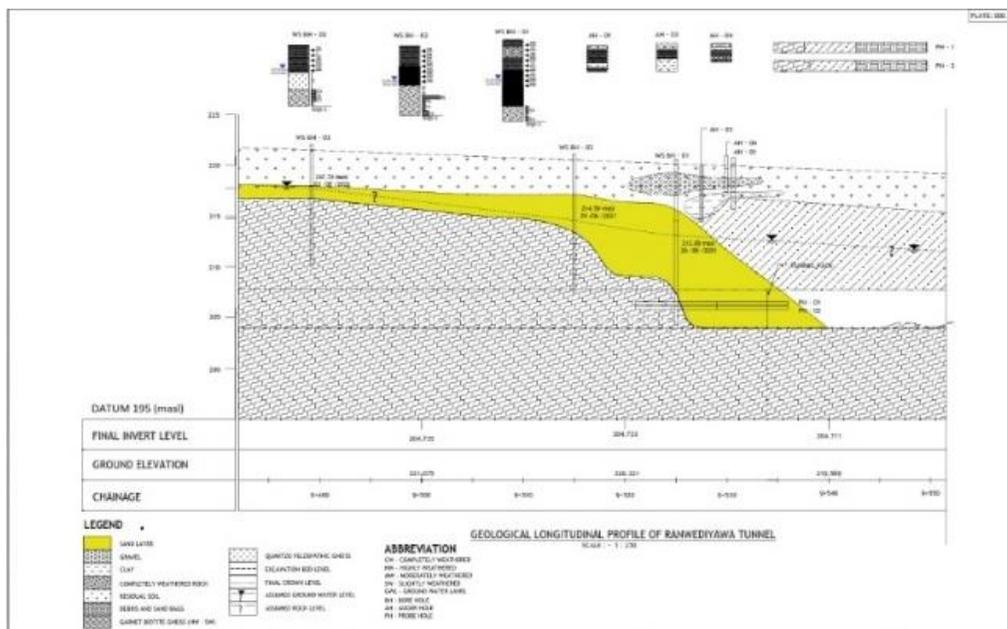
The actual geology of the collapse area is shown in Figure 7 which was the root cause of the collapse which was developed after a few further agreed investigations in the area a few days later. The collapse area has been identified as the sandy formation from the completely weathered pegmatite. The field and laboratory tests confirmed the formation is non-plastic sandy clay with $4.4 \times 10^{-8} \text{ ms}^{-1}$ permeability.

Figure 7 Actual Geology of the Collapse Area

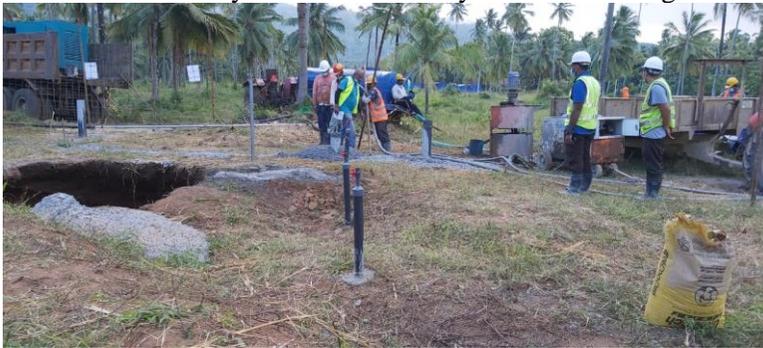
1. Removal of floated material and moving the sandbag barrier at chainage of 9+540, 6 m behind the collapse start location chainage 9+534.
2. Completed the balance invert support works to complete the full ring support as per both parties' agreement and according to the original design support class 4.
3. Same time it was observed continuously sinking the concrete block and stable after touching the hard formation front of the tunnel face and the already completed lattice girder support at 9+534.4.
4. Cavity was daylighted on 23rd June 2024 as a sink hole of 1.2 m diameter and increased by 3-4 m in a few days as shown in Figure 8.

Figure 8 Daylighted cavity and surface drilled holes for investigation and treatment

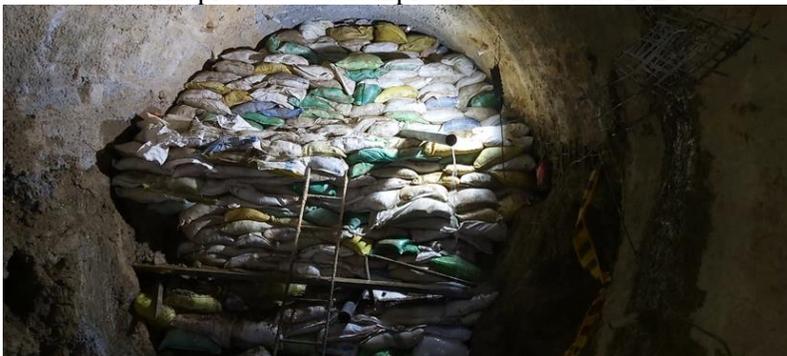
Figure 9 Tunnel face covered with sandbags before filling the gaps with concrete and grout

5. After careful observation it was known some cavities between the concrete block and the natural ground on either side of the concrete block. To treat this, sandbags were filled up to the tunnel crown shown in Figure 9, some concrete was filled through the newly drilled holes from the surface, balance void was filled with grout and this process was completed on 29th June 2024.

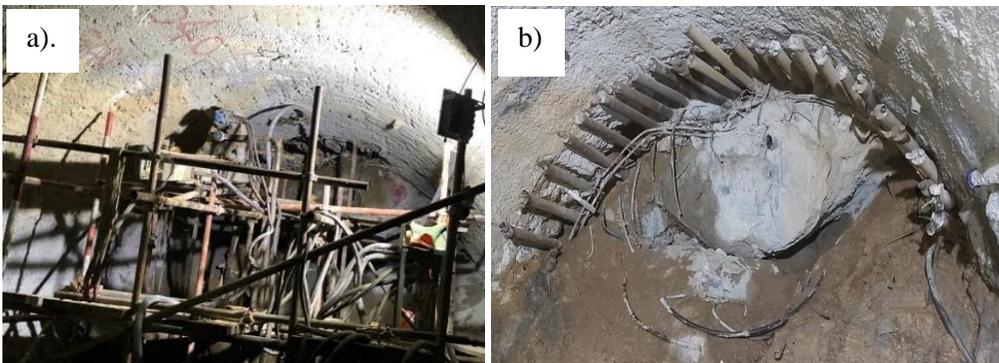
Figure 10 Tunnel face a) on 6th July 2024 and b) on 17th July 2024

1. It was drilled one probe hole at the face to identify the ground condition then another two drain holes at the possible lowest (1 m from the invert) location in the tunnel face were drilled to avoid or minimize the developing porewater pressure in the face. This stage of work continued until 3rd July 2021, also some sandbags were removed to make visible any movements of the casted concrete block while starting the next stage of the agreed procedure.
2. After arranging the drill machine ZBE 100B and the stage preparation as shown in Figure 10 on 7th July 2024, drilling and installation of 24 numbers of long pipe roofing with 87 mm diameter and 12 m length to reach into the hard ground was completed on 17th July 2024 with 32 mm diameter rebar and grouting which is shown in Figure 11.

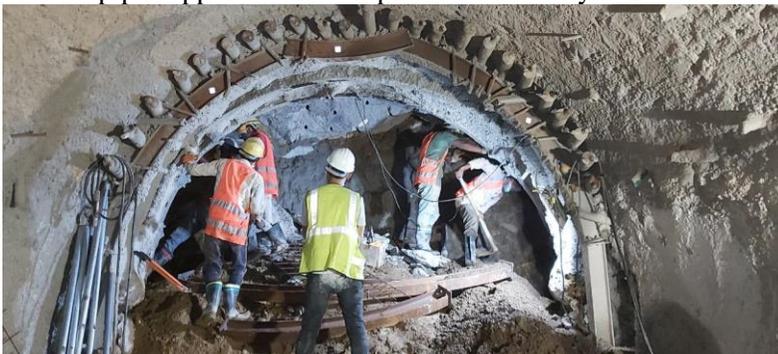
Figure 12 Initial steel arch support and starting of manual cleaning of the drive

3. Start the temporary steel arch with modification to hold the crown already installed pipe supports were completed on 18th July 2024 shown in Figure 12.

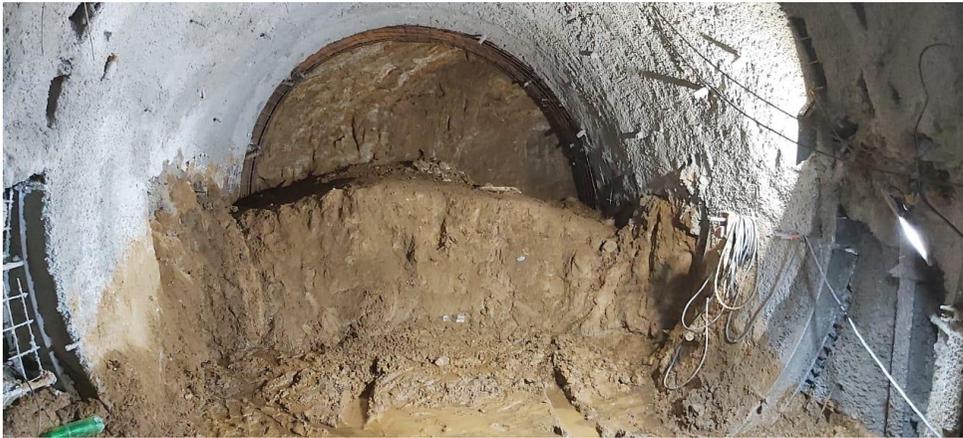
Figure 12 Stagewise excavation and supports at the collapse area

4. Manually concrete block was chipped out after drilling a few holes and the top heading was excavated manually by hand-held machines and supported with steel arch sets as agreed for the next 3 rounds with an average of 1m intervals.
5. Completed the previous balance lattice girder supports after carefully excavating and supporting separately each side wall then completed the invert support to form the full ring support up to 9+536.
6. After that, stagewise the top heading, benching and invert excavation and support work with the steel arch of the full ring as shown in Figure 12 was done to complete the collapse zone up to chainage 9+528. Then only the top heading and benching up to 9+525 were completed with steel arch support and continued the tunnel excavation as per the design support classes as per the face mapping after each round of excavation.

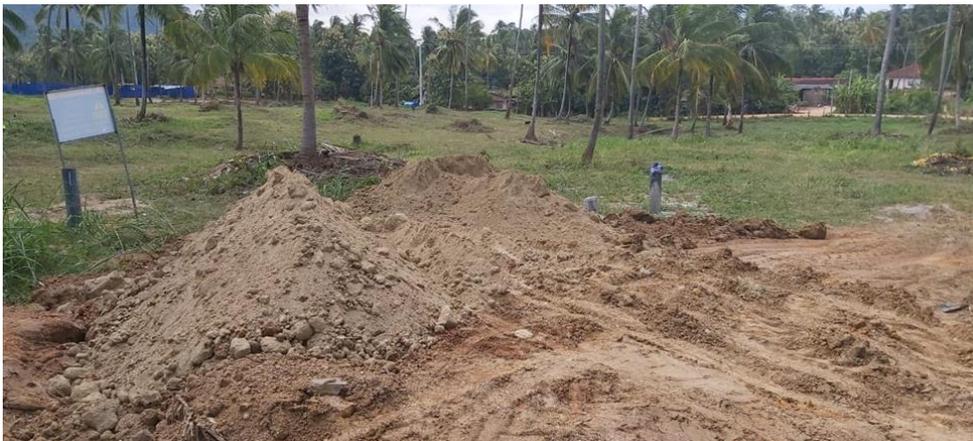
Figure 13 While backfilling the sink hole open-pit

7. Also followed 5 m length of fore polling pipe supports of each 5 m excavation and support work completion to stabilize the tunnel as the long pipes support were installed at an angle of 10° to the tunnel alignment.
8. After passing the collapsed zone excavation and support work, the opened sink hole pit was filled with soil as the agreed working procedure for the treatment of the collapsed zone shown in Figure 13.
9. After reaching the tunnel drive to the hard strata, the first steel rib was rearranged after cutting the steel pipes inside the required tunnel section as designed. Also, the actual supports of the tunnel chainage between 9+540 to 9+515 are shown in Figure 14 which gives the variation of the supports with design in this tunnel section.

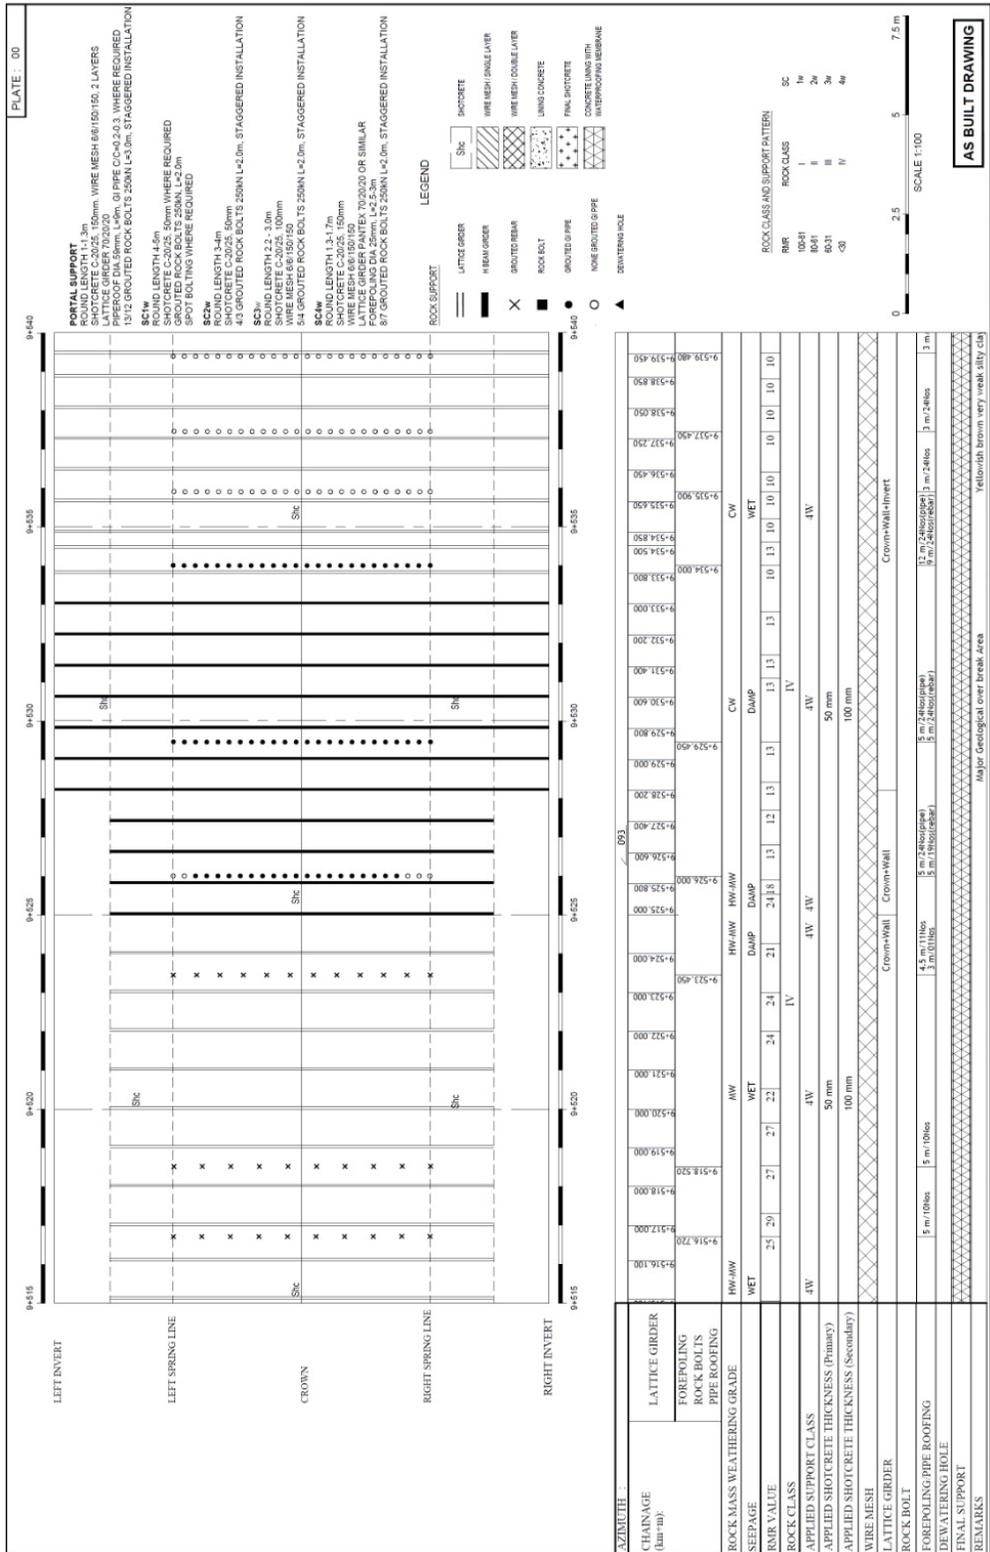
Figure 14 Actual support followed between chainage 9+540 to 9+515 to show the variation of the support system due to the collapse
