LB/DOR/77/2018

INVESTIGATION OF STRUCTURAL DEFECTS IN GOVERNMENT HOSPITAL BUILDINGS IN SRI LANKA

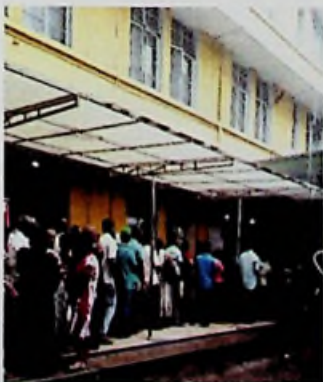
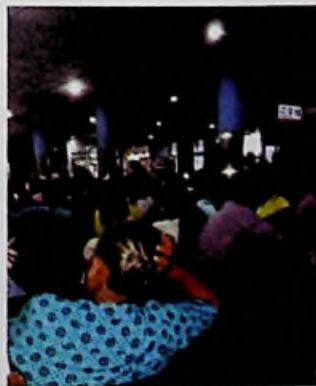
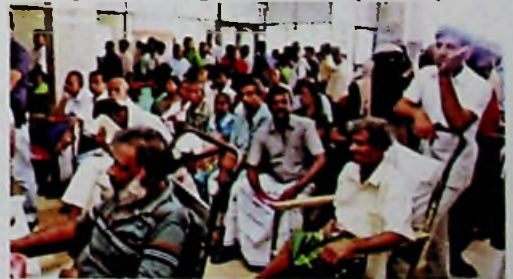
Figure 1.1: OPDs full of patients

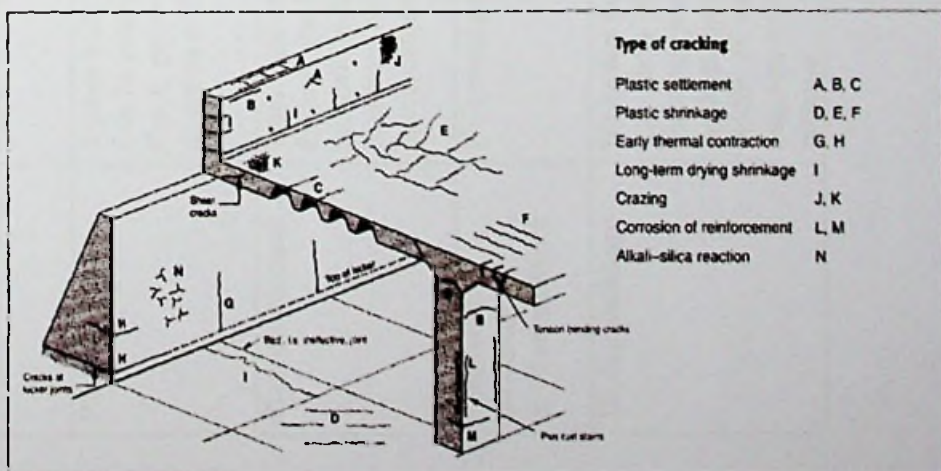
Figure 2.1: Examples of intrinsic crack in a hypothetical structure [11].

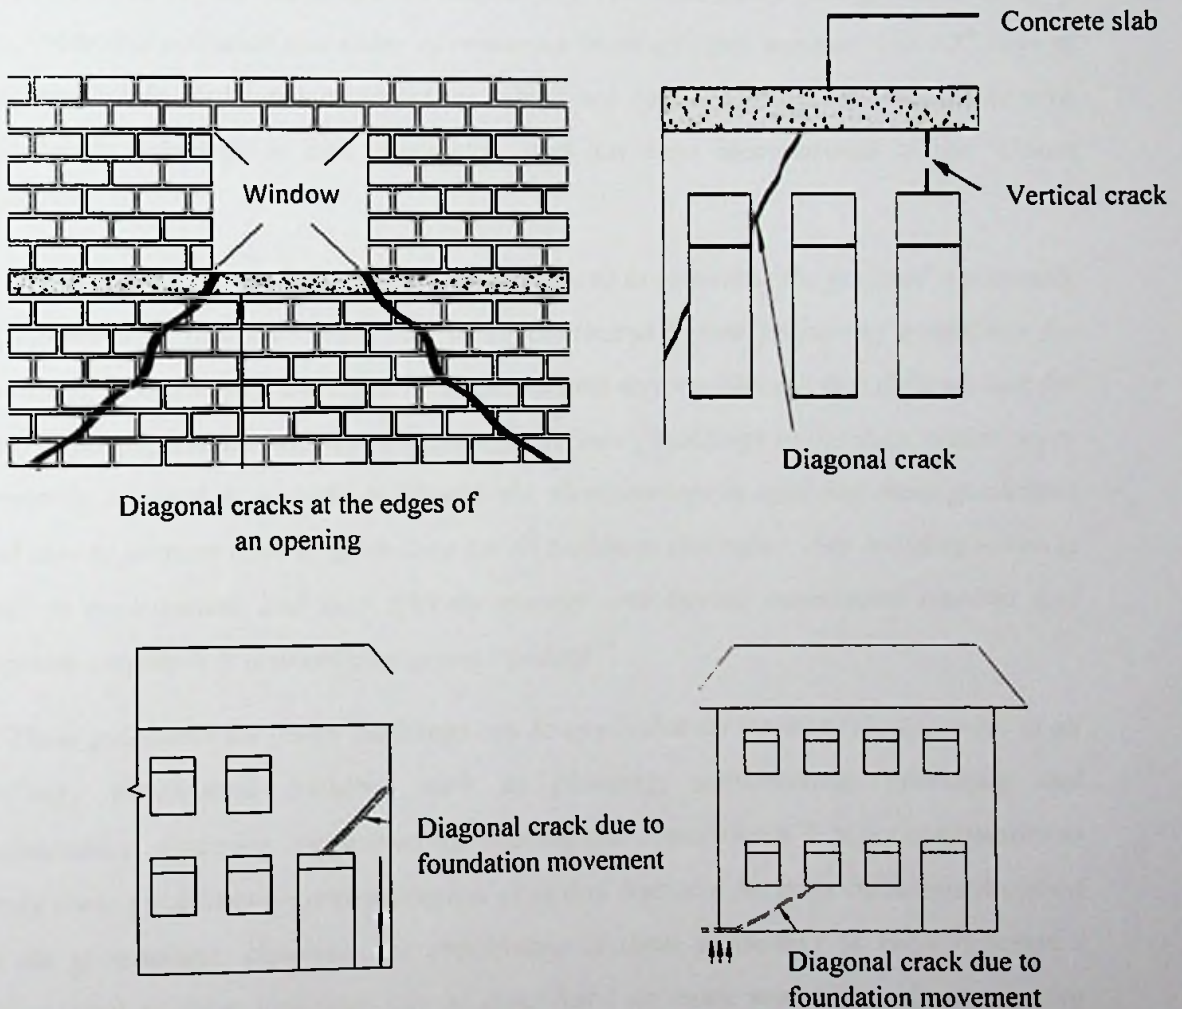
Figure 2.2: Diagonal cracks at Masonry walls

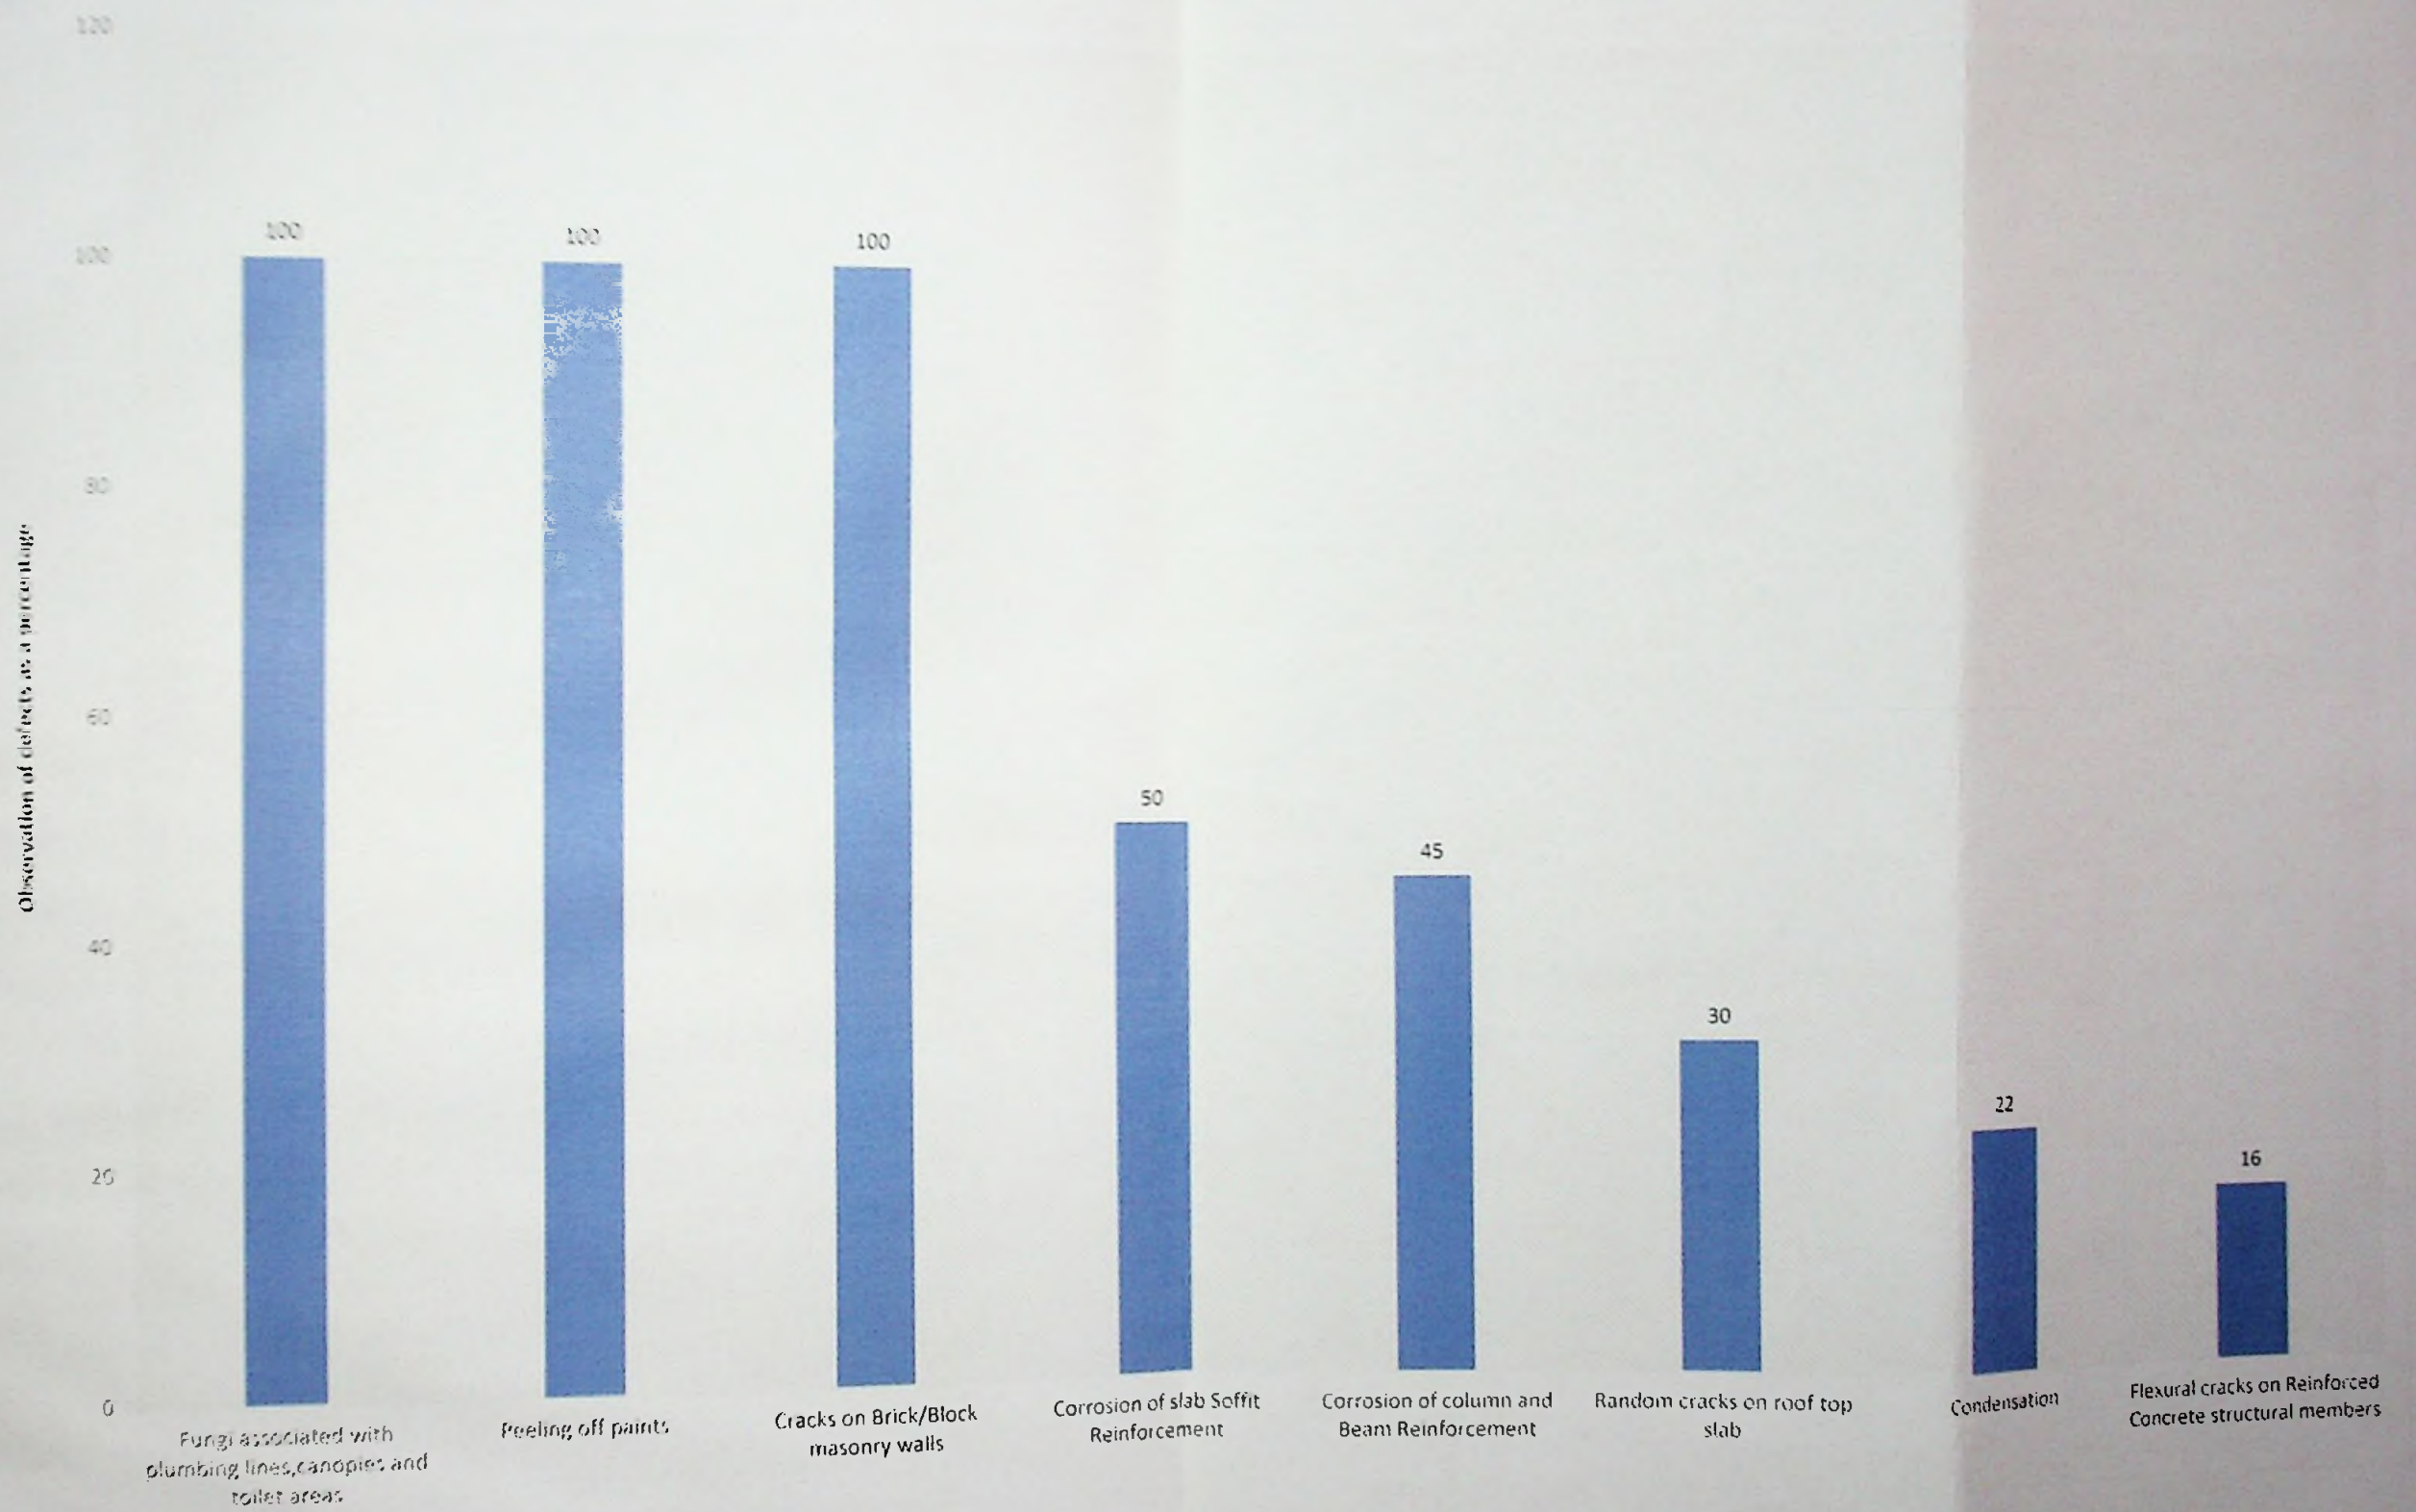
Figure 3.1: Quantitative analysis of Common Defects as per the observations

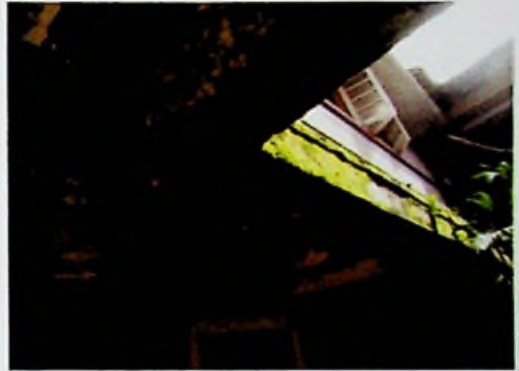
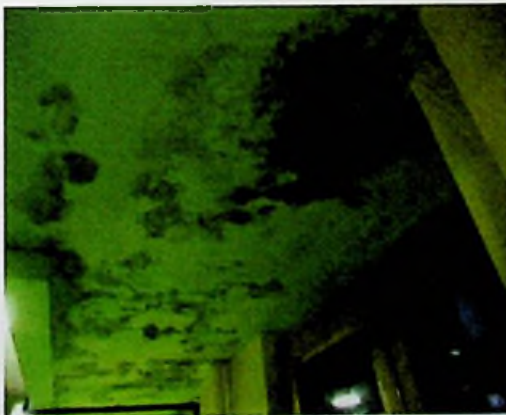
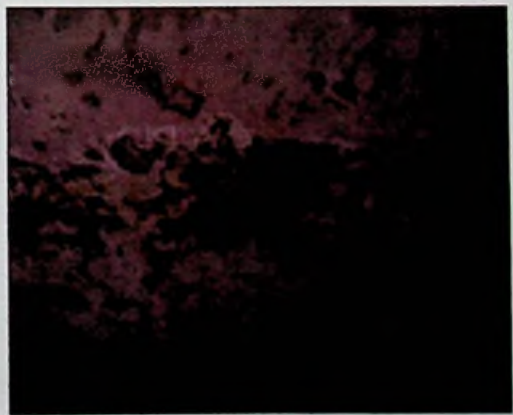
Figure:3.2: formation of fungii,peeling off and blistering of paint at LRH

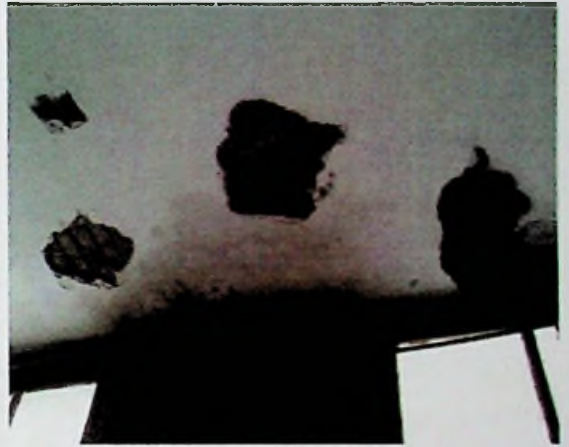
Figure 3.3: Corrosion of reinforcement of slab soffits of OPD building of LRH

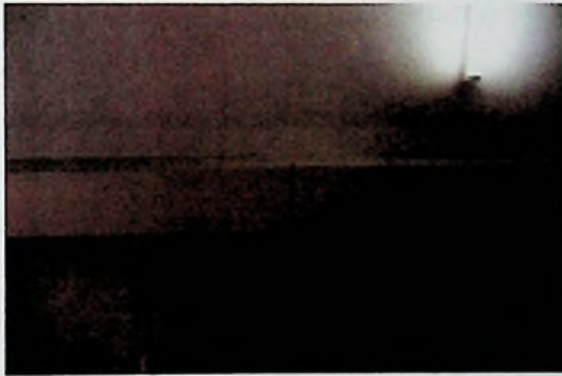
Figure 3.8: Flexural cracks on beams

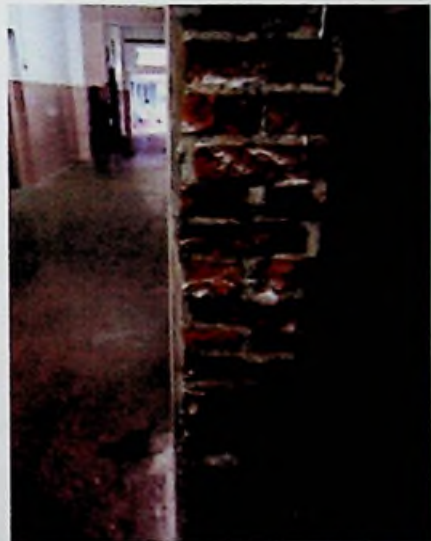
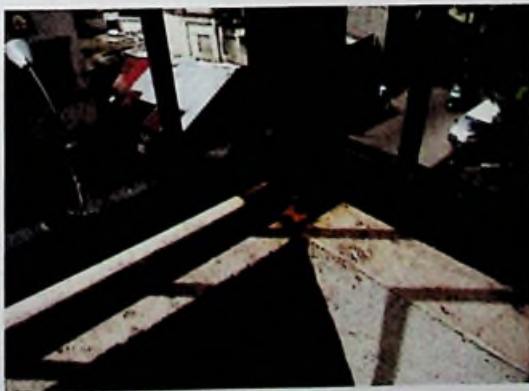
Figure 3.10:
Walls of Block masonry in 02
years old Nephrology and
Neurology wards of LRH

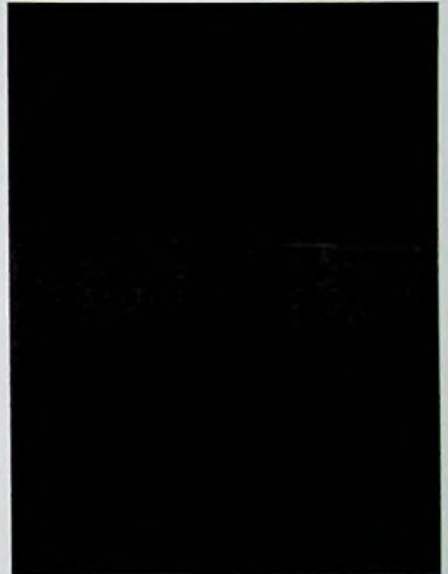
Figure 3.12: Cracks in nine-story building - LRH

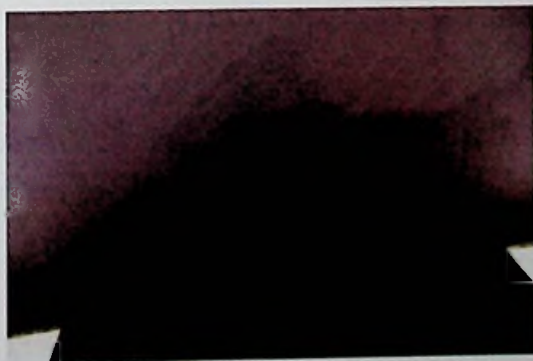
Figure 3.13: Water damp patches at LRH

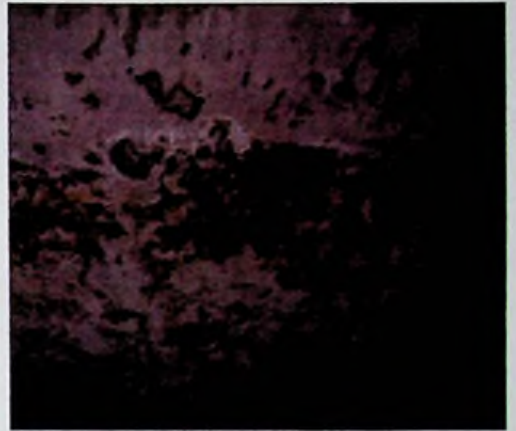
Figure 3. 15: - Fungi and deterioration of wall plasters of OPD Building -LRH

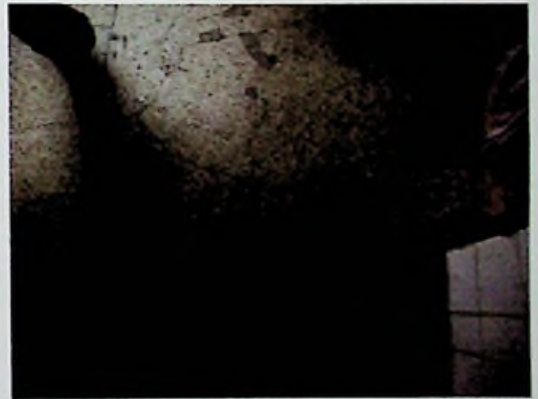
Figure 3.16: Cracks in wall and floor tiles of nine-story building at LRH

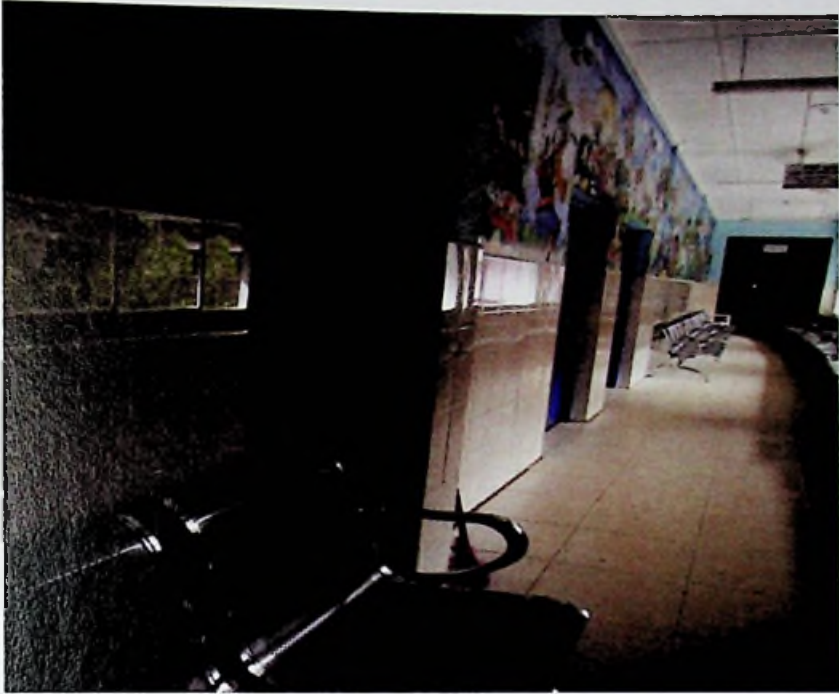
Figure 3.18: A Lobby area finished with locally manufactured tiles in OPD building at LRH renovated with local funds

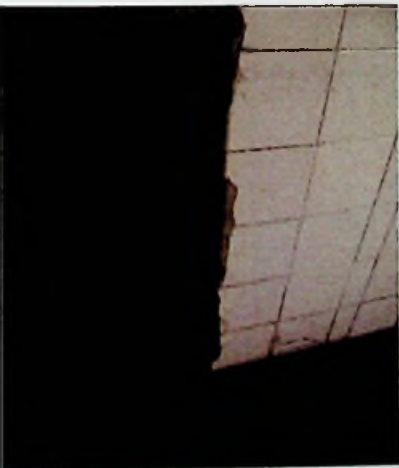
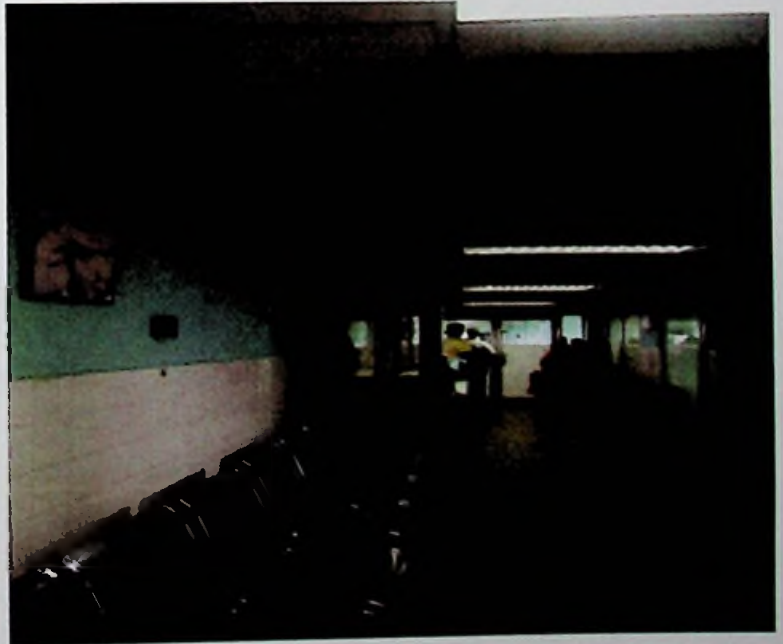
Figure 3. 19: A Lobby area finished with imported tiles in recently constructed nine-story building in LRH renovated with foreign funds
