MEASURES TO REDUCE TRANSFORMER FAILURES IN THE DISTRIBUTION NETWORK OF CEB

A dissertation submitted to the
Department of Electrical Engineering, University of Moratuwa
in partial fulfillment of the requirements for the
Degree of Master of Science

February 2011

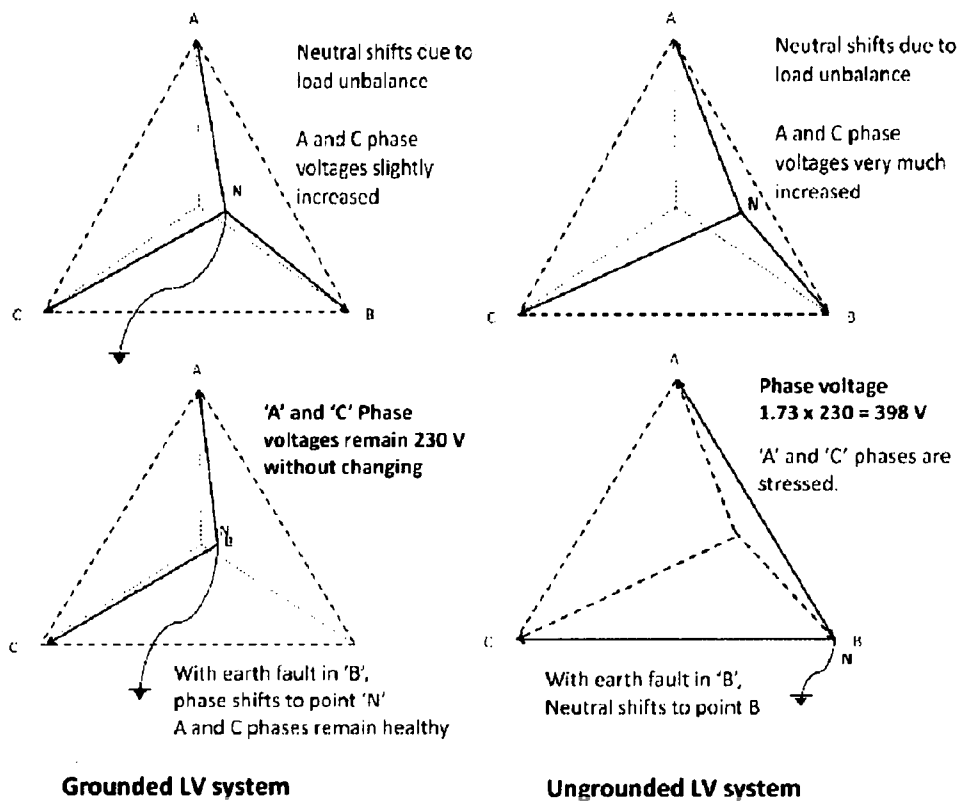
Figure 2.1: Effect of phase earth faults in LV systems with and without neutral point earth

LV voltage unbalance can cause sustained stresses. Unbalance in loading can be a reason for this. Load balancing is done by CEB mostly based on the loading data collected at the peak hour, which falls between 7 pm to 10 pm. It is found that loading pattern of the consumers change from day time towards the peak time, so that any balancing carried out based on the peak hour's data can cause unbalance during the non-peak day time. Also if the neutral earth cable is absent or the neutral earth is weak, unbalance becomes more severe. This situation can be worse if a phase to earth fault happens at the LV side, where the voltage of the healthy phases can reach upto the line voltage (see figure 2.1).

When the LV neutral earth is weak or absent, if any intermittent phase to earth fault happens, that can generate very large voltages in the magnitude of six to eight times the nominal voltage at the healthy phases. This is due to the persisting arc at the ground fault location and high frequency current oscillations associated with. These types of faults are commonly caused by touching of plants and trees. When an arc is established, even if the branch that caused the earth fault is burnt out, the arc created persists for a longer duration than expected, due to ionization of the surrounding air. This phenomenon is called 'arcing ground', which is very harmful to the transformer's winding and insulation. As the 33 kV HV network is not a solidly earthed system, again if the ground fault is arcing or intermittent type, there is possibility of having very high transient over voltages at the healthy phases. These transients at the HV side can cause fatigue on insulation and subsequent failures in the insulation system of the transformers, leading to extensive damages.

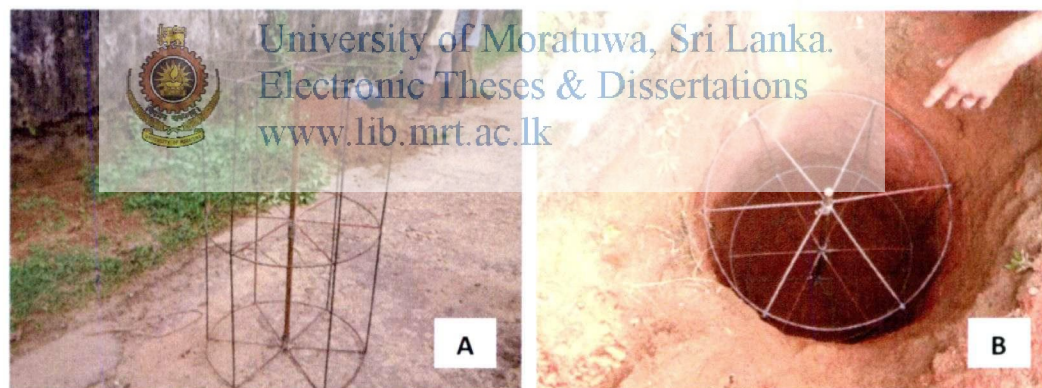
Figure 2.3 : Concrete Mesh Earth (A) Mesh before concreting, (B) Mesh inserted into the ground pit before concreting
(Original is in colour)

It is found in transformer installations, earth resistances are greater than what it should be. It must be ensured that the earth resistance is within the acceptable limit (less than 20Ω) to have proper protection of the transformer [7]. In CEB's installation practice, now mostly practiced grounding method is the concreted mesh method (see figure 2.3).

It has shown that by putting this concrete block, earth resistance is drastically reduced compared to that of a single rod earth, but still it is showing unacceptable higher readings. The mix of the concrete used is the normal construction mix. Since the strength of the earthing structure is not the prime requirement, this mix can be revised. A study is initiated on this which is described in chapter 3. In this study, kind of 'conductive concrete' is experimented with commonly available material.

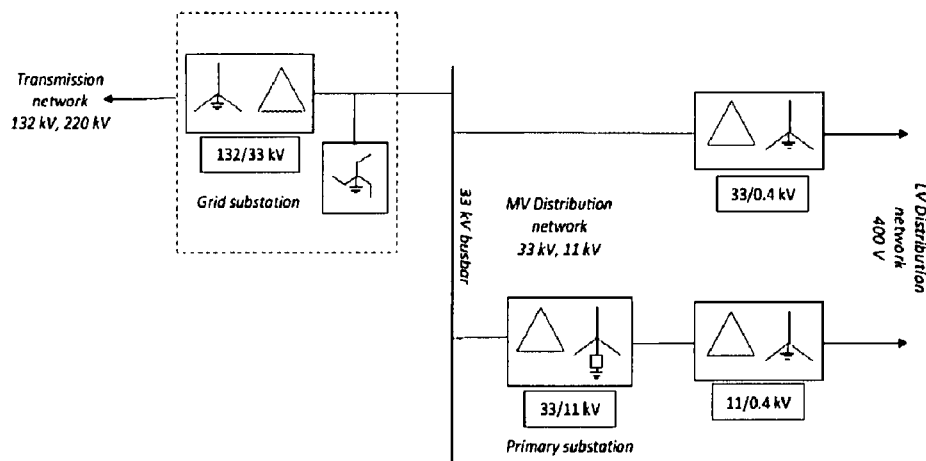
Figure 3.1 : Distribution network configuration of CEB

Distribution transformer's HV primary is delta connected and the secondary LV distribution side is star connected with its neutral earthed once at the transformer installation (T-T configuration). Consumer is supplied with the 400 V secondary distribution lines run overhead (see figure 3.1). The consumer's protective earth and the transformer's LV neutral earth provides a fault current path through the ground upto the supply transformer in case of earth fault, until the house hold protection activates and trips the circuit. LV distribution circuits running from the transformer are connected through LV fuses to prevent overloading of the transformer. These fuse cutouts are fixed onto the transformer pole itself.

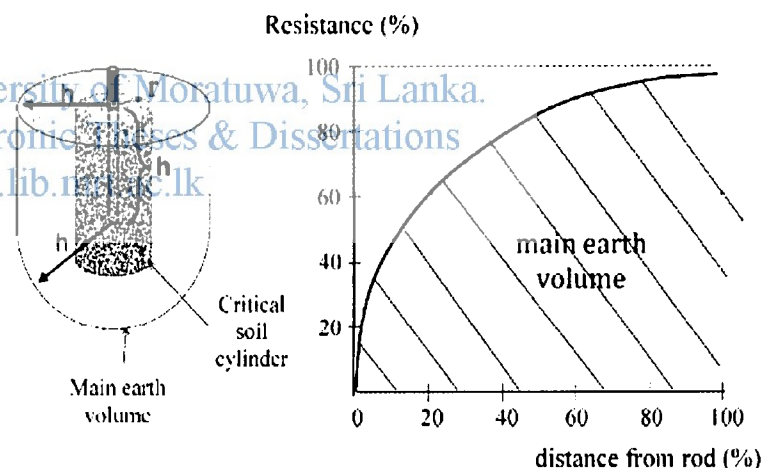
Figure 3.4 : Illustration of critical soil volume
(Original is in colour)

For effectively dispersing the lightning surge current, earth impedance has to be brought to an acceptable level. It is found in most of the transformer installations earth resistances are greater than what it should be. It must be ensured that the earth resistance is within the acceptable limit (less than 20Ω). Presently a meshed concrete block is used for earthing at the transformer installations. The principle behind this is the improvement of critical soil volume that influences mostly for the earth resistance. From the figure 3.4 it is seen that the soil beyond a distance roughly equal to the rod length, do not contribute to improve the overall earth resistance. In order to get the plateau of the curve further down, a practically possible soil volume is selected and treated. This is shown as the critical soil cylinder in figure 3.4. CEB uses a steel mesh with 60 cm in diameter and 110 cm in height with the copper clad earth rod inserted in the middle. This is placed inside a pit dug on the ground, and concreted. Diameter of the concrete block becomes roughly 80 cm.

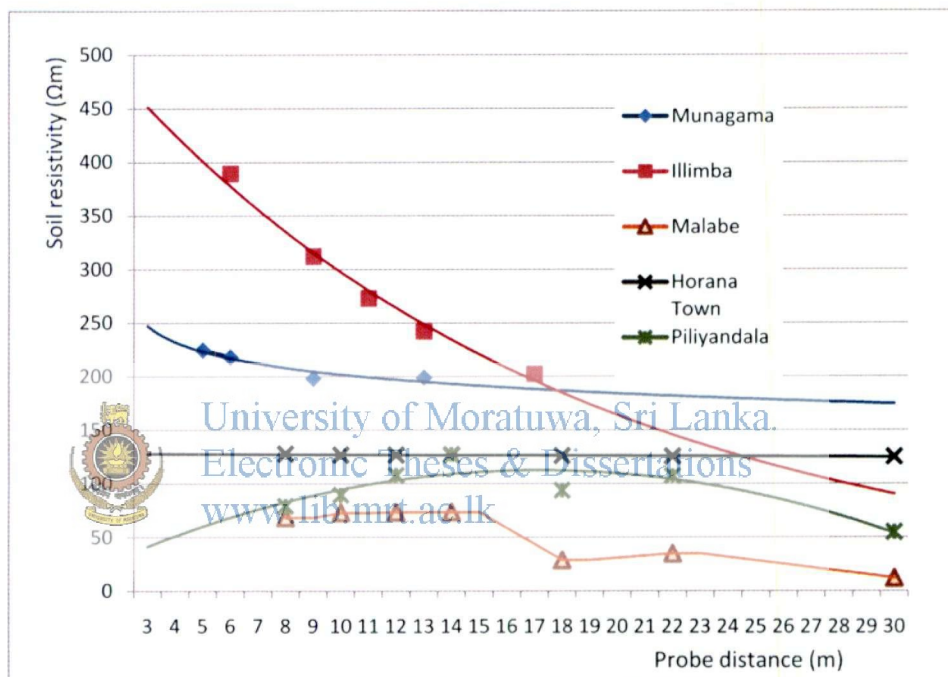
Figure 3.5 : Soil resistivity graphs (20% moist soil)
(Original is in colour)

It is seen that most of the sites are having multi layer soil profiles (eg : Illimba, Munagama, Malabe). Top soil resistivity matters for the measured earth resistance. We could observe the top soil resistivities (at low probe distances) are around 200 Ωm to 400 Ωm in Illimba and Munagama sites while Malabe, Horana Town and Piliyandala sites exhibit low resistivities (around 50 Ωm to 150 Ωm). Due to geographic reasons, most lightning prone areas are having higher soil resistivities (rocky soils). Hence the suitability of the present earthing system is questionable. An improved earthing method has to be investigated. Studies are in progress on different earthing methods that can be adopted.

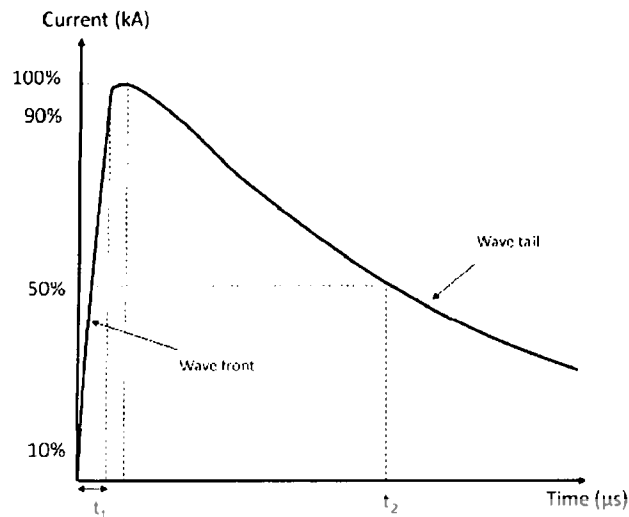
Figure 4.1 : Lightning surge current waveform

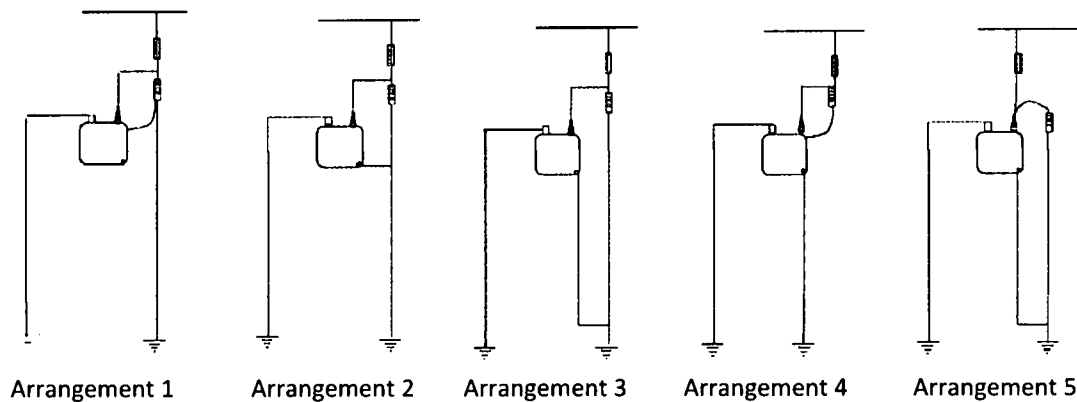
Figure 5.1 : Transformer installation arrangements used for transient analysis

Here also the flexible leads of the arresters connect to the transformer tank first. Then the earth lead connects to the tank's earth flange, separately.

Compared with arrangement 1, arrangement 4 has its advantages in installation as it uses only the available connectors and flanges. However, it is observed that the mild steel transformer tank also becomes a part of the surge current path that contributes to lead length.

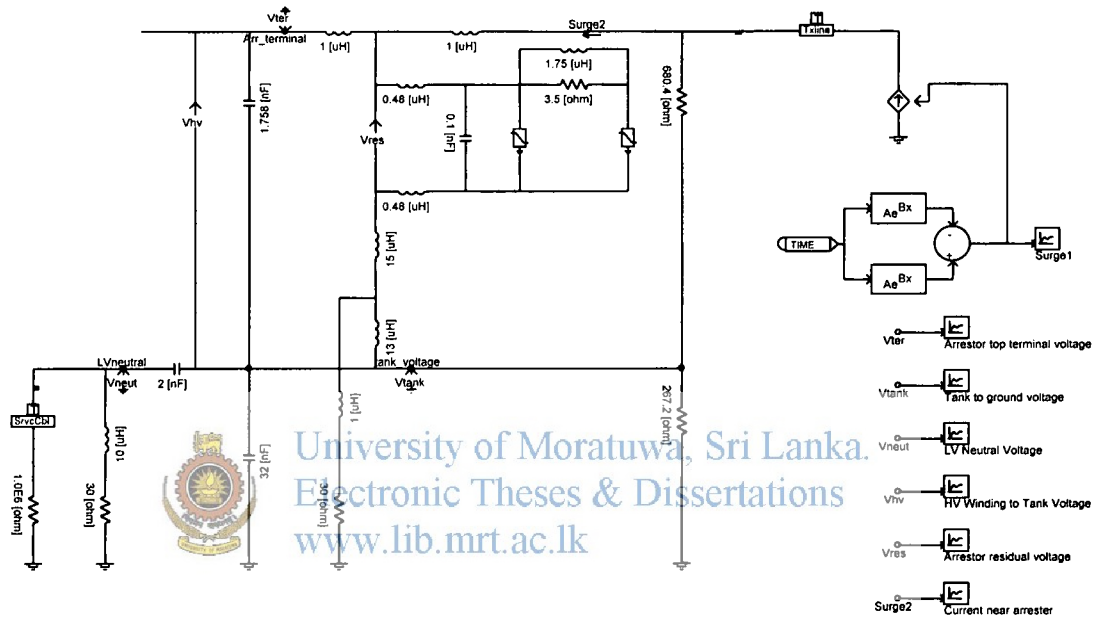
Figure 5.6 – Installation arrangement 3 modeled in PSCAD

Figure 5.6 shows the installation arrangement 3 as a PSCAD model. The length of the cable connecting the arrester's bottom terminal to the earth is taken as 5 m, hence $15 \mu\text{H}$ is given, considering the bends. The tank connection that runs to the earthing point is about 4 m in length, but is having bends. Hence, $13 \mu\text{H}$ is given for this, taking into account the inductance due to bends and the connecting inductance. Inductance of $1 \mu\text{H}$ is given for the earth rod.

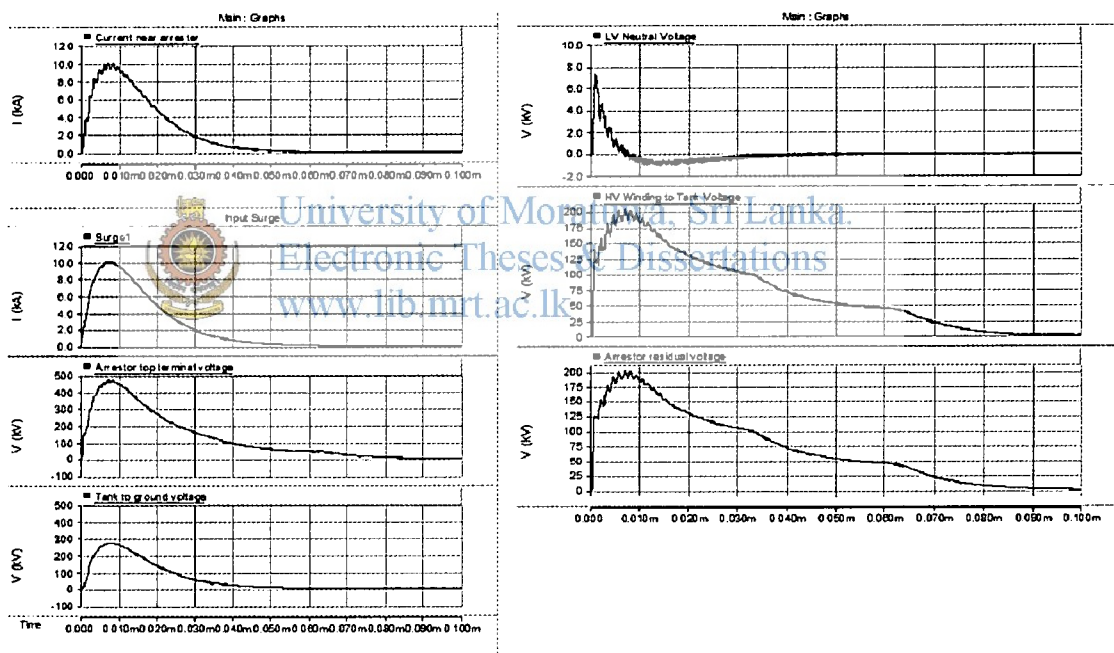
Figure 5.10 - Output plots for arrangement 1 with 10 kA , $8/20\mu\text{s}$ waveform

Output plots of the simulations done for 10 kA , $8/20\mu\text{s}$ surge current waveform are shown in the figures 5.10 to 5.14. Further, sensitivity analysis is done for all the five waveforms given in the table 5.1. As we are interested only on the peak voltages, peak values are extracted from the output plots and are summarized in table 5.2.

Surge waveform		Unit	Simulation arrangement (as per figure 5.1)				
			1	2	3	4	5
5 kA, 8/20 μ s	I_{surge}	kA	4.9	4.8	4.8	4.7	4.9
	V_{ter}	kV	269	269	267	270	267
	V_{res}	kV	133	133	131	132	131
	V_{tank}	kV	136	135	135	134	135
	V_{hv}	kV	135	136	182	169	193
	V_{neut}	kV	3.3	3.1	3.6	3.3	3.8
10 kA, 8/20 μ s	I_{surge}	kA	9.8	9.9	9.9	9.8	9.9
	V_{ter}	kV	473	474	467	475	469
	V_{res}	kV	202	200	196	197	196
	V_{tank}	kV	273	271	271	270	270
	V_{hv}	kV	204	207	313	279	339
	V_{neut}	kV	7.2	6.7	7.2	6.6	7.6
20 kA, 8/20 μ s	I_{surge}	kA	19.7	19.7	19.8	19.6	19.7
	V_{ter}	kV	896	900	882	898	886
	V_{res}	kV	354	351	340	343	341
	V_{tank}	kV	546	543	541	539	541
	V_{hv}	kV	359	366	555	477	617
	V_{neut}	kV	15	14.5	14.2	13.2	14.3
10 kA, 1.2/50 μ s (Steep wave)	I_{surge}	kA	9.9	9.8	9.8	9.7	9.8
	V_{ter}	kV	609	647	1324	1229	1460
	V_{res}	kV	331	360	362	396	360
	V_{tank}	kV	317	300	273	281	277
	V_{hv}	kV	422	572	1237	1113	1365
	V_{neut}	kV	40	39	34	38	34

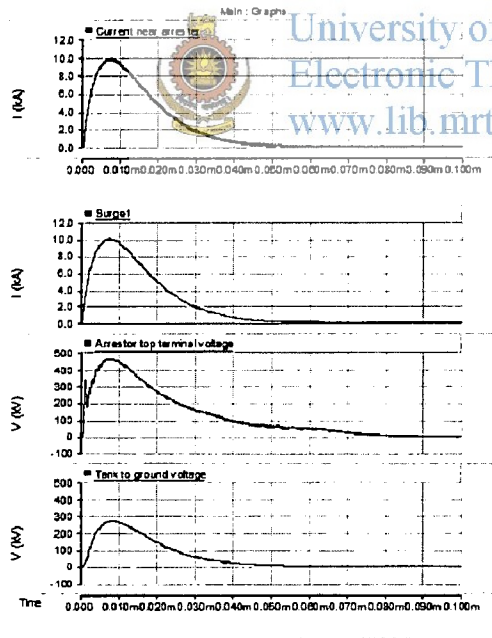
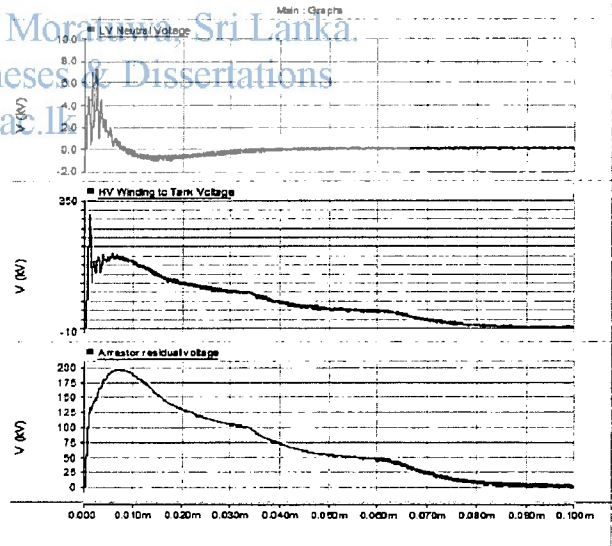
Figure 5.12 - Output plots for arrangement 3 with 10 kA, 8/20 μ s waveform

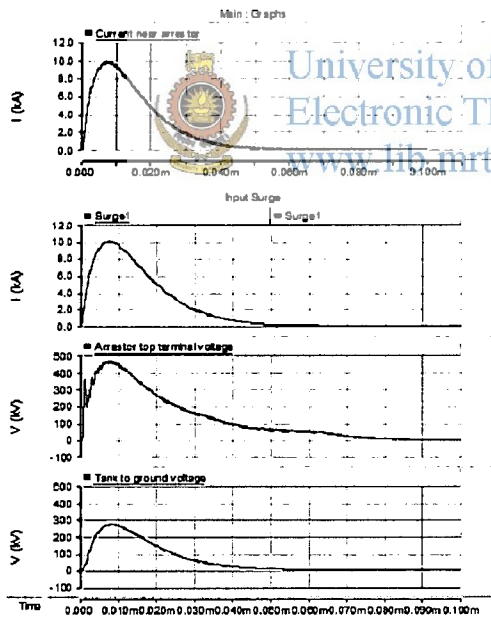
Figure 5.14 - Output plots for arrangement 5 with 10 kA, 8/20 μ s waveform

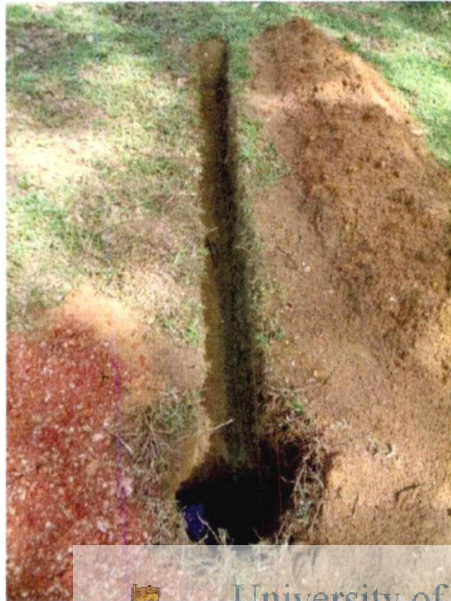
Pit dug for installing the earth

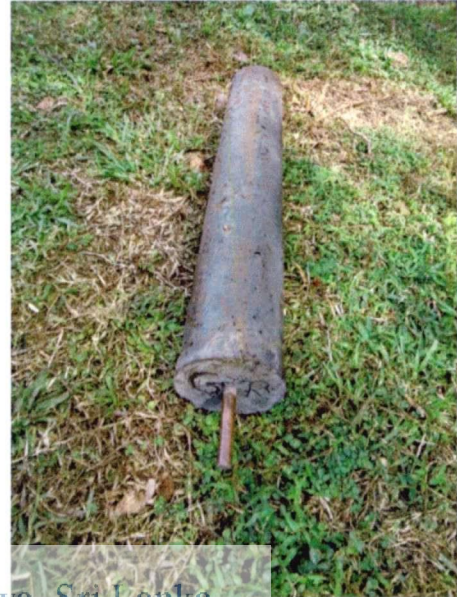
Pre cast earth cylinder

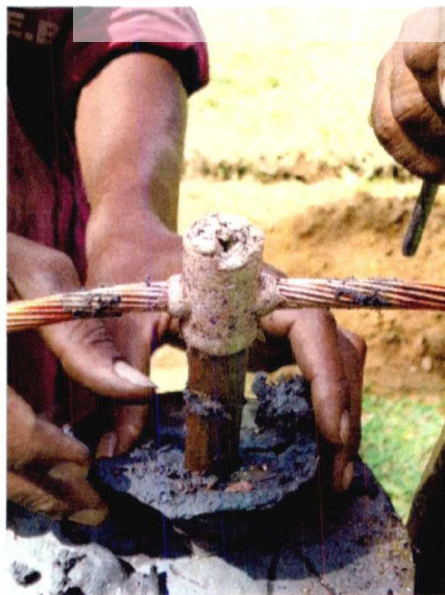
Exothermic Welding of the copper Conductor

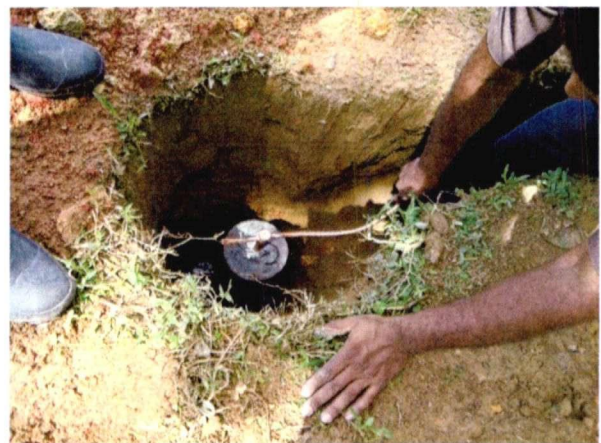
Laying the horizontal cable part

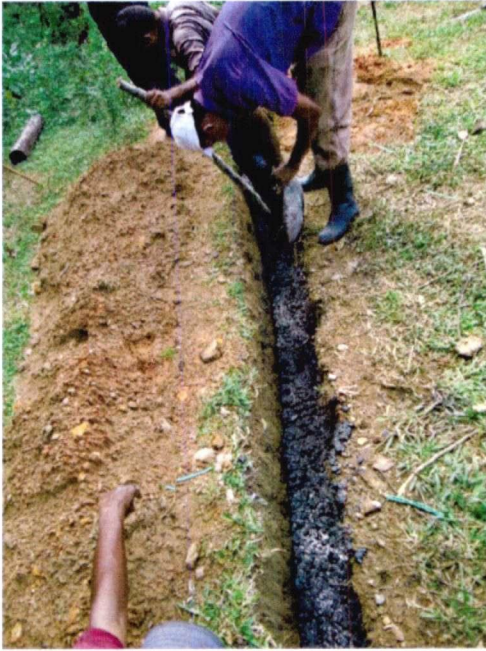
Covering the horizontal cable part with conductive concrete mixture

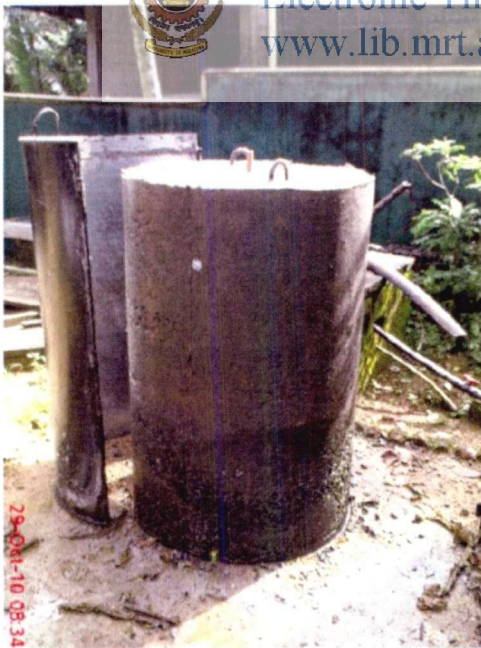
Presently used meshed concrete block pre cast at site to obtain a smooth surface

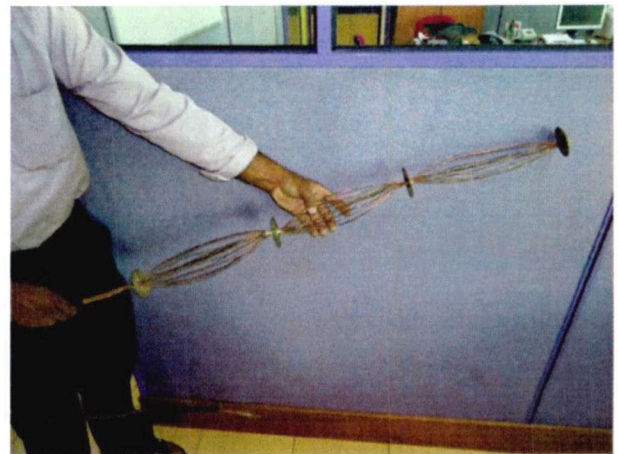
Copper conductor outer strands separated to be laid inside the cylinder – no joints
