**INVESTIGATION ON LIGHTNING IMPACT TO
NEIGHBORHOOD GROUPS DUE TO THE
TELECOMMUNICATION TOWERS**

Degree of Master of Science

Department of Electrical Engineering

May 2012

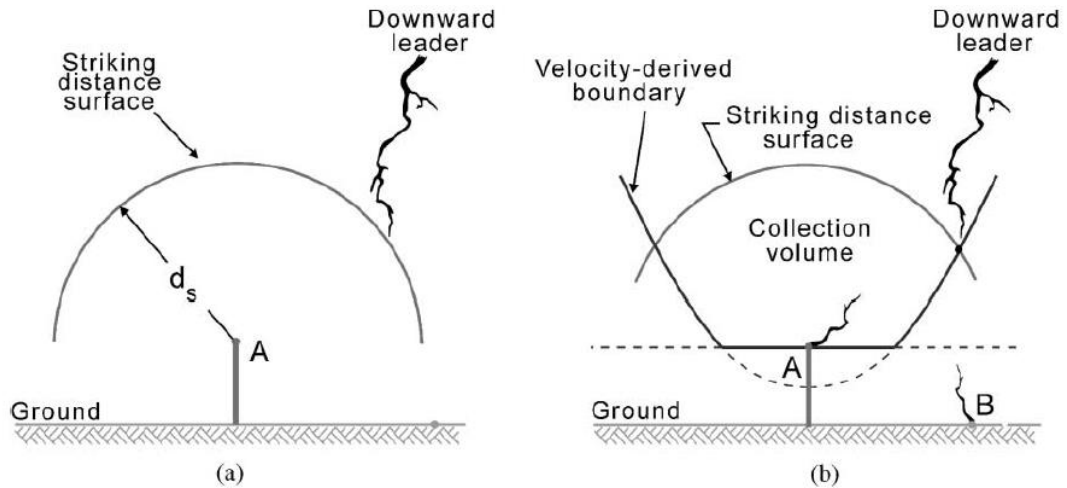
Figure 1.7 (a) Iterative calculations which apply the leader inception criterion give rise to a striking distance surface above the point. (b) Application of a leader propagation and interception criterion leads to a velocity-derived boundary, completing the collection volume of the point on the structure.

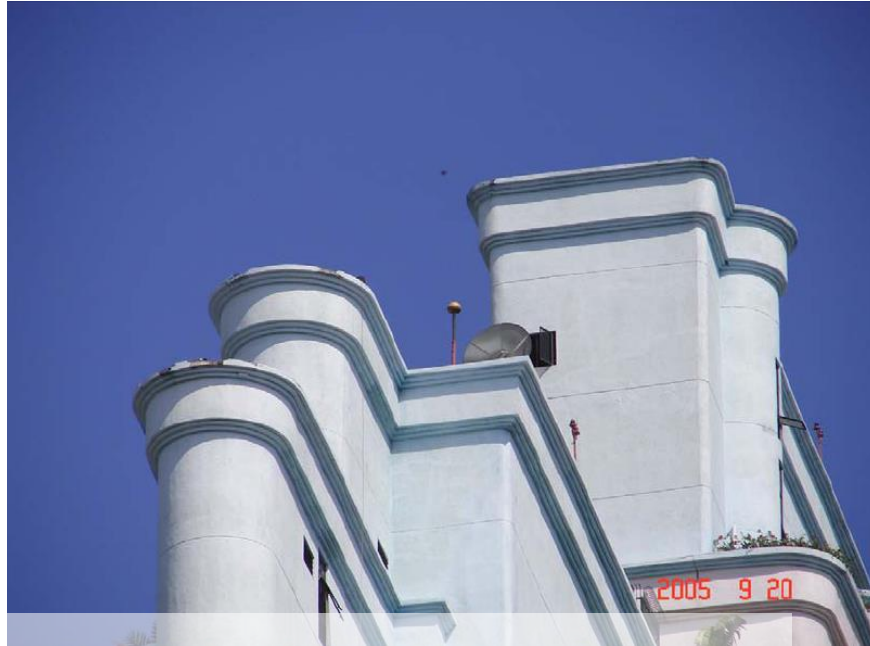
Figure 1.11: A view of the Villaputti building from a different angle. Since the curved edges had been struck by lightning repeatedly, the claimed existence of the collection volume is doubtful.

For easy explanation, we can consider a lightning incident happen in Villaputri Building, downtown Kuala Lumpur in year 2005. This 170 meter high building was installed with two Dynasphere air terminals. The unique feature of this building is that most of the corners are curved instead of angular thus giving the two Dynasphere air terminals the maximum opportunity to collect all lightning strikes that come within their claimed enhanced "collection volumes". However, several bypasses have been observed as shown in below Figure on the curved corners which are not supposed to have any collection volume, thus dispelling the CVM hypothesis [15].

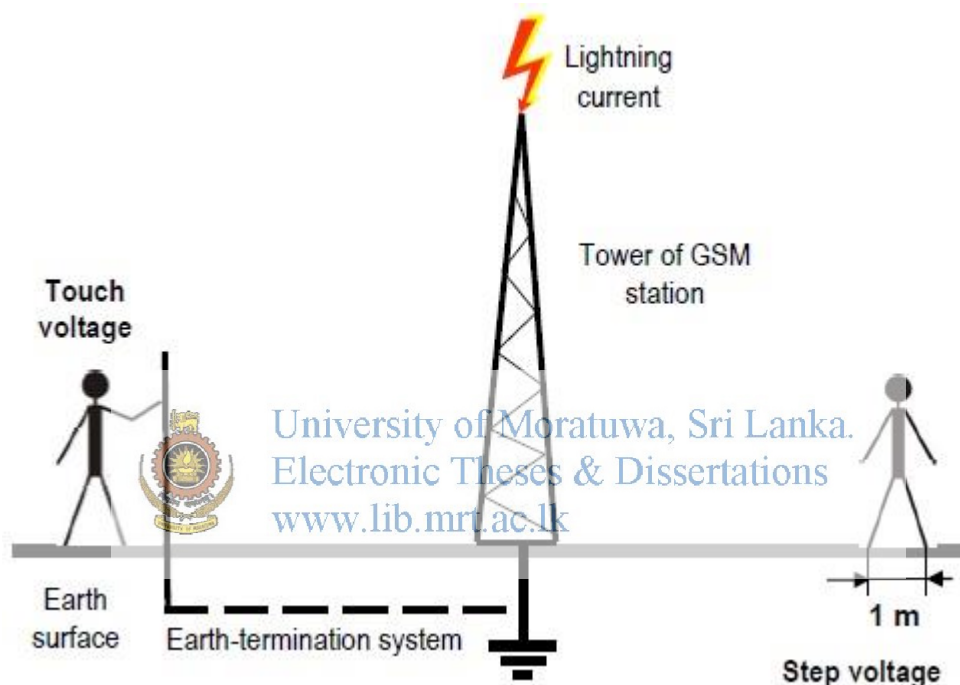
Figure 1.12: Transient step and touch voltages

Therefore it is very important to know about the distribution of step, touch and earth potential rise around the telecommunication tower. The step voltage is defined as the potential difference between one's outstretched feet, usually 1m apart. The touch voltage is the potential difference between one's outstretched hand touching an earthed structure and one's feet. The maximum hand-reached distance of 1m is usually assumed. Detail graphic representation of step and touch voltages is presented in Figure 1.12.

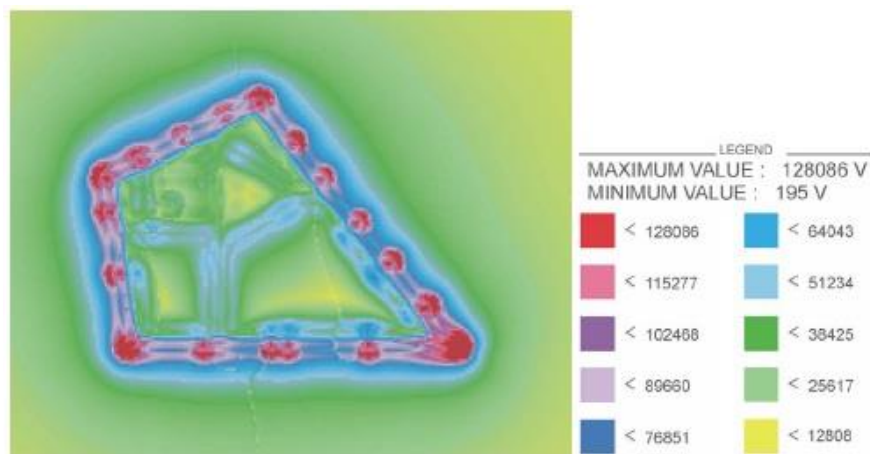
Figure 1.16: Step voltages in and around the base station

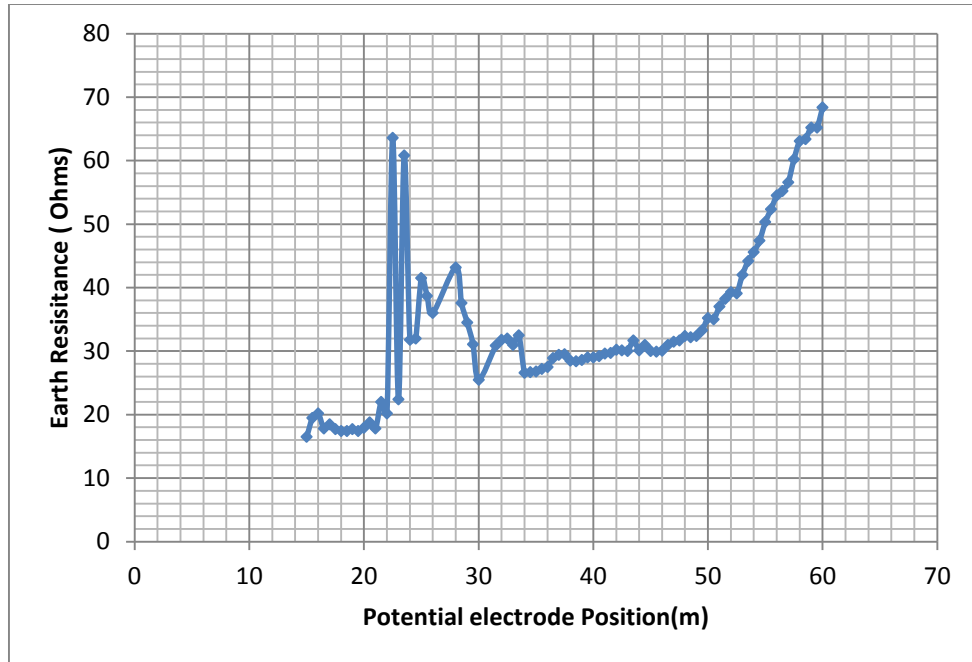
Figure 3.8: Fall of potential curves for Erathna Radio base station
(Source: Author)

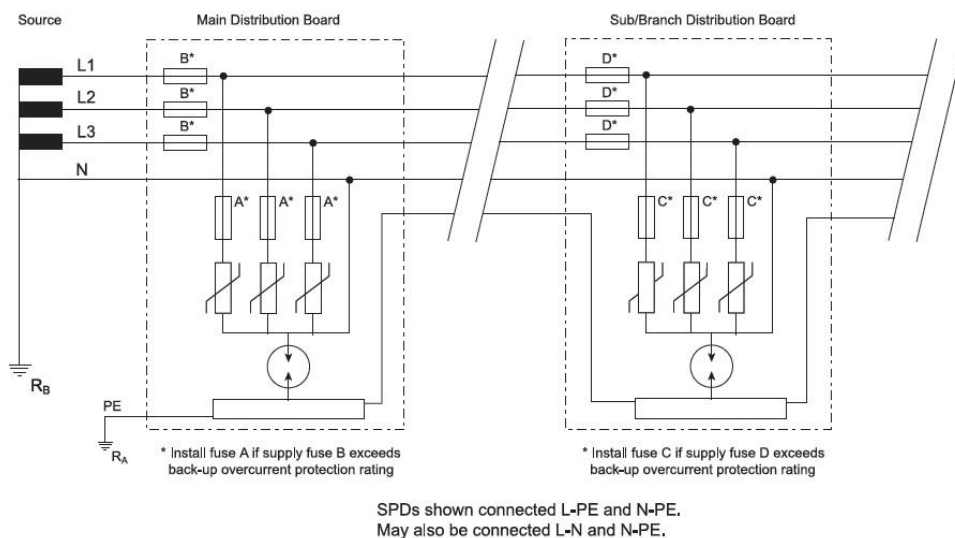
Figure 3.9: Power Distribution Systems and SPD Installation
(Source: ERICO Lightning Technologies)

In Sri Lanka we follow power distribution system as TT system. The system having one point of the source of energy earthed and the exposed-conductive-parts of the installation connected to independent earthed electrodes.

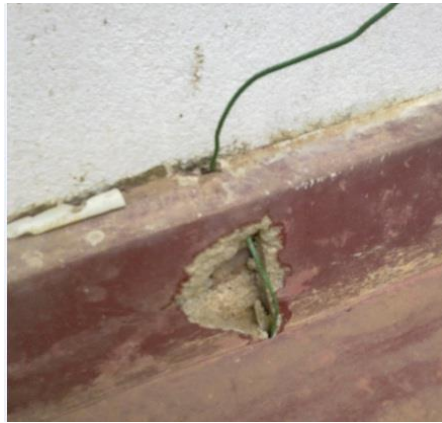
Figure 3.20: wall damages reported in homes near the Madampegama telecommunication tower

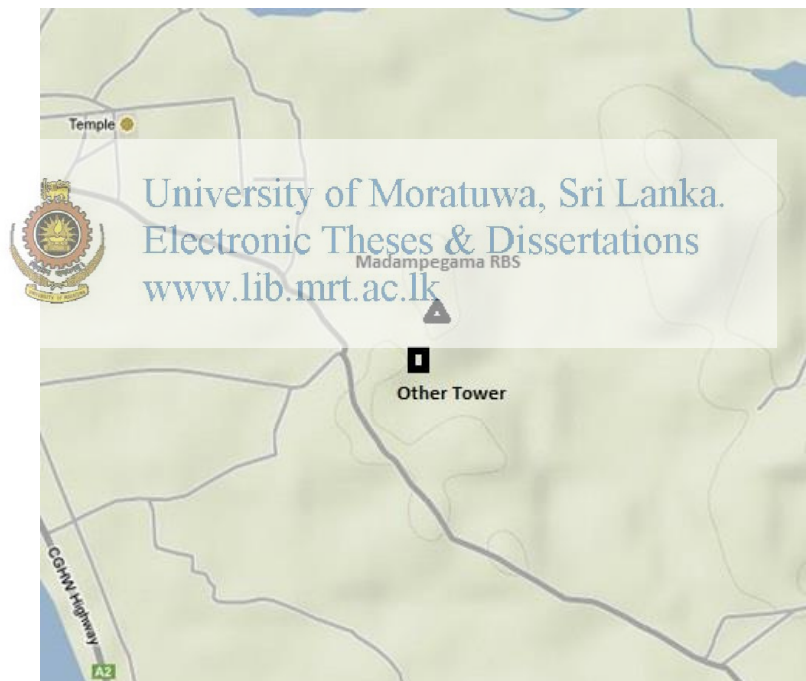
Figure 4.2: Contour map -Madampegama site with respect to other operator site

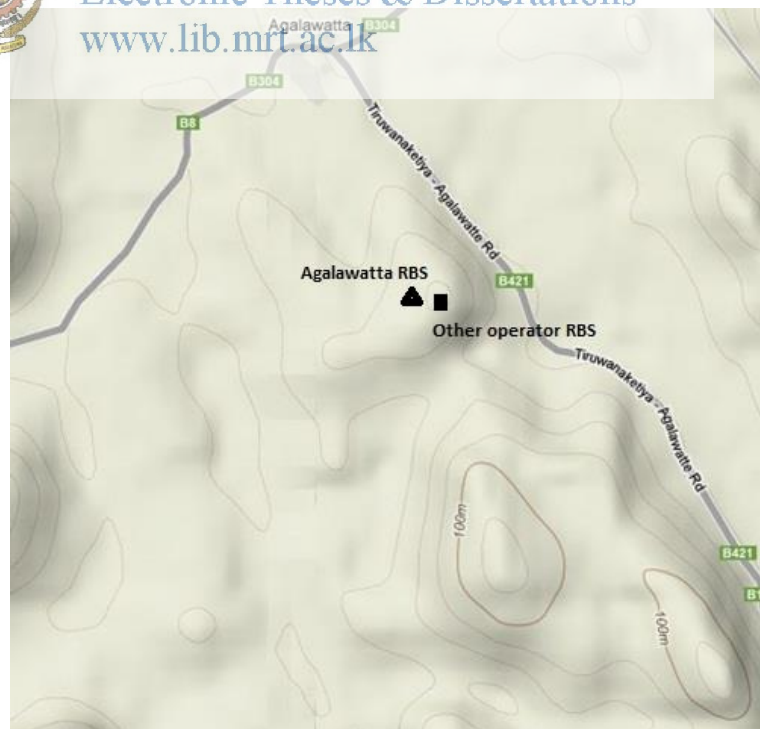
Figure 4.4: Contour map -Agalawatta site with respect to other operator site

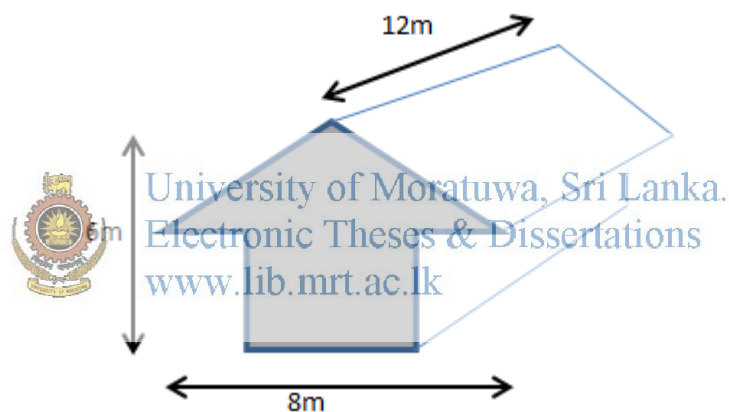
Figure 4.7 Dimensions of the damaged Home

The only thing can do is to protect home is to develop a shielding area for the home. Simply we can route the discharge path through the Airterminals that we are going to use for the creation of shielding area. Then the discharge happen previously through the wall can now be discharge through the Airterminal without damaging any other object.

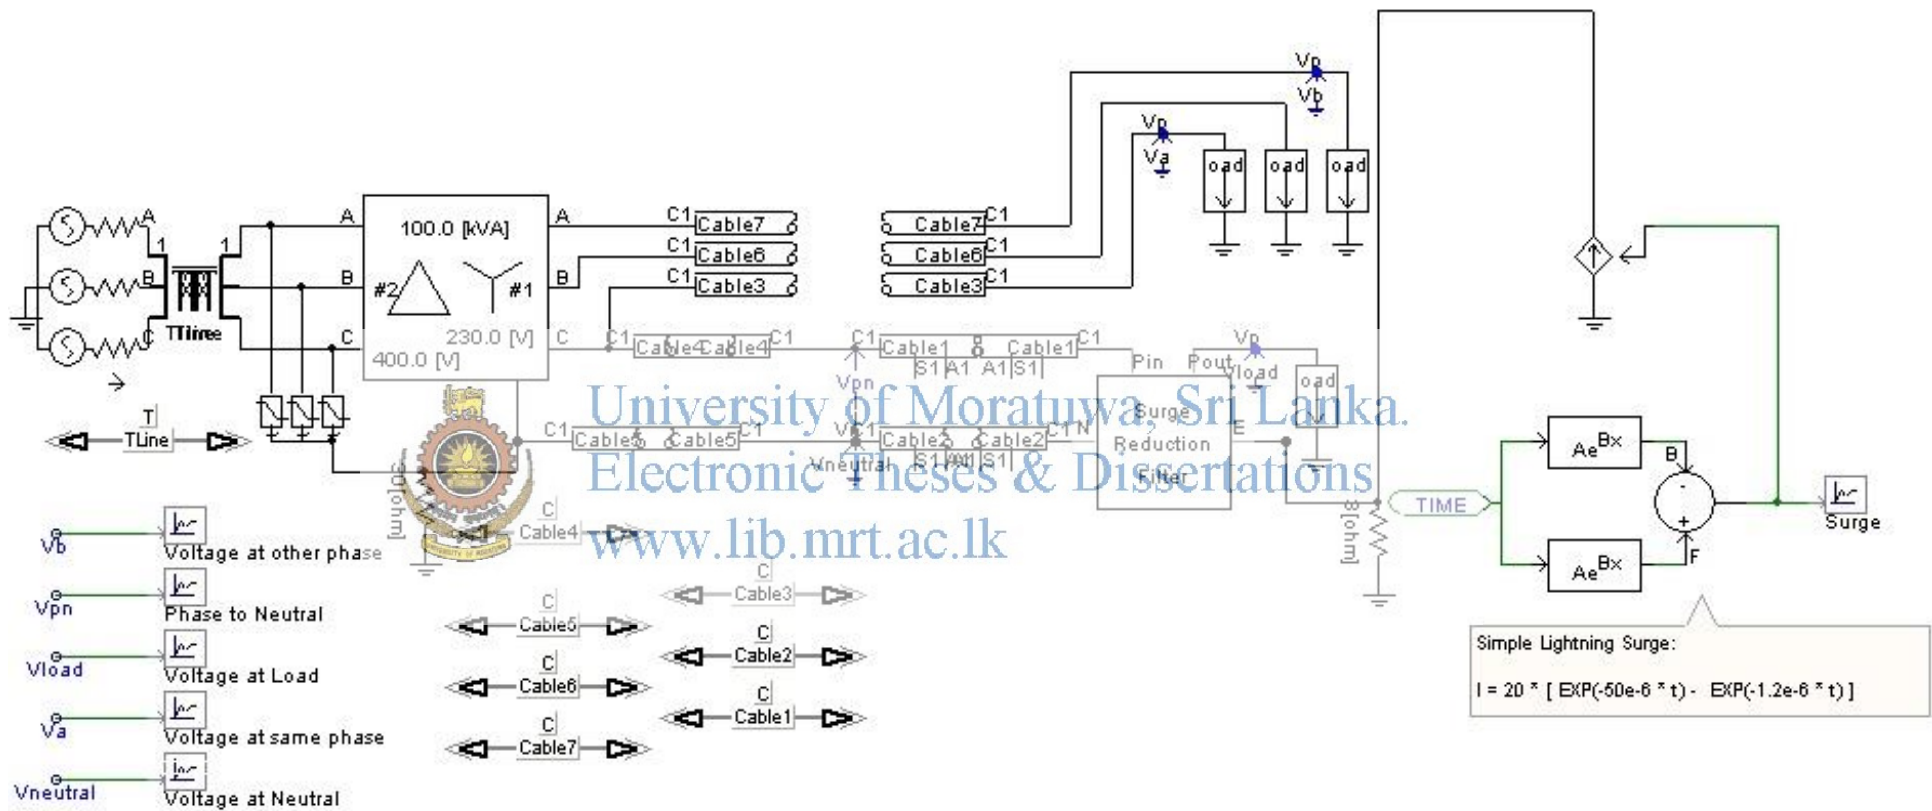
Figure 4.14: Power line model for the telecommunication Radio Base station

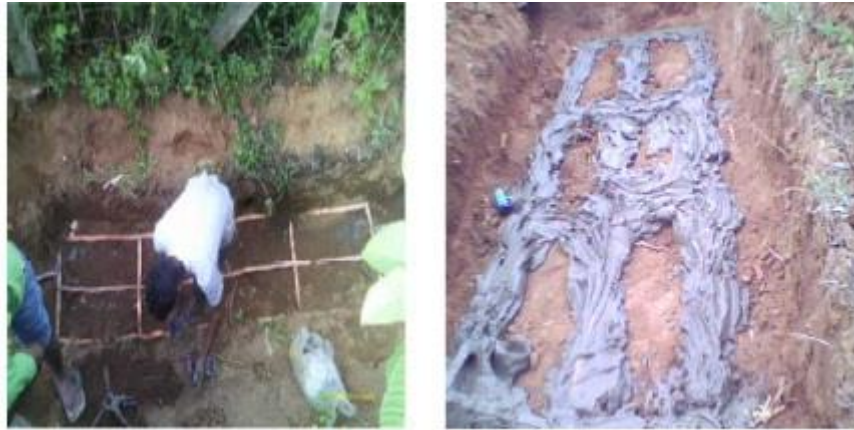
Figure 6.1: Distributed earth with copper earth mesh
