**COMPARATIVE EVALUATION ON STATOR  
INSULATION METHODOLOGIES OF OLD LAXAPANA  
PRIOR AND AFTER REHABILITATION**

Degree of Master of Science

Department of Electrical Engineering

University of Moratuwa

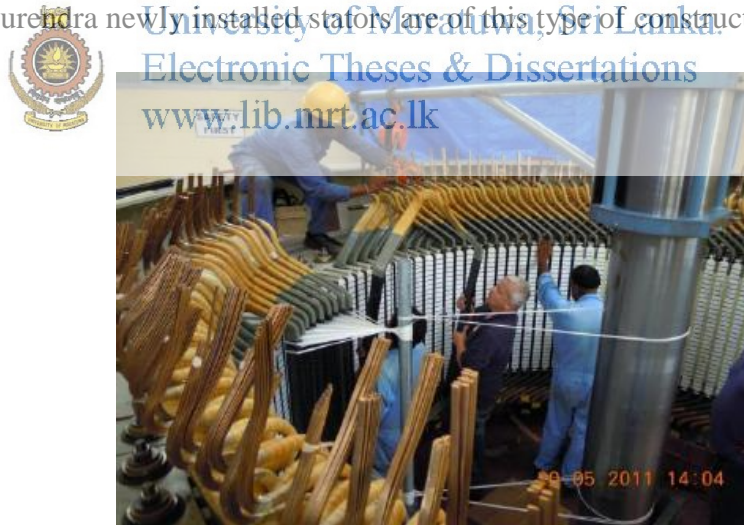
Figure 1.1 : Form wound coils of Wimalasurendra power station ‘original in color’

Form wound stators are made of insulated coils which are pre-formed prior to inserting to the slots as shown in figure 1.1. The pre-formed coil consists of turns of diamond shape. Several coils are connected in series to create the proper number of poles and turns between the phase and the neutral. They are carefully designed to ensure that each turn has smallest voltage difference with the adjacent turn. This design requires very thin insulation between turns. Hence the stators of higher voltages are not unnecessarily bulky with the insulation. This type of stator constructions are used for higher operating voltages [3]. Old Laxapana and Wimalasurendra newly installed stators are of this type of construction.

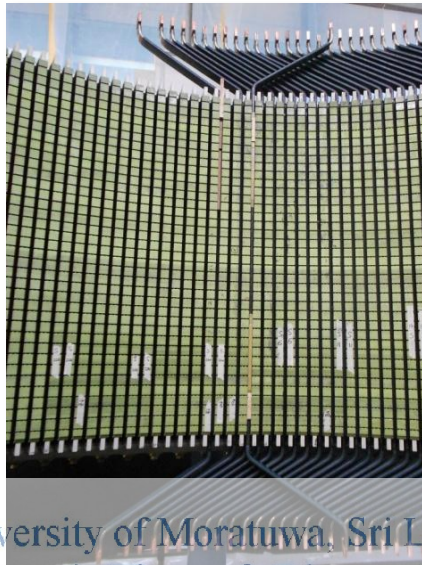
Figure 1.2 : Roebel bar windings of New Laxapana stator 'original in color'

any mechanical damage to the coil as well to the core. Therefore large generators are made using half diamond coils as shown in figure 1.2 and these are referred to as roebel bars. With roebel bar construction only one half of a diamond is inserted to the slot at a time and this avoids the difficulties in inserting two sides of the coils simultaneously. When using roebel bars, electrical connections need to be done on both ends.

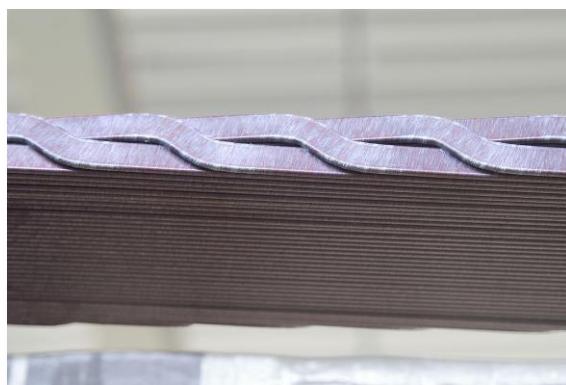
Figure 1.3 : Transposition of roebel bars 'original in color'

To avoid circulating currents within the winding due to different voltages induced within the strands, the strands are transposed regularly as seen in figure 1.3 to compensate currents which could cause circulating currents in the strands.

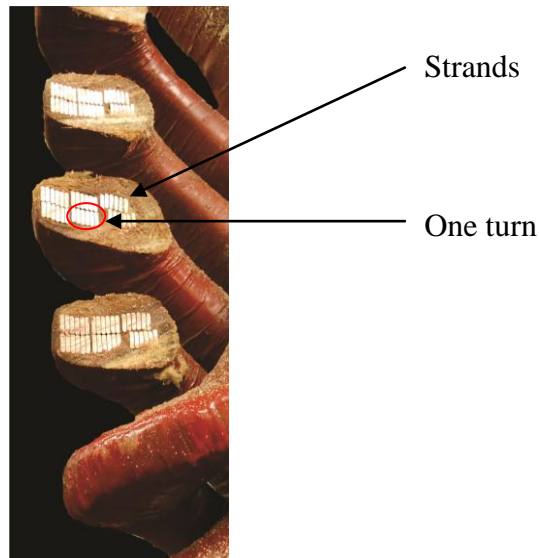
Figure 1.4 : Cross section of OLPS stator with six turns and six strands per turn  
'original in color'

In order to reduce the above two kinds of losses it is always preferred to use stranded conductors instead solid conductors with larger cross section. Figure 1.4 shows a cross section of OLPS stator winding in which the strands could be clearly seen.

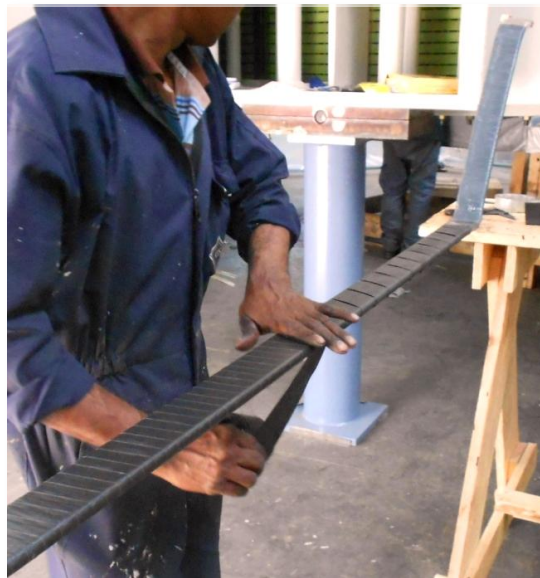
Figure 1.5 : Applying semi-conductive tapes to the roebel bars at New Laxapana  
'original in color'

Slot corona protection layer is a semi conductive tape layer/coating used to provide better contact with the ground wall. If the electric stress in this air gap exceeds 3kV/mm, which is the breakdown voltage of air, partial discharges would begin to occur, which will gradually cause the groundwall to fail. Therefore manufacturers have been coating the coil/ bar area in the slot with semi conductive coating. This is usually a carbon-black loaded paint or tape as shown in figure 1.5.

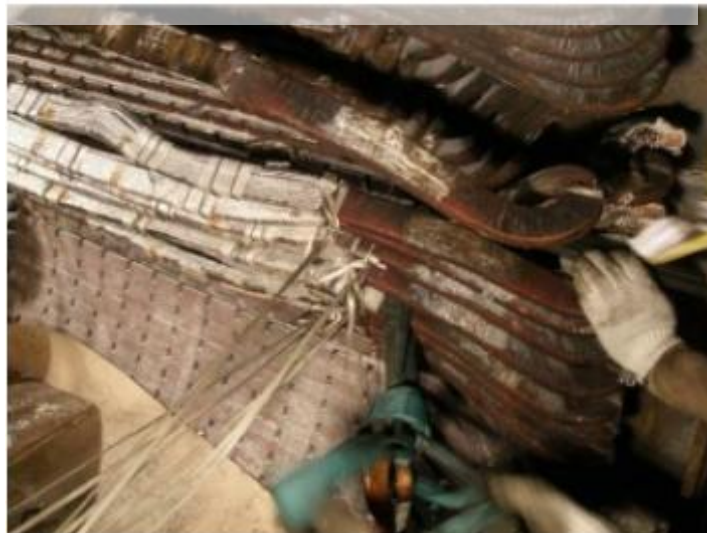
Figure 2.1 : Removing the damaged windings of GVPI stator at Tenau diesel plant

Failure of a 5 MW GVPI type generator in Tenau Diesel Power Plant, Kupang, Indonesia had occurred due to partial discharges and over voltages. Site repair as shown in figure 2.1 had been carried out for five months and reported as a success after 35,000 hours running [12].

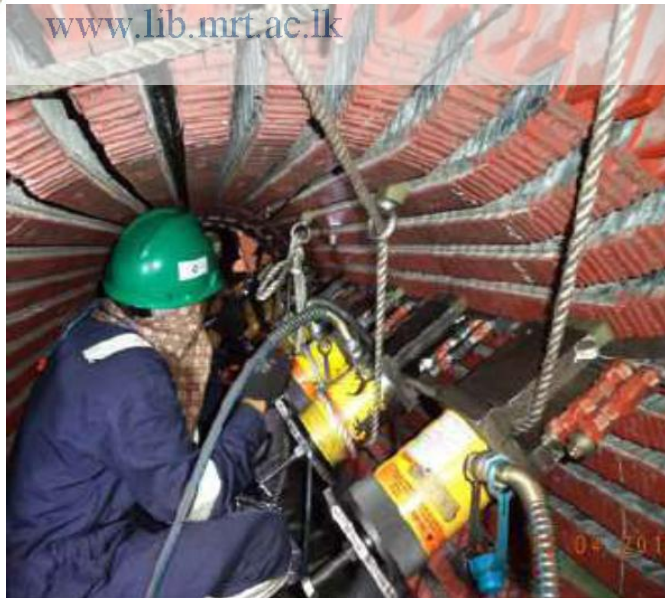
Figure 2.2 : Removal of the winding bars using hydraulic jacks

Failure of a large air cooled GVPI stator of capacity 100.7 MVA and of generating voltage 13.8 kV, belonging to a geothermal power plant of Indonesia is reported. The generator had failed after 13 years of operation. After a bus duct phase to phase fault, cracks in surge supports were observed. Evidence of excess vibration on end windings and loose core were witnessed. After six years from the fault the GVPI stator core had failed catastrophically burning significant amount of core laminations. Windings had been removed by mechanical procedure. By screwing the top of each bar, lag bolts had been fixed. Lag bolts had been pulled using hydraulic jacks and bars had been taken out of the slot as shown in figure 2.2 [14].

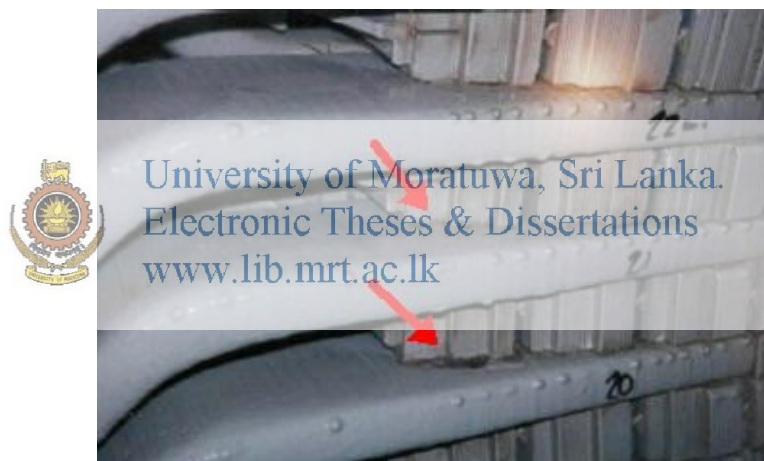
Figure 2.3 : Effects due to vibration sparking

As a preventive maintenance action for the vibration sparking that can occur in GVPI stators, some consultants recommend resin injection every 17,000 to 25,000 hours [15]. This could reduce stator bar looseness happening at early stage of operation. Also it may reduce partial discharges and earth fault occurrences for some time. Effect of vibration sparking is shown in figure 2.3.

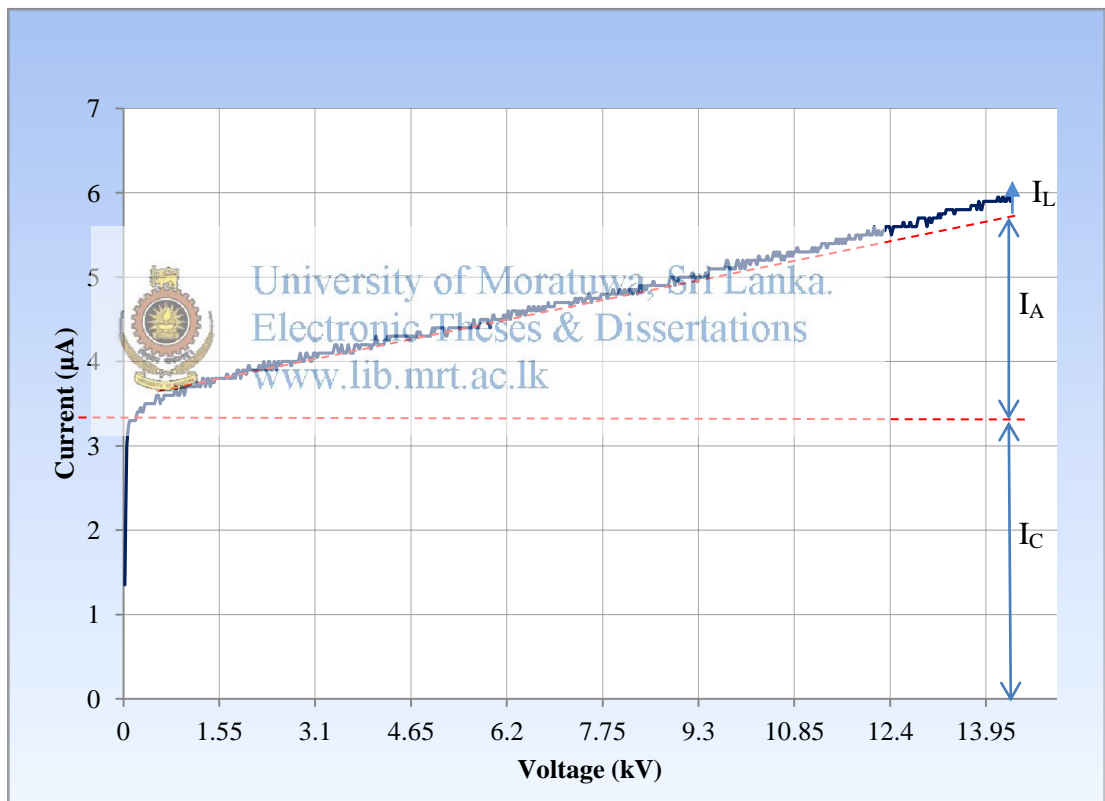
Figure 3.2 : Response curve of a DC ramp test

The total current ( $I_t$ ) measured in a DC Ramp Test shows a rapid increase initially due to capacitance charging current ( $I_C$ ). Afterwards, absorption ( $I_A$ ) and leakage ( $I_L$ ) currents contribute to linear rise of the total current. The condition of the insulation can be analyzed if the three current components can be separated.

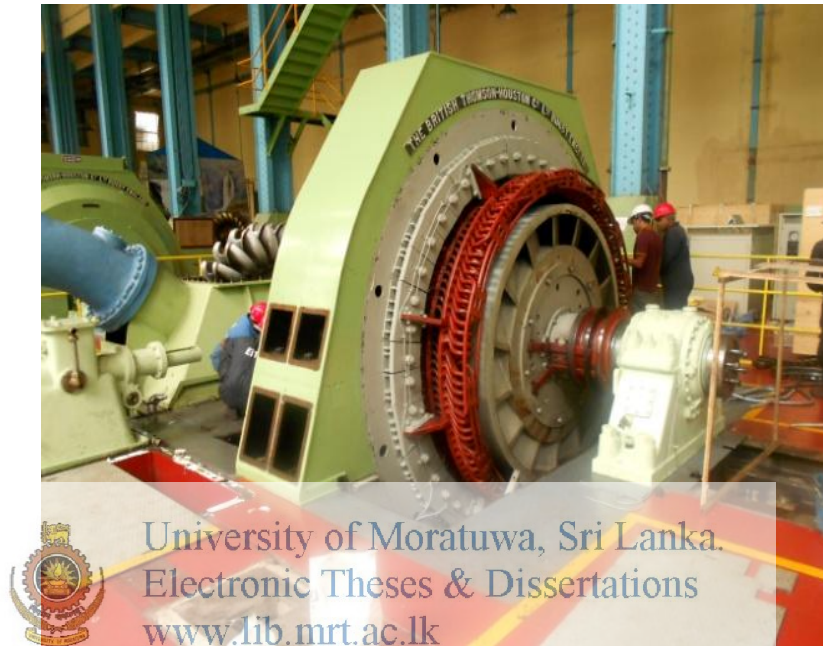
Figure 3.4 : VPI stator of Old Laxapana 'original in color'

Current through the groundwall was measured. This winding had been in operation For 33 years since 1979. Figures 3.4, 3.5, 3.6 and 3.7 show the test setup.

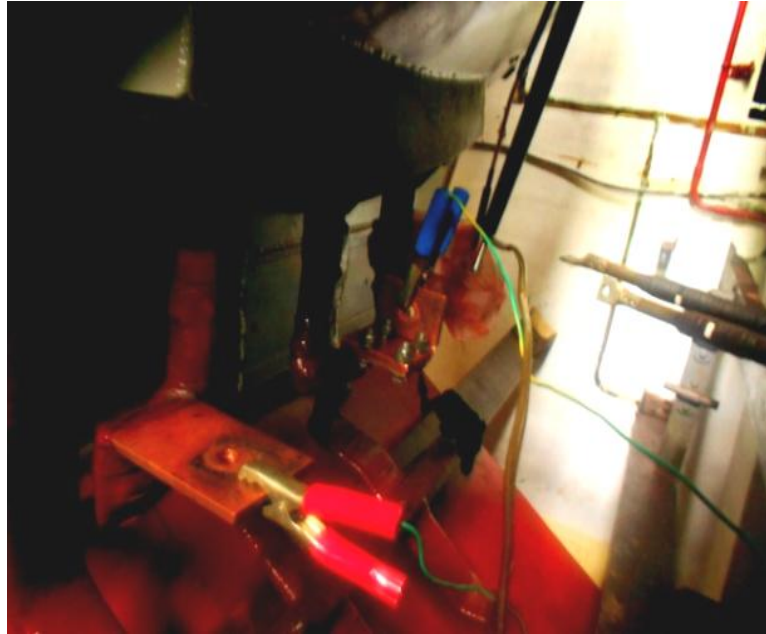
Figure 3.6 : Grounded two phases 'original in color'

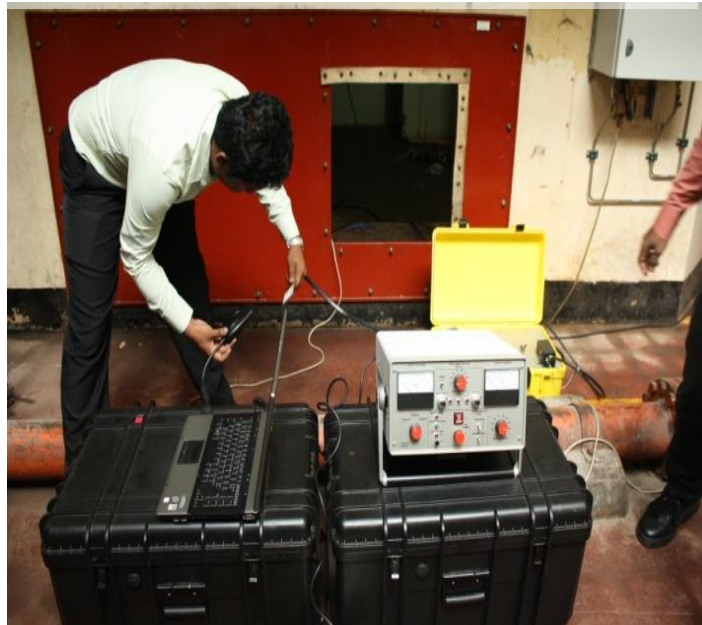
Figure 3.9 : Setting up the apparatus to test GVPI stator 'original in color'

Old laxapana newly installed GVPI stator was tested after six months in operation. After six months operation, the winding can be assumed as completely cured. Similar to the previous case, voltage was ramped at a rate of 1 kV/min up to 15 kV maximum. Current through the ground wall was measured. Figures 3.8, 3.9 and 3.10

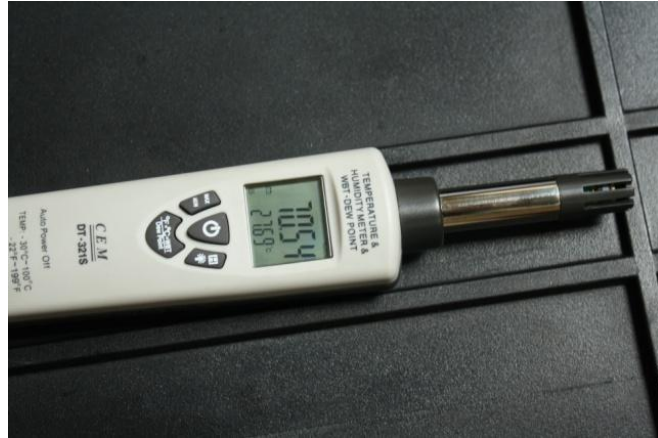
Figure 3.10 : Measurement of temperature and relative humidity 'original in color'

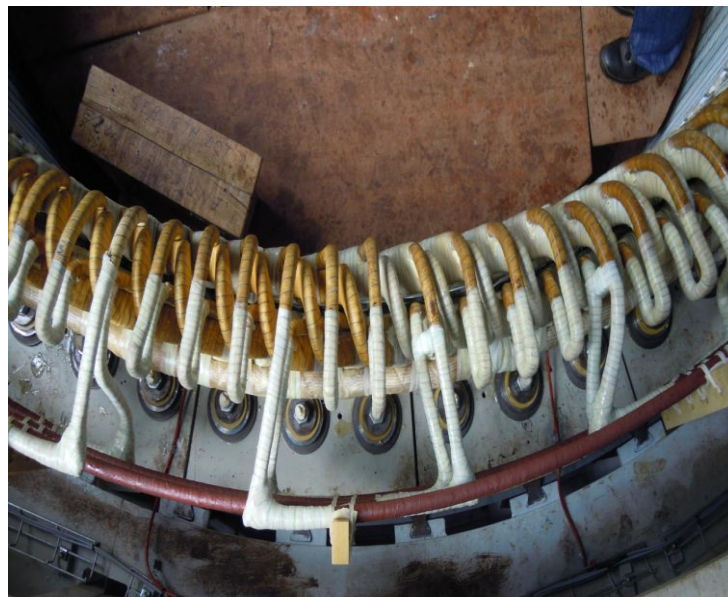
Figure 3.11: Wimalasurendra form wound stator 'original in color'

Newly installed Wimalasurendra stator winding was tested after 3 months of operation. This time period can be assumed as sufficient for curing of the insulation. Voltage was ramped up at a rate of 1 kV/min up to 15 kV. Figure 3.11 show the winding and figure 3.12 show the test setup.

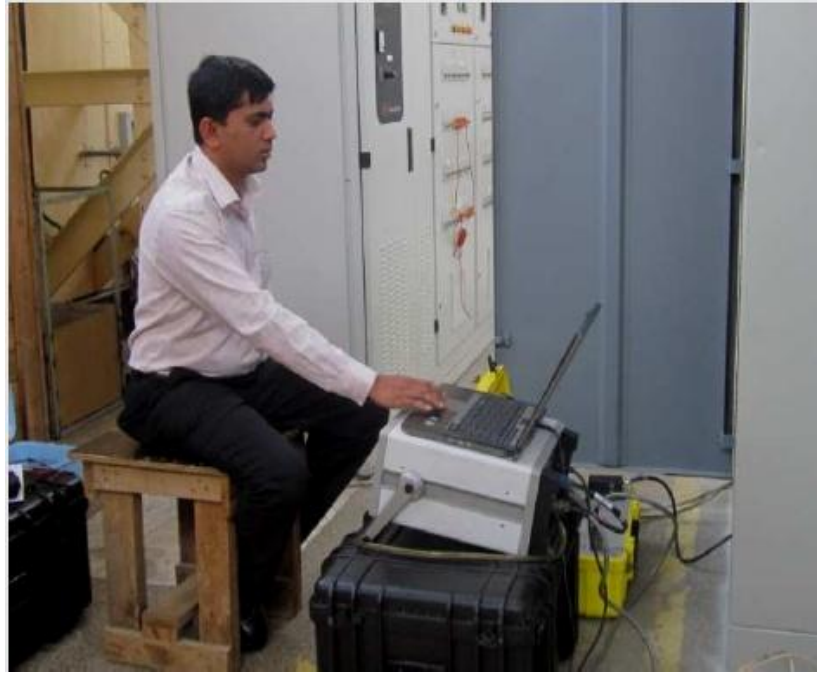
Figure 3.12 : Applying high voltage through the DCR-50 instrument at Wimalasurendra power station 'original in color'

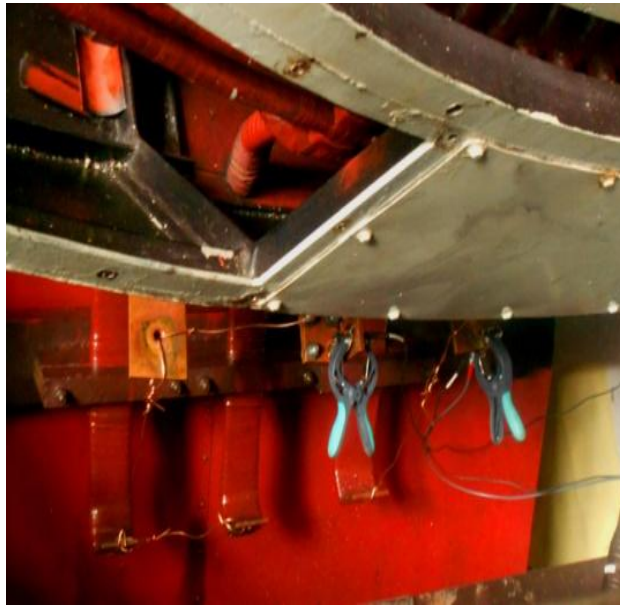
Figure 3.16 : Voltage application to one phase of VPI stator of Old Laxapana while

other two phases being guarded 'original in color'

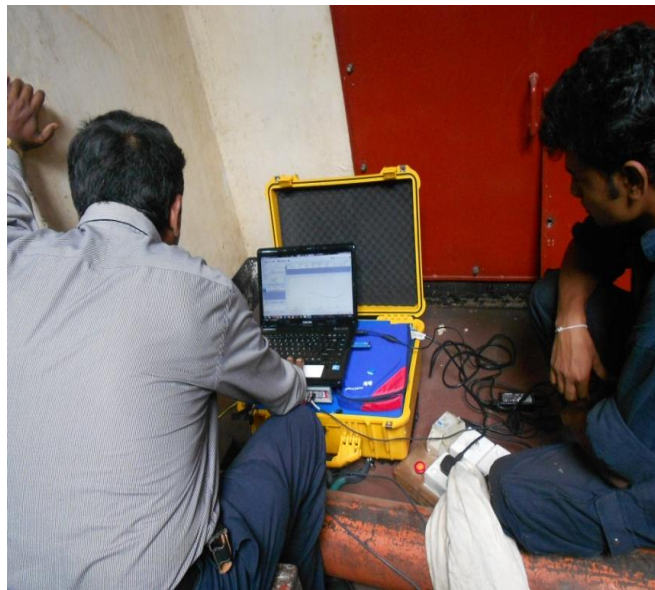
Figure 3.18 Monitoring the waveform along the frequency sweep 'original in color'

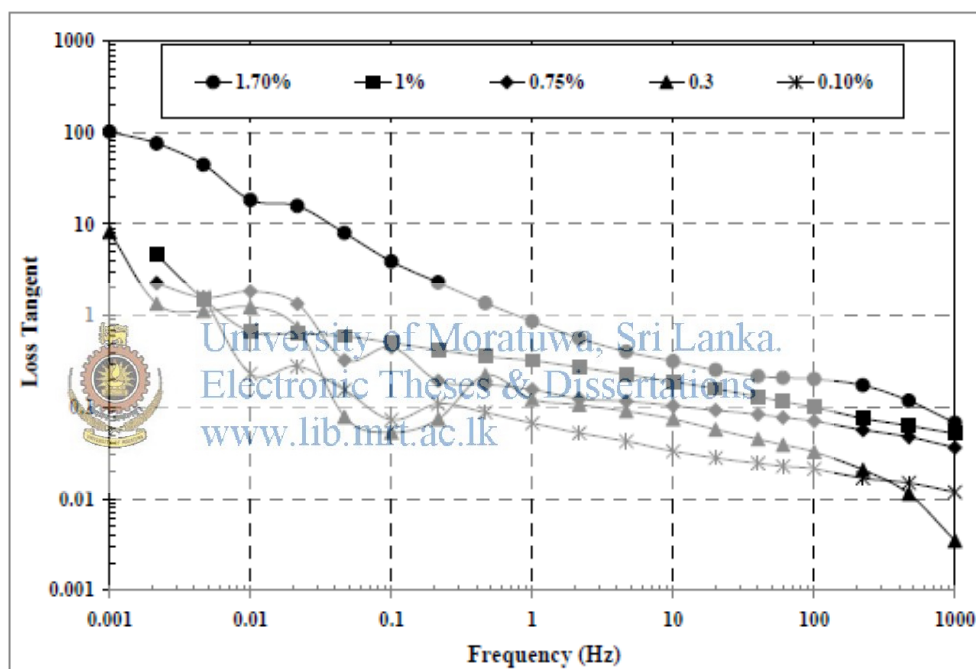
Figure 3.20 : Variation of loss tangent with different moisture contents at 70 °C

Figure 3.20 show that loss tangent is higher for the samples with higher moisture contents in the low frequency region.

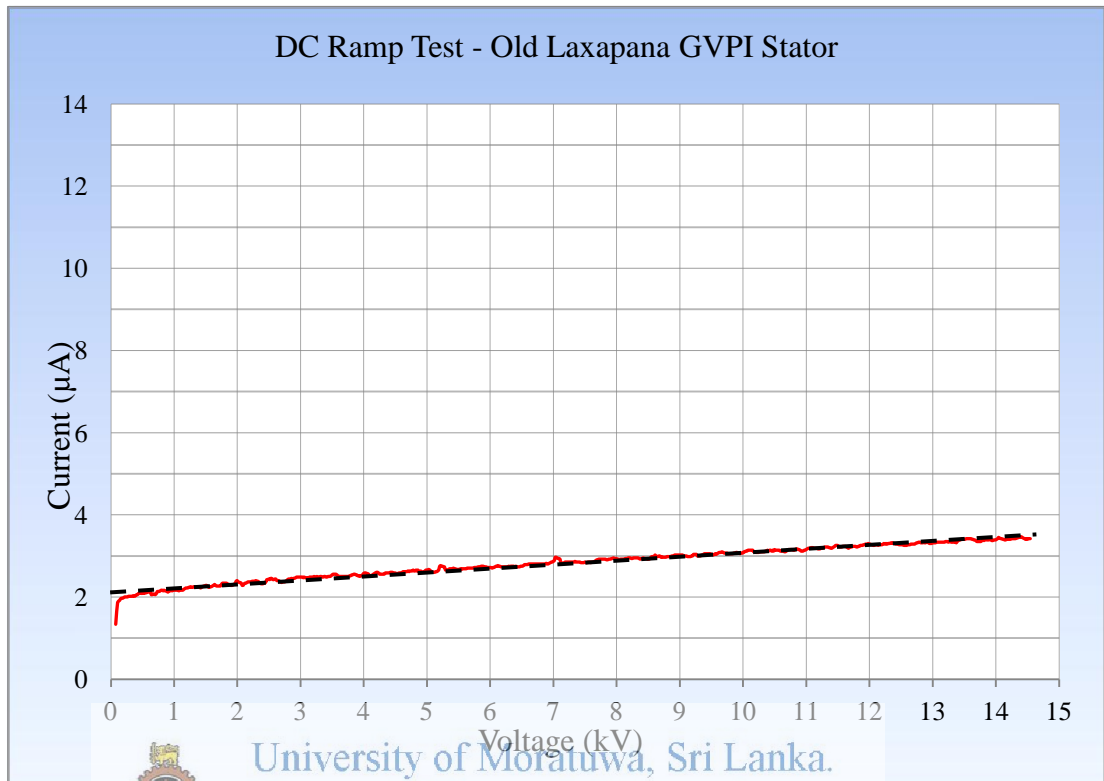
The I-V curve obtained for R phase of Old Laxapana newly installed GVPI stator is shown in figure 4.2 below. Actual measured data is given in table A.2 in appendix A.

University of Moratuwa, Sri Lanka.  
 Electronic Theses & Dissertations  
 www.lib.mrt.ac.lk  
 Figure 4.2 : Current vs. voltage plot for Old Laxapana GVPI stator

Linear rise of current with respect to the voltage is observed. No signs of winding delaminations. Curve is almost flat indicating minimum absorption and leakage. The leakage current at 15 kV is 3.5 µA which is relatively a very small value.

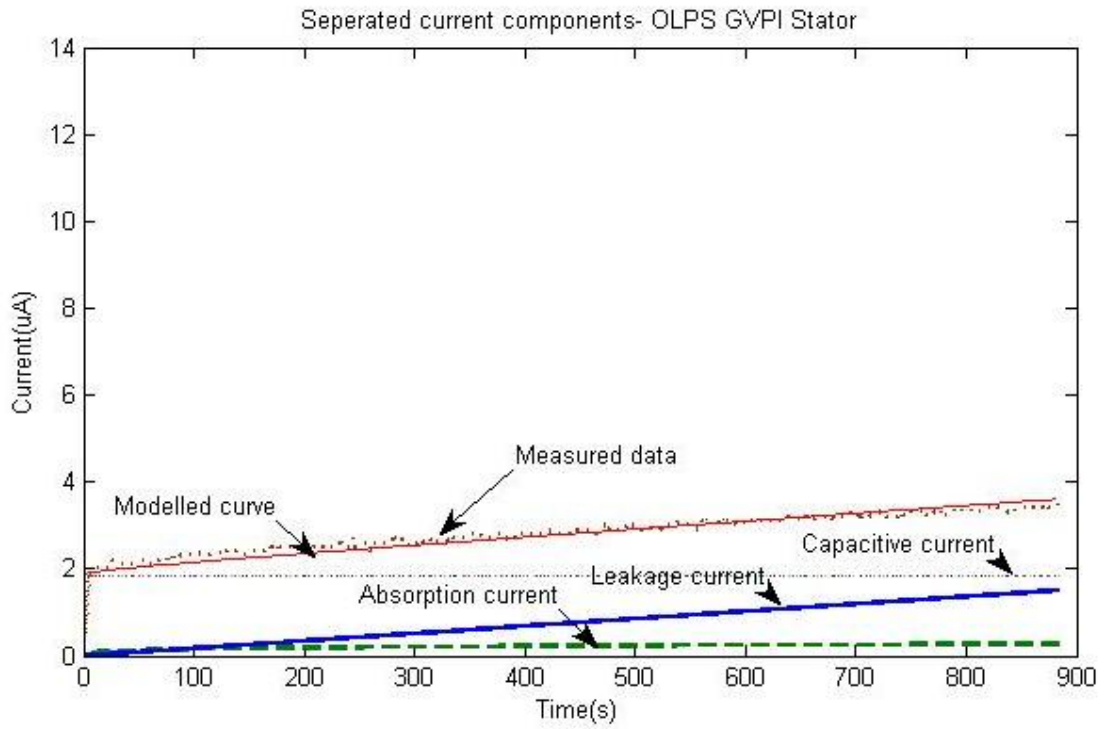
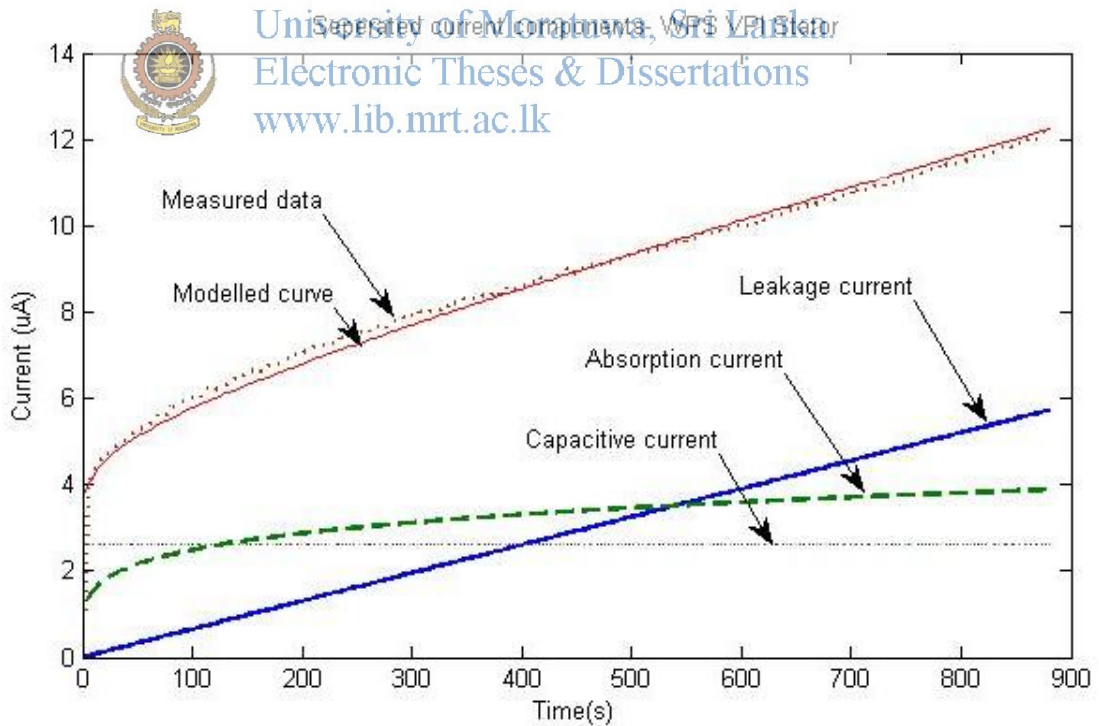
Applying the estimated parameters again to the mathematical model, the capacitive, leakage and absorption current components were re-calculated. Behavior of absorption current is clearly observed in Figures 4.4, 4.5 and 4.6.

Figure 4.4 : Separated current components of DC ramp test- OLPS VPI stator

Figure 4.5 : Separated current components of DC ramp test - OLPS GVPI stator

Figure 4.6 : Separated current components of DC ramp test- WPS VPI stator

The modeled curve gives close approximation to the measured data.

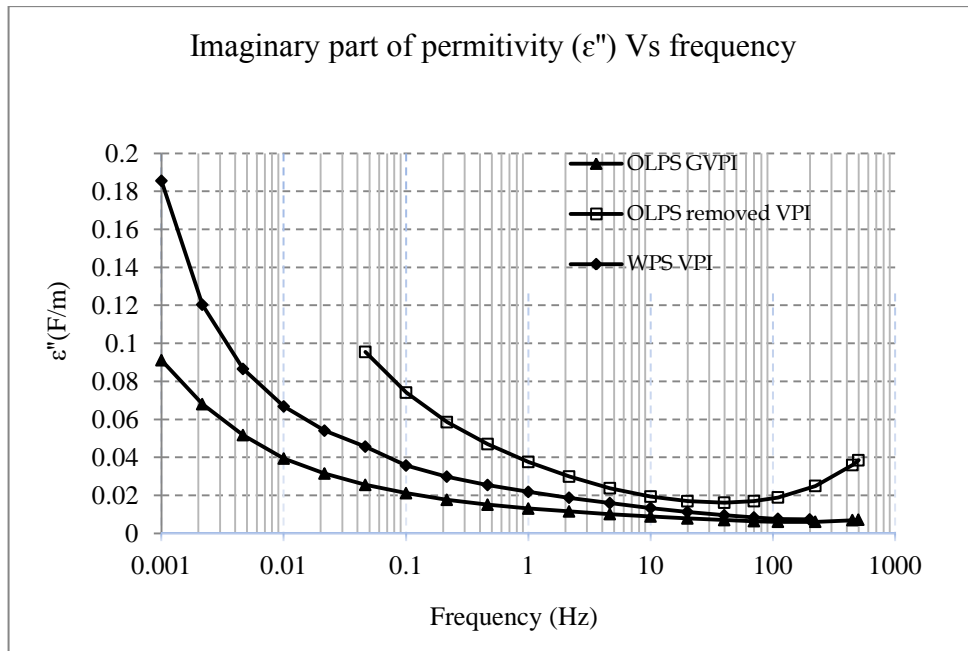
Figure 4.8 : Imaginary part of permittivity vs frequency plot

Dissipation factor is one electrical parameter that represents the losses in a dielectric medium. The information revealed from figure 4.8 is further verified by observing the dissipation factor Vs frequency plot in figure 4.9.

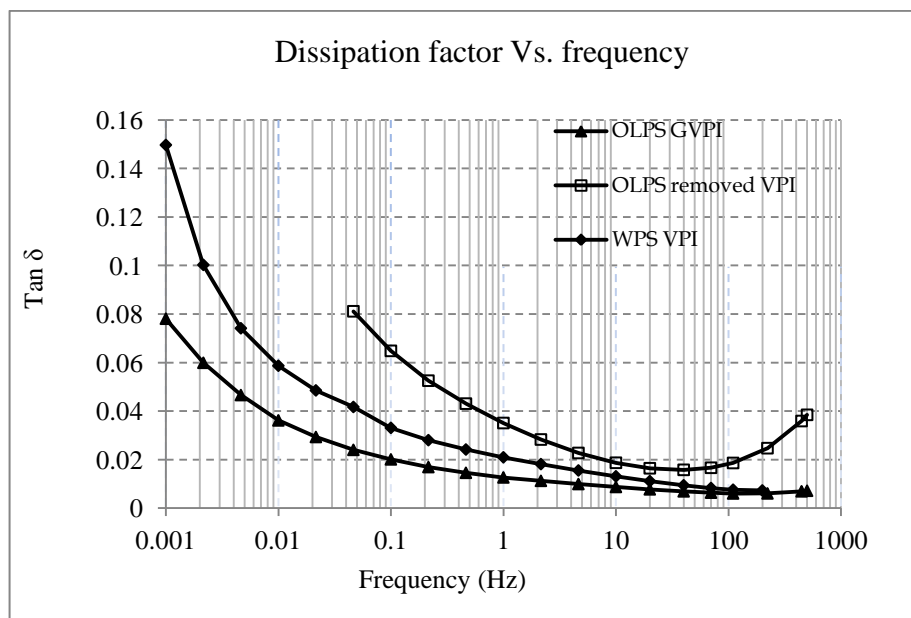
Figure 4.9 : Dissipation factor vs frequency plot

It is observed that the lowest dissipation factor in the low frequency region exists in the new GVPI insulation. Old VPI insulation has higher dissipation factor in the low frequency region implying the aged Class H insulation is highly wet than new VPI and GVPI insulation. The new VPI insulation of Wimalasurendra power station demonstrates moderately wet condition.
