STUDY OF ACCIDENTS AT MID-BLOCK PEDESTRIAN CROSSINGS IN SRI LANKA

Thesis submitted in partial fulfilment of the requirements for the Master of
Engineering in Highway and Traffic Engineering

Department of Civil Engineering

University of Moratuwa
Sri Lanka

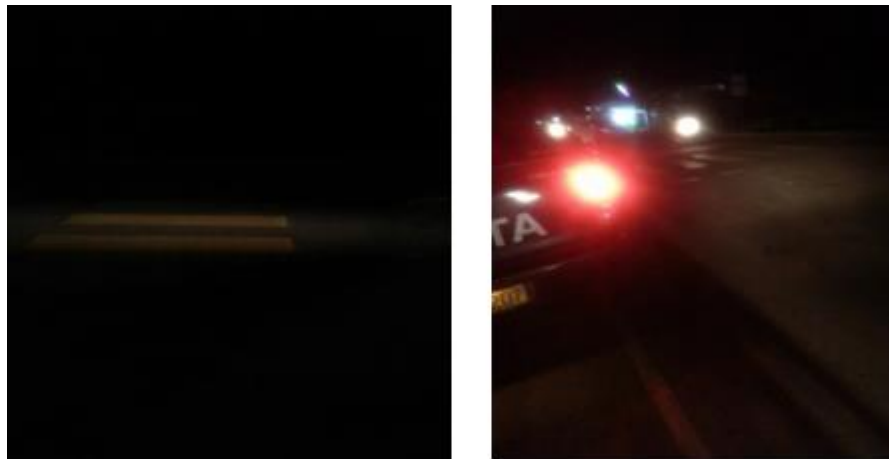
Figure 4.1: When vehicle approaching at that pedestrian crossing (A03 Road)

From the observations it was revealed that 66% mid-block pedestrian crossings have improper or unavailability of stud (see figure 4.1). This is due to unclear stud illumination during nights. There are number of stud suppliers. As a result price and quality of studs differ. Damaged studs have not been replaced by the appropriate authority. Thus, at night high illumination stud has to be selected. Further, damaged studs should be replaced. According to RDA design specification, studs (cat eyes) must be installed on “A” class road.

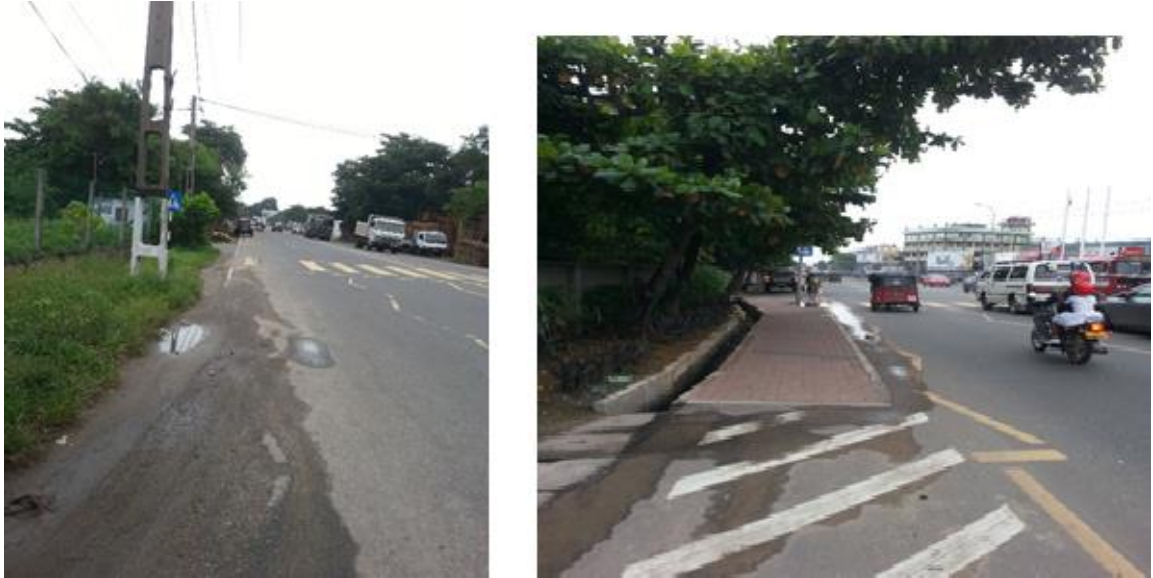
Figure 4.3: Obstruction of signboard by electric post and tree (A3 Road)

Visibility of sign board and obstruction are improper in 10% and 5% of mid-block pedestrian crossing. In some places proper materials are not used for sign board. For example, low illumination paints are used for sign boards. In some places sign boards are not in the proper location. For example, in some places pedestrian crossing sign boards are not located at a standard distance. Obstruction of sign board is due to trees, utility services, advertisement board etc.

All the mid-block pedestrian crossings are improper or unavailable for differently impaired persons (Figure 4.3). Even though, in some places mid-block pedestrian crossings are constructed for differently abled people, they are improper due to water stagnation, obstruction by signboard and trees, vehicle parking, no connectivity, etc.

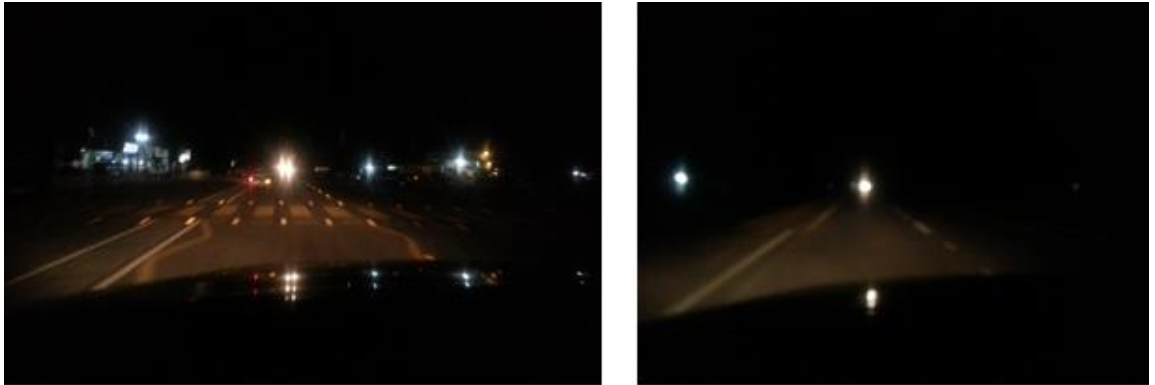
Figure 4.8: White colour marking is clear than the yellow colour road marking (Night Vision)

Forty (40%) of the drivers said, the improper stud and road marking affect their driving through pedestrian crossing. This may be due to poorly illuminated studs and wear off

of pedestrian crossings. They also said white colour marking on roads is clearer than that of yellow colour markings. (See Figure 4.8)

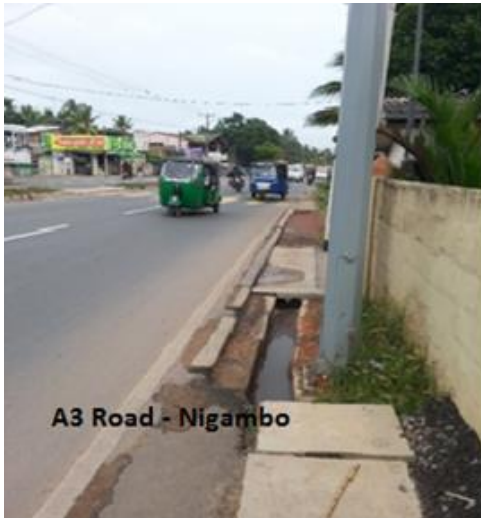
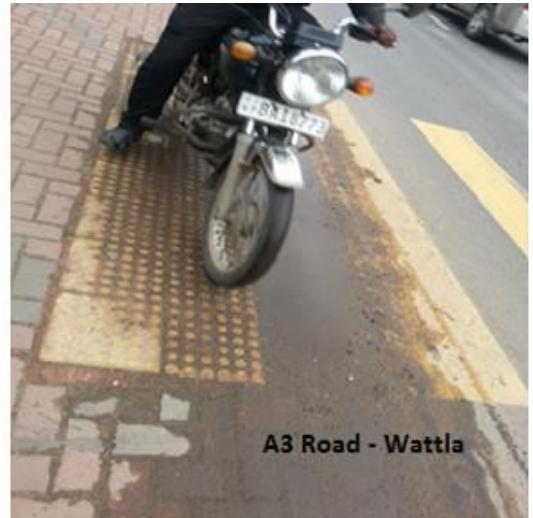
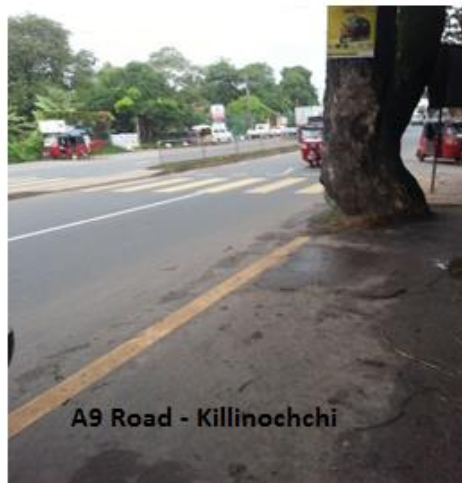
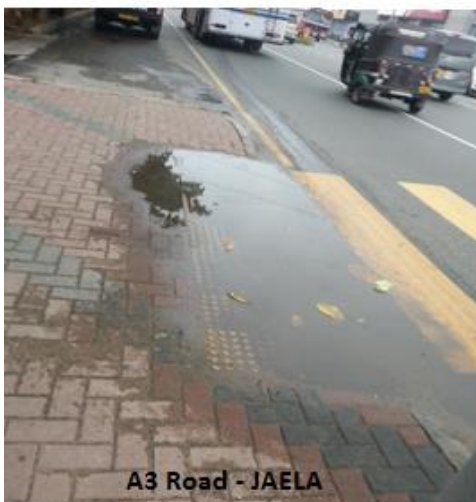
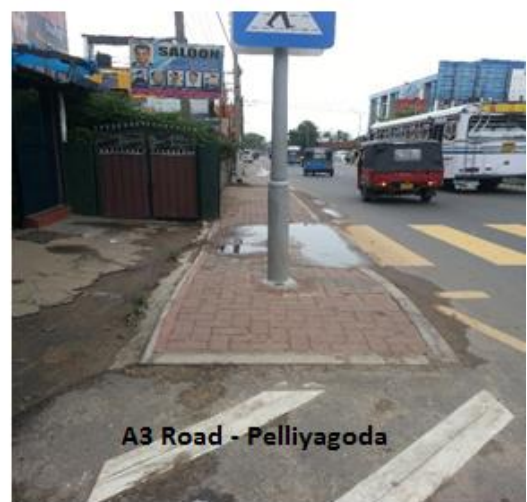
Appendix III – Photos of mid-block crossing

The following pedestrian crossing are not suitable for differently abled person.
