# **Regreening and Environmental Enhancement at Akurala Sri Lanka**

Wijsekera, N.T.S,(2008) Regreening and Environmental Enhancement at Akurala Sri Lanka, A Project Implemented with Community, University and Regulator Partnership, ISBN 978-955-9027-10-5

A Project Implemented with  
Community, University, Regulator Partnership (CURP)

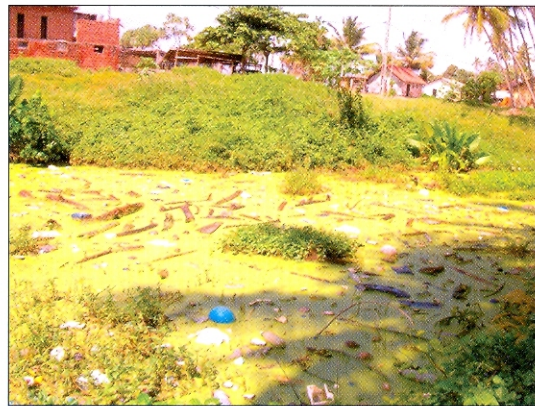
An Example of a Polluted Coral Mine Pit

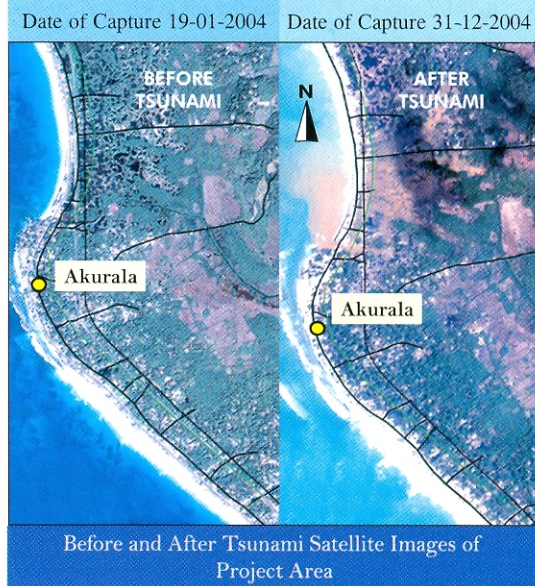
Before and After Tsunami Satellite Images of Project Area

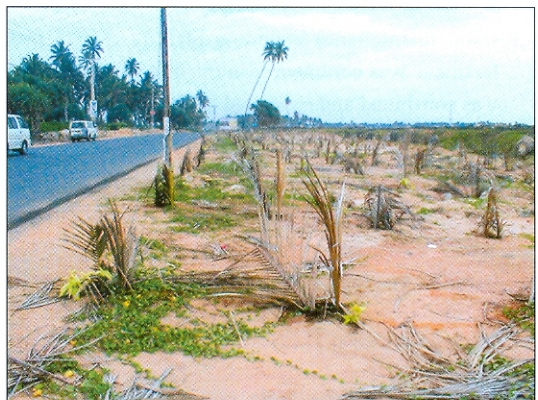
Coconut Branches did not Provide Adequate Protection to the Plants

Regreening activity experienced severe dry weather conditions in the months of December 2006, January and February of 2007. As a result plants were protected from sunlight and dry winds by using coconut branches. Coconut branches were selected considering the availability, low prices, the easy biodegradability and environmentally friendliness. An assessment of the plants were done at the end of the Phase I. Project being in a vulnerable area, plants experienced a significant salty sea breeze and sea water splashing due to the monsoonal windy weather in the months of June and July 2007. The plants covered with coconut leaves were not adequately protected from the salt water. A survey of plants was done in the project area to identify plant survival status and to make appropriate recommendations. This assessment through the GIS database enabled the identification of plants for gap filling and maintenance (ICGAT 10).

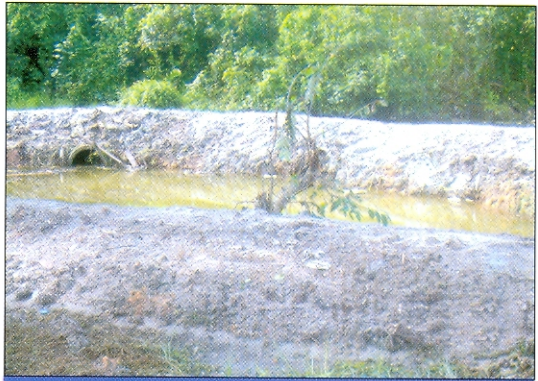
Coral Mines were Cleaned with Machinery and Manual Labour

parts of houses and concrete posts swept and dropped in the pits as a result of the Tsunami. Such debris were removed with the use of heavy machinery, boats and manual labor. Some very heavy concrete pillars such as broken street lamp posts and telecommunication posts could not be removed because of their size, weight and as they were partly buried in mud. Three abandoned coral mine owners objected to carrying out any rehabilitation activity in their pits other than filling them. As filling was not the option identified by the project, these pits were left alone.

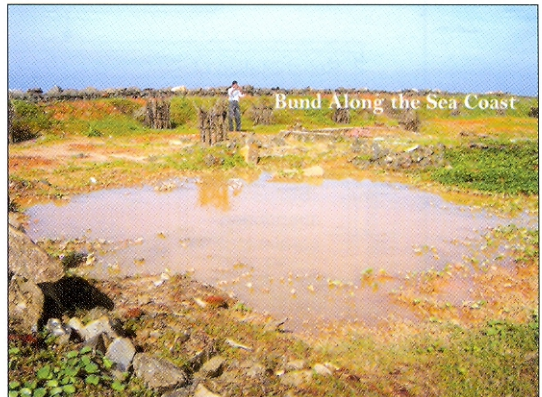
Bund Along the Sea Coast Obstructs Natural Drainage

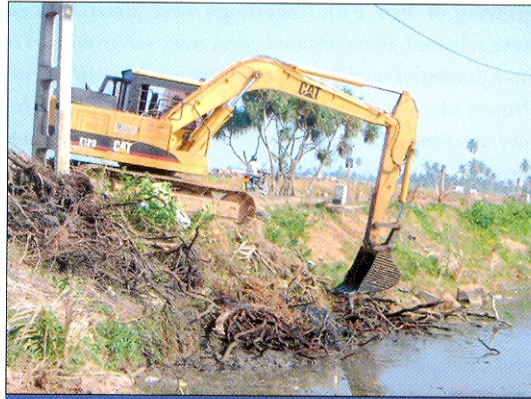
Use of Heavy Machines for Mine Pit Cleaning

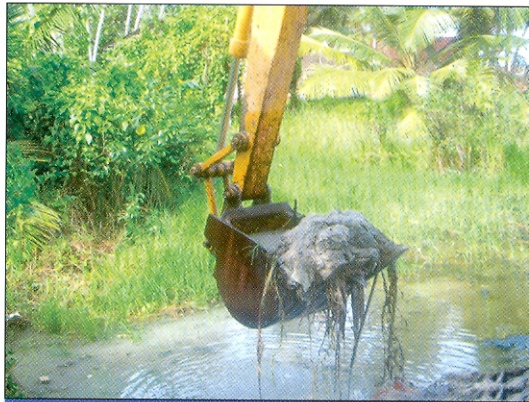
Tsunami Debris were Removed Using Machines

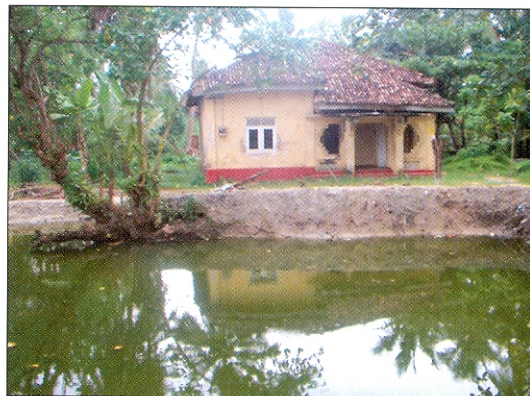
Earth Bunds were Formed Around Rehabilitated Coral Mines

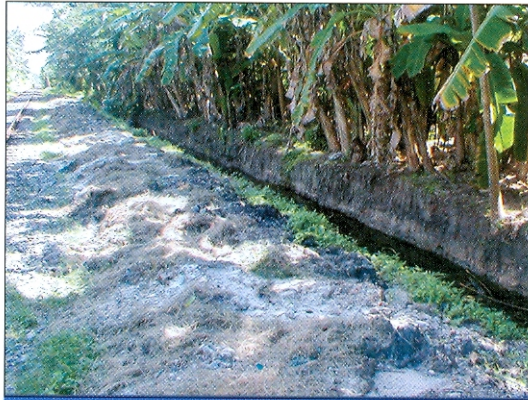
DR1 after cleaning

Another drainage canal which crossed the project at the Northern boundary close to Wenamulla was flowing into the project area (DR3). Though the 1960 Engineering Survey Sheets (ES) indicated a clear drainage path leading to the Telwatta Ganga, the present field conditions did not indicate a flowing connection at this location. This drainage which brought significant surface water from watersheds in the Wenamulla area was draining into one large coral pit causing flood threats. This drainage had to be developed creating a

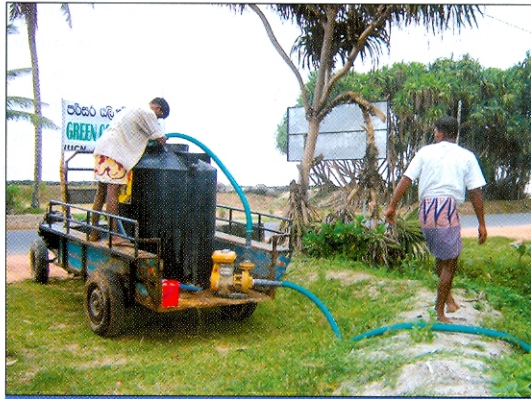
A Hand Tractor with a Tank and a Pump was Used for Watering

At the plant count, it was found that altogether 4654 plants had been in place at the end of Phase I in March 2006. Thereafter plant watering was continued and fertilizer was added from time to time. As the plants were to experience dry weather from January to April, all these plants needed shading from sun and wind to reduce moisture loss. Therefore, the plants were shaded and covered with the use of coconut branches. Coconut branches could be easily found and are environmentally friendly due to their biodegradability. During the drought weather, plant watering needed to be continued at a rate of twice a day. With the drought, a low-recharging rate was experienced in the dug well from which water was taken for the plants. Water had to be pumped from a rehabilitated coral mine using a fuel operated pump to ease the load on the dug well. A one thousand litre tank placed on a tractor trailer was used as a mobile watering truck.

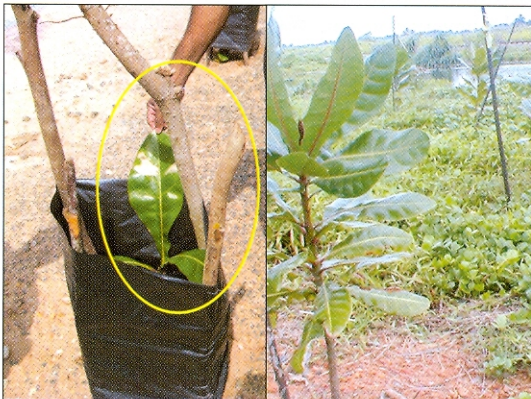
(i) Affected Young Mudilla Leaves Near the Coast  
(ii) Eco-Park Plants Received Protection

As a result of rough seas and seawater splashes the regreened plants near the coast protection bund were damaged. However, it was a pleasure to note that Teak and Mahogany plants had shown a healthy growth in the home gardens where they received reasonable protection. All plants which received protection either from another tree or a man made structure had grown very well. Bamboo trees planted around pits which were in the middle of dwelling units survived the rough season. Mudilla plants which were planted in the designated Eco-Park grew well since this area was shaded by the coast protection embankment and also because these were at a lower elevation than the road embankment. Even in Mudilla leaves one could observe damage in places exposed to the sea breeze.

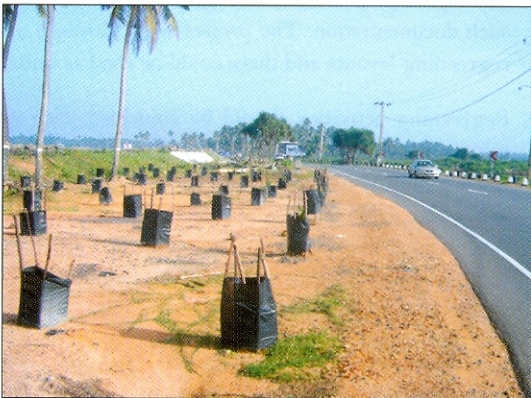
Polythene Covers were used for Plant Protection

In order to protect new plants from direct sunlight, the plant cover was made out of black polythene. Cover was so designed that it enabled vertical direction air circulation from the bottom and from top of the cover. Protective cover for the reasonably established plants but yet to reach the level of surviving critical winds, were covered with transparent polythene. Color of the polythene protection was the only change made from transparent to black. The transparent polythene was expected to provide shade from sea breeze but enable sunlight to pass through thereby facilitating plant growth. A frame made out of tree branches was used to hold the polythene which was protecting the plants. A cylindrical polythene cover was fixed around the frame. Gap filling staff noted that stray cows had eaten the

leaves of plants after damaging the the transparent polythene cover protection. It was also noted that that cows did not eat the same plant variety which was not covered, but had only eaten the ones which were covered with transparent polythene. This was not observed in the case of black polythene. Therefore as a remedy, black polythene was used to cover the remaining plants and the plants that required repair. Black protection cover obstructs sunlight entering the plant through the sides. Vertical growth rate of plants covered in black was noted much higher than the plants covered with transparent sheets. Only difference was that in the black polythene cover sunlight reached the plant only from the top. By growing at a rapid rate, the plants covered with black polythene very positively contributed to the project expectations.

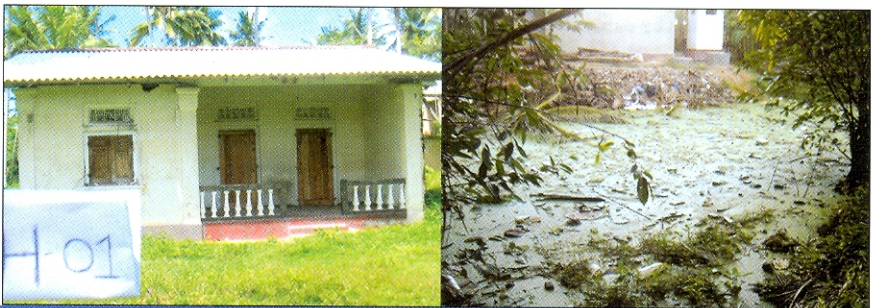
Photographs and Videos were Hot Linked in the GIS
