INVESTIGATION OF DISTRESSES OF BLOCK PAVED ROADS AND CONDITION EVALUATION

Degree of Master of Engineering

Department of Civil Engineering

University of Moratuwa

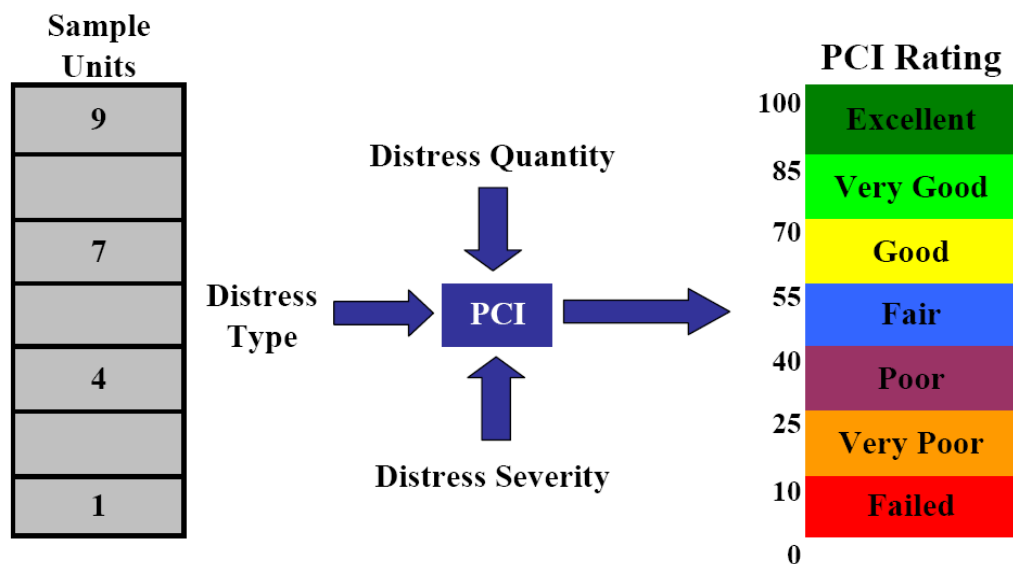
Figure 2-2 PCI rating

In 1992, US army corps developed a pavement management system for concrete block paved pavements. They have considered eight types of distresses and identify severity from low to high severity. However, the system does not calculate overall condition of pavement but give remedial measures base on condition of the pavement. (David Hein & Robert Burak, 2007)

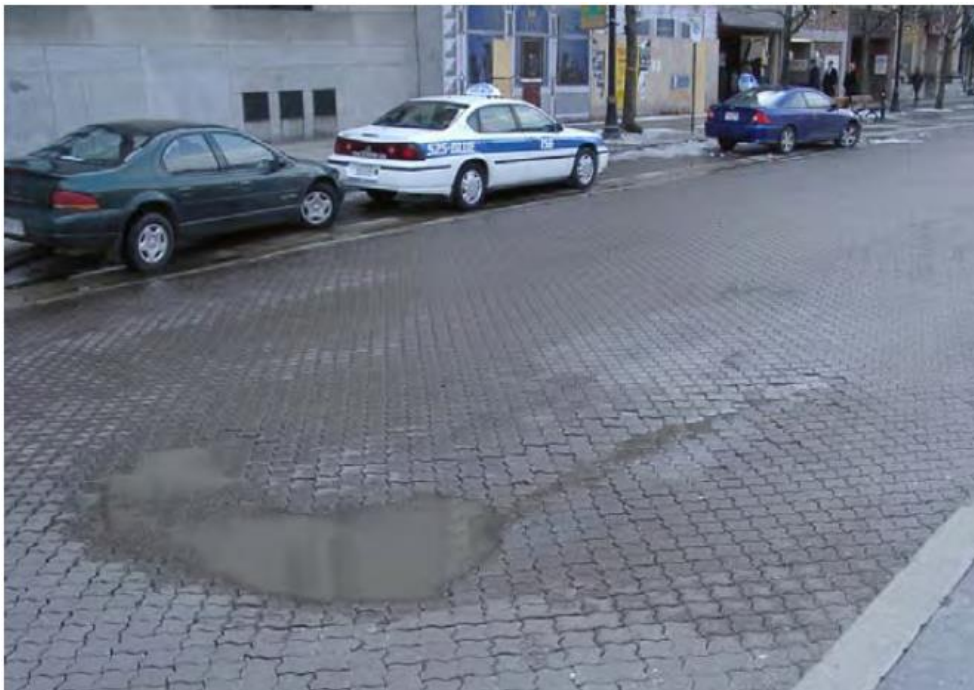
Figure 3-4 Sample distress (High severity)

If an area of the pavement's elevation is lower than surrounding level, that area is identify as depression. This is cause due to underlying sub grade or granular base settlements. Settlements can be found frequently over utility cuts and adjacent to road hardware. According to the manual, depression causes roughness, when raining happens water stagnates on these depression areas and can cause hydroplaning of vehicles.

Severity Level	Maximum Depth of Depression
Low	5 – 15 mm [0.2 to 0.6 inches]
Medium	15 – 30 mm [0.6 to 1.2 inches]
High	> 30 mm [1.2 inches]

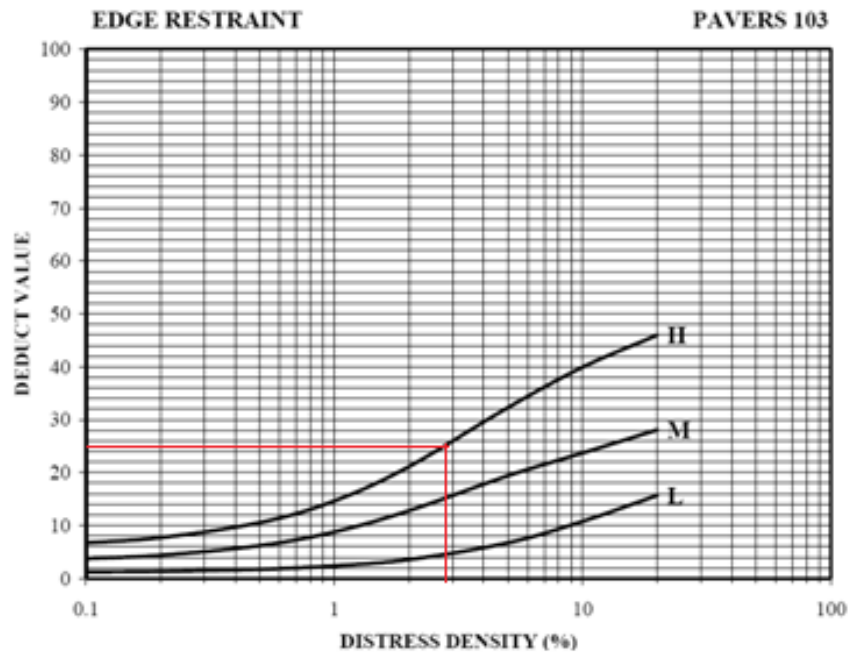
Figure 3-7 Deduct curves for edge restrain

First selected the deduct curve relevant to Edge Restrain. Then the value was found for 2.8% with high severity.

- Deduct value- this value obtain using Deduct Curves, which are annexed in the Distress Manual. First select the graph for relevant distress type and find deduct value by severity curve and distress density.
- Total Deduct Value (TDV)- summation of all deduct values for particular sample.
- If there are deduct values which greater than 10% of TDV, it is needed to be corrected. The correction curves have been supplied with the Distress Manual.
- Corrected Deduct Value (CDV) obtains from those curves.
- $PCI=100-CDV$, final Pavement Condition Index could be obtain.

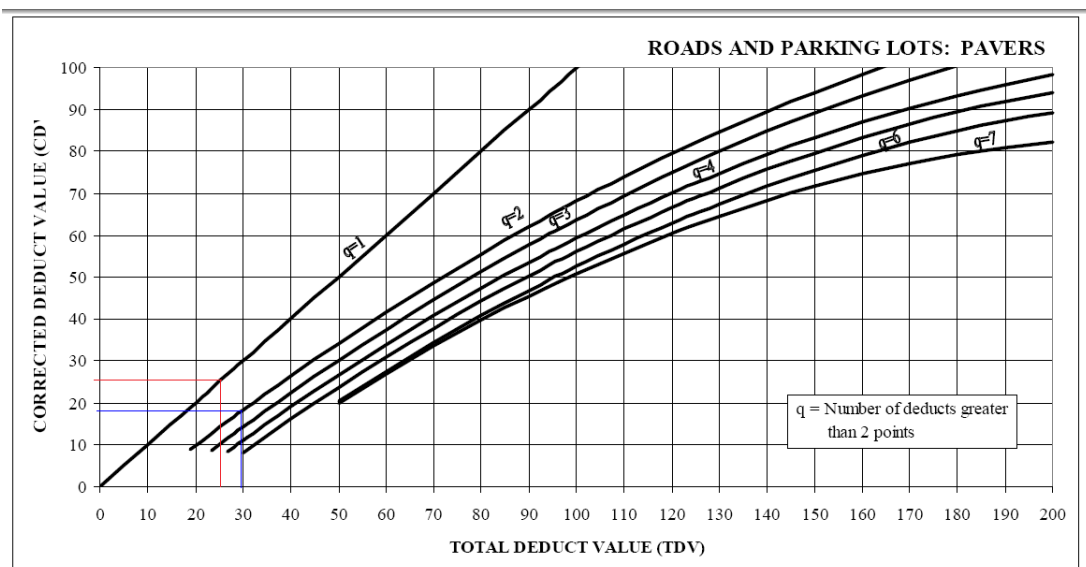
Figure 3-8 CDV curves

$$q_1 = 2 \quad \text{and} \quad \text{TDV} = 25 + 4 = 29 \quad \Rightarrow \quad \text{CDV}_1 = 18$$

$$\begin{aligned}\text{Pavement Condition Index} &= 100 - \text{CDV} \\ &= 100 - 25 \\ &= 75\end{aligned}$$

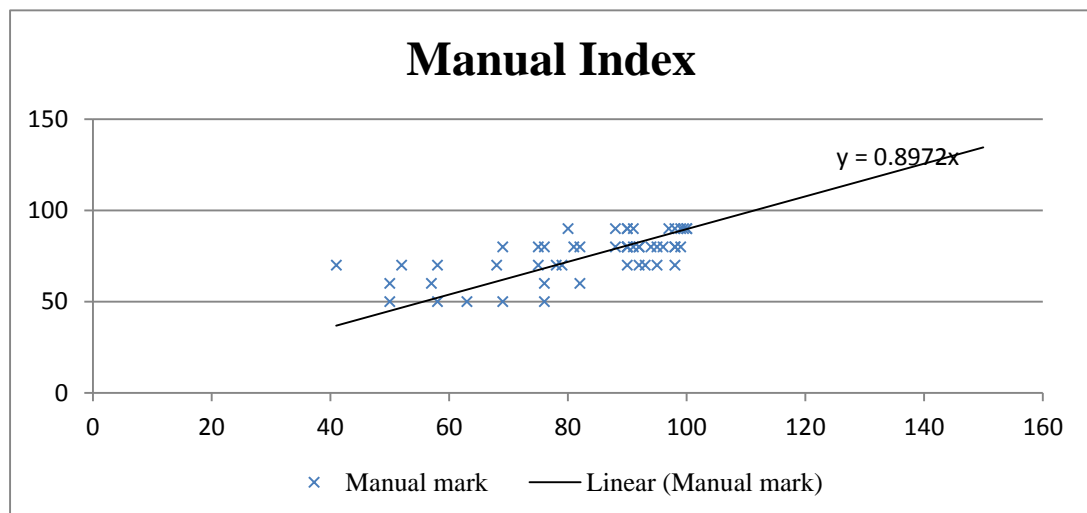
Figure 4-1 PCI vs Manual Index

This validation procedure was carried out manually and compared these values with obtained PCI value. Firstly, along with collection data and taking measurements surveyor assigned a value in between 0-10 which 10 is considered the best. When this mark was assigning time, the valuator did not have clear idea about the PCI value of the sample. Hence, it is reasonable to assume the manual assigned value and PCI are independent from each other. Then calculated PCI value graphed verses ten times of manual value of the samples. The graph obtained is as follows,

By observing PCI vs Manual value graph, we can validate method of calculating PCI was reliable with actual situation. The Pearson's correlation of $y=x$ line derived by MS Excel is 0.66 and the points of the graph cluster along the trend line. Even though the most of points are laid within 50-100 in manual and PCI scale. This is because of the data not vastly distributed.

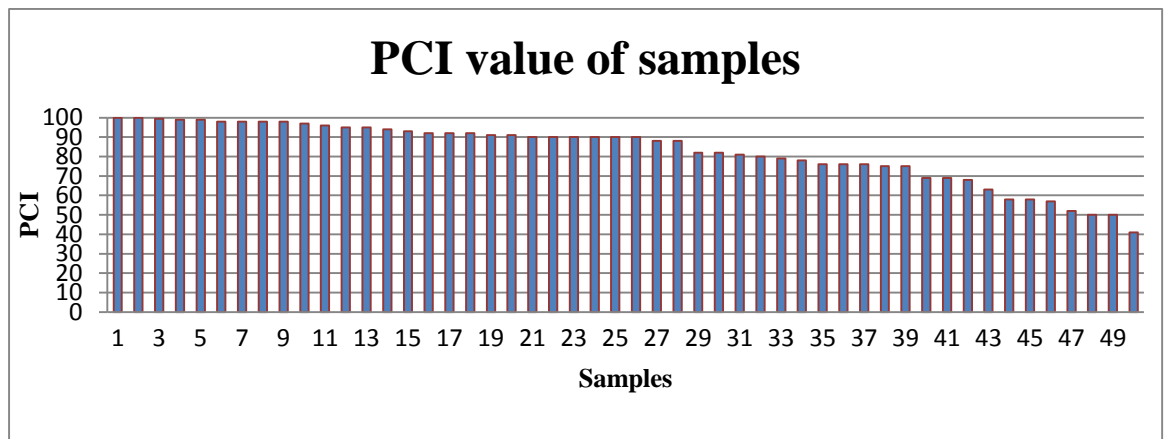
Figure 4-2 PCI variation of samples

According to the graph, 27 of samples (52%) are in excellent condition, 12 samples (24%) in very good condition, 7 (14%) and 5 (10%) in good and fair conditions respectively. There was no sample in poor, very poor or failed condition. Therefore, the all road segments were in functional stage when survey was carried out. It is worth to note that all these roads were aged between four to six years. Other than that, there are no outliers or identifiable fraudulent values in the data set. Indeed this data can be use further analysis without omitting or modifying any sample and these

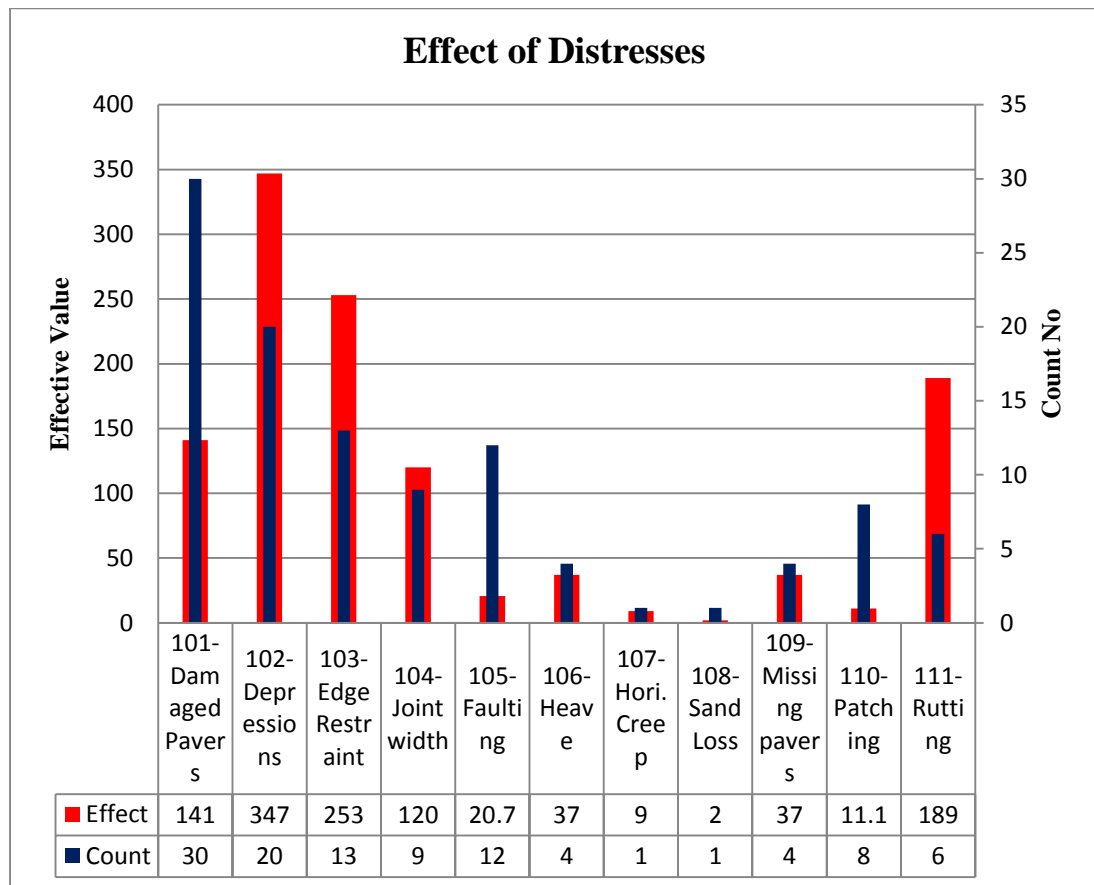
Figure 4-3 Effect and Occurrences

The Pavement Condition Index calculates based on eleven distresses types and severity. As each distresses data collect separately, occurrence of distress and effect on PCI value by each type can be illustrate as follows. Here thin blue column implies count of distress. In other words, number of times surveyors found that particular distress type. The deduct points due to each distress type is shown in thick brown column.

For an example, 101-Damaged pavers had been found in 30 sample units and it deduct 141 points from all samples while 102-Depressions occurred in 20 road units although it deducted 347 points. That implies damaged pavers are more common but not significant effect on road condition with compared to depressions. The road maintainers target should be reduce distresses that are considerably affect road conditions. However some distresses were found rarely such as Heave (106), Horizontal Creep (107), sand loss (108) and Missing pavers (109). We could overlook these distress types as their effect also bare minimum.

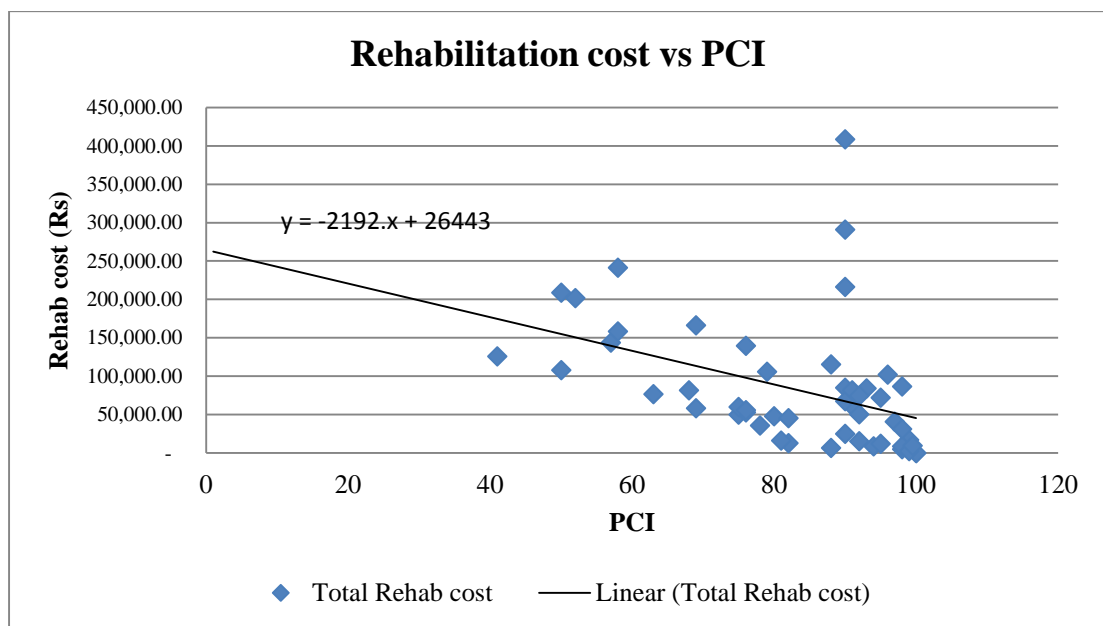
Figure 5-1 Rehabilitation cost vs PCI

Two trend lines have been generated using Excel as linear and second order polynomial. Rehabilitation cost increases with PCI value decreases, which is desirable.

There are three out liars could be identified. That is because these samples have large surface area with low severity damaged pavers.

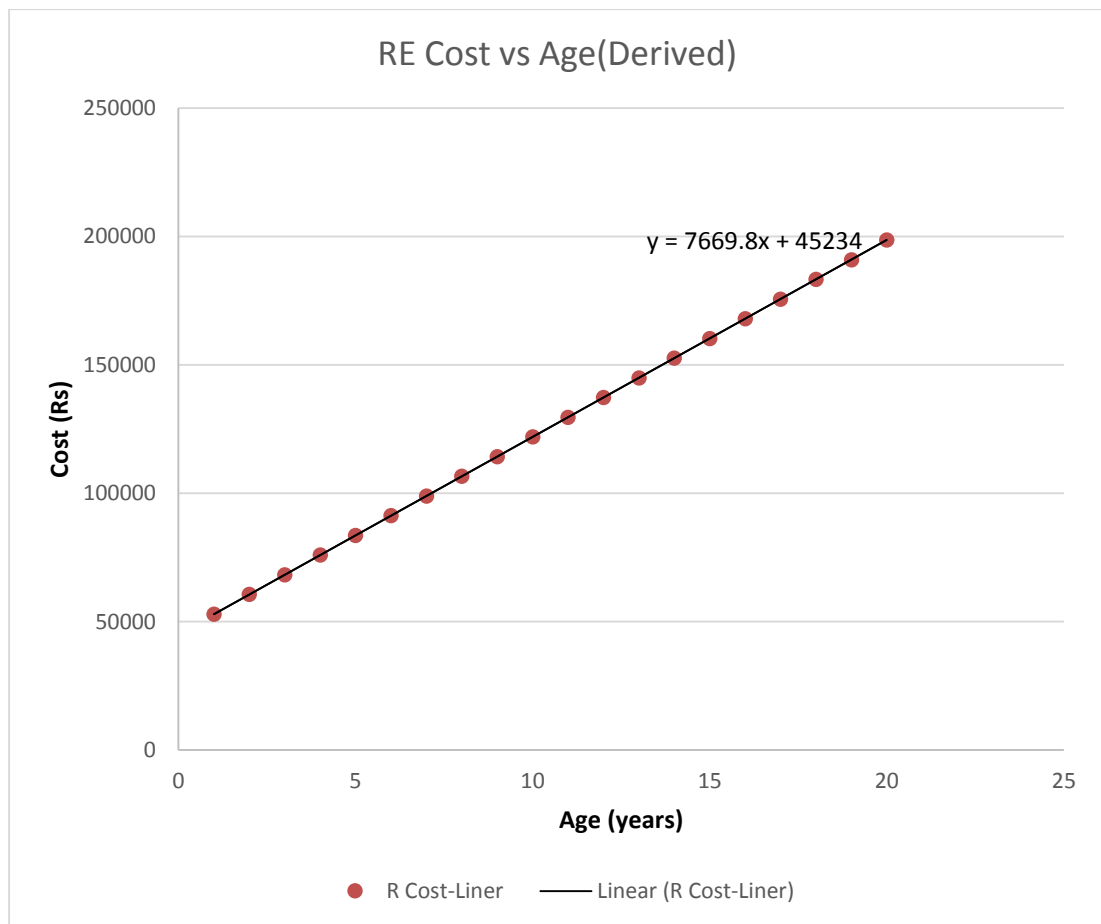
Figure 5-2 Total rehab cost vs Age - derived

$$y = 7669x + 45234 \rightarrow (c)$$

This graph gives general idea about how much cost would need in future for rehabilitation. It will be useful situations where there are number of damaged roads segments and initially need to decide financial requirement without doing field survey.

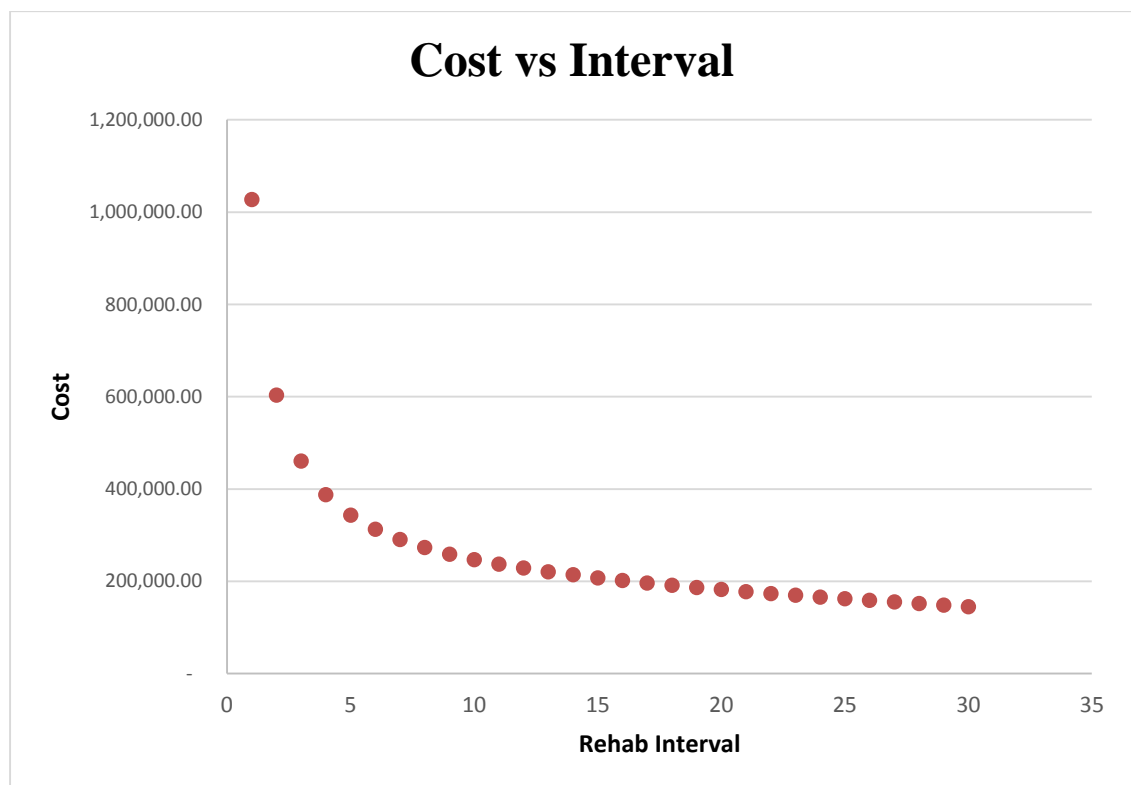
Figure 5-3 Total cost vs Rehabilitation interval

Even graph 5.3 gives clear idea of rehabilitation cost we cannot decide extract when we should start rehabilitation process. The graph of rehabilitation cost vs time interval is drawn to find out when the most economical to initiate construction. The total rehabilitation cost is calculated for 20 years period. Said otherwise, if rehabilitation was carried out in certain time interval, cumulative value of the cost, at end of twenty years.

According to above graph 15 years of time interval would be economical for periodic maintenance. The predicted value for reconstruction is around LKR 200 000.00 in 2016 value. This value is calculated for pavement of 150 m² of area that is about 50m long road section.

- Our main research problem was finding the most economical time interval for periodically maintenance. It was suggest 15 to 20 years would be better for such maintenance. This value was obtained based on the facts and finding of this research study. First fact was based on PCI vs Age graph. In that graph PCI value reach 40 when age is about 16 years. Last graph gave the second fact which is Total cost agents Rehabilitation time interval. Here it was showed us the cost had not varied much after 12 years of time interval. In conclusion if every fifteen years doing a pavement condition evaluation and taking necessary action to rectify distresses would be economical to road maintaining institute. Nevertheless carrying out rehabilitation shorter time interval would not be financially sensible while longer time period would be damaged pavement and unusable road pavements due to lack of maintenance.
