**IDENTIFICATION OF A METHODOLOGY FOR
REDUCTION OF NON REVENUE WATER & IMPROVEMENT OF
PIPE BORNE WATER SERVICE IN
COLOMBO CITY**

By Eng. S.S. DEVARAJA

**A Dissertation Submitted in Partial Fulfilment
of the Requirement for the
Master of Science Degree in Environmental Engineering & Management**

Department of Civil Engineering

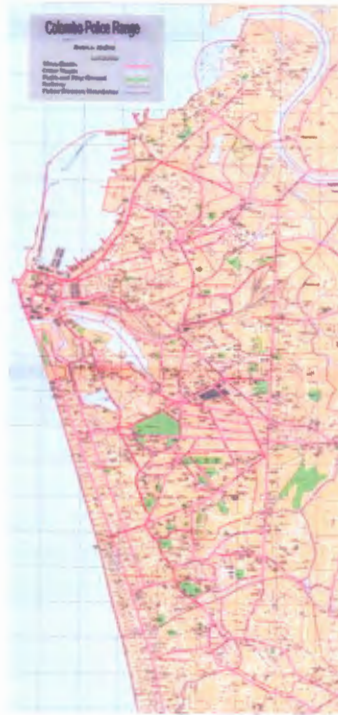
Figure 1-6 : Map of Colombo City

Colombo City is the commercial capital of Sri Lanka with approximately 642,000 inhabitants. It is expanded daily by nearly 400,000 floating population. According to the Colombo Municipal Council data the City covers an area of 37 sq. Km. consisting of over 120,000 numbers of dwellings including 65000 underserved settlements. However most of the inhabitants of Colombo City have basic needs of water supply and sanitations facilities at least as common services. Presently Colombo City receives a pipe borne water supply of 66mgd, out of which 54% is recoded as NRW including 11% is used to provide free water supply to maintain common services to improve sanitation conditions in the underserved settlements. Figure 1.6 shows the main road net work of Colombo city. Most of the pipe lines are along this road all over the area.

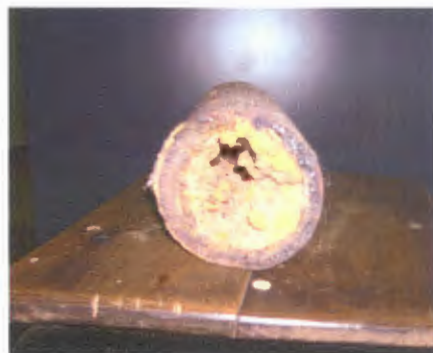
Figure 1-9: Status of smaller diameter pipes in Colombo distribution system

Colombo City distribution system comprises more than 70 years old Cast Iron pipes. Due to the deterioration, frequent pipe bursts, underground leaks are common in the system. Scaling is another deficiency of this system as shown in figure 1-9. Scales will reduce actual internal diameter and the associated theoretical calculations produce inaccurate results. Further, due to these reasons most of the inhabitants of the Colombo City suffer with unreliable and poor service.

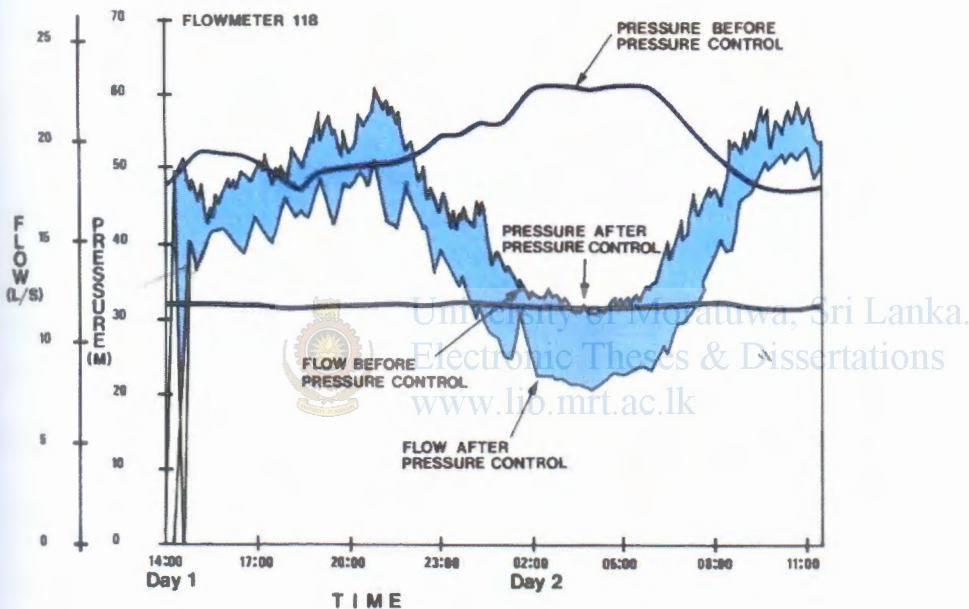
Figure 2-7: Water Saving due to Pressure Management

There are other ways of pressure reduction systems available such as reducing pumping capacities by using series of pumps which will start on demand (special pumps are set to cater for night demand), Variable Speed pumps, installing break pressure tanks or, more commonly, using pressure reducing valves. Pressure control provides no information on the level of leakage or the location of leaks, but it can be implemented in conjunction with any of the other control options.

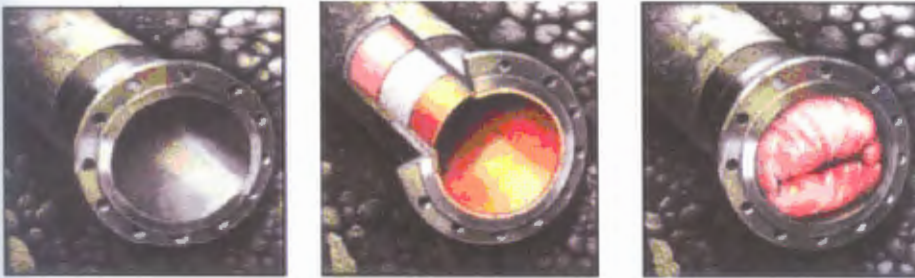
Pipe before rehabilitation / pipe with impregnated textile tube / rehabilitated pipe

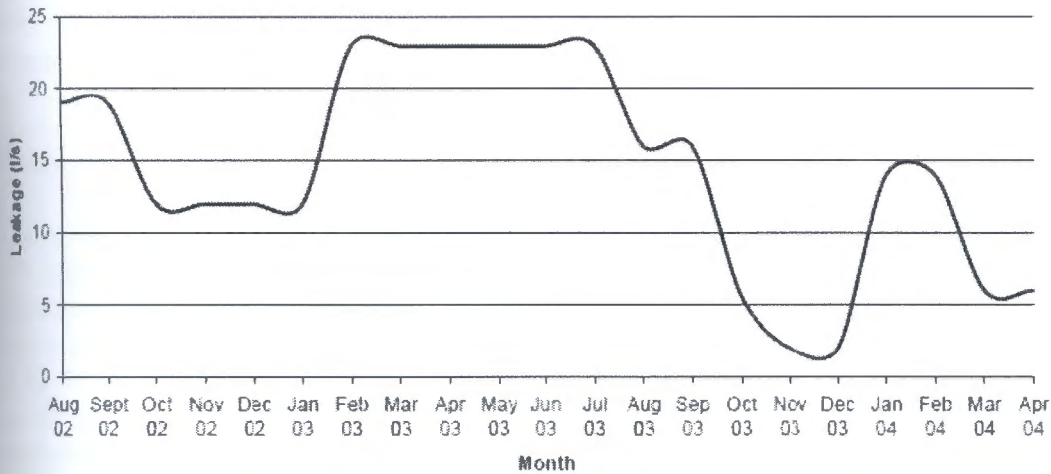
Figure 2-17 : Variation in leakage level over time (Source: McKenzie et al, 2002)

The objective of a permanent leakage control system was not just to reduce the leakage but to enable a low leakage level to be maintained in the future. The approach developed for Jakarta proved highly successful in locating the leaks. However it soon became apparent that no sooner had a big leak been eliminated that another broke out. Figure 2-17 presents the variation of the leakage level in one permanent area over an 18 month period. The reason was pressure.

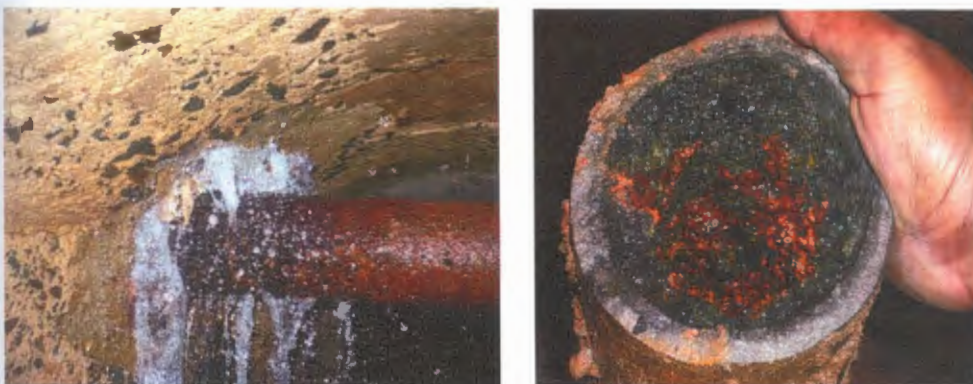
Figure 4-2 : Leaking Cast Iron pipe and Scaled Cast Iron pipe

Figure 4-2 shows some of the problems currently being faced in the distribution system of leaking and corroded pipes.

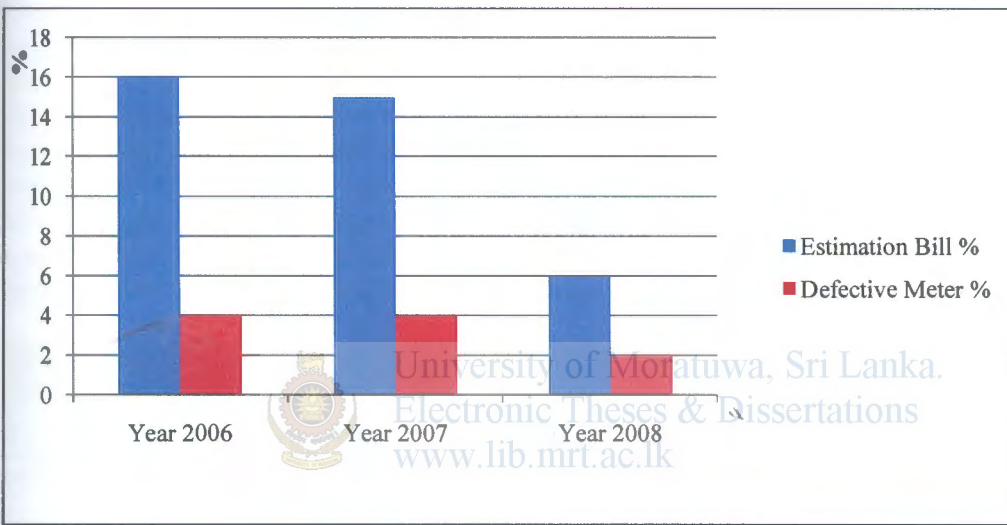
Figure 4-6 : Reducing of Estimated Bill and Defective Meter Percentages in Colombo City

Year 2006	Year 2007	Year 2008
Estimation Bill %	16	15	6
Defective Meter %	4	4	2

According to the present available water meter specifications, it clearly says that these water meters are only suitable for use with clear water and without impurities or air. Due to the high leak repair rate and low pressure, it is very difficult to maintain such requirements favorable for present water meters. Therefore when such situations occur, it is needed to purchase suitable water meters to withstand said conditions for long life usage.

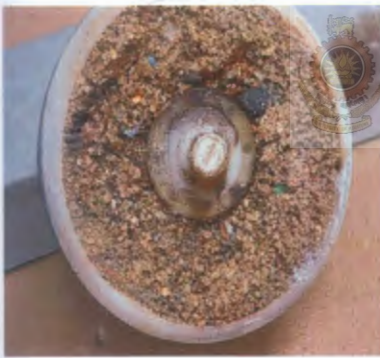
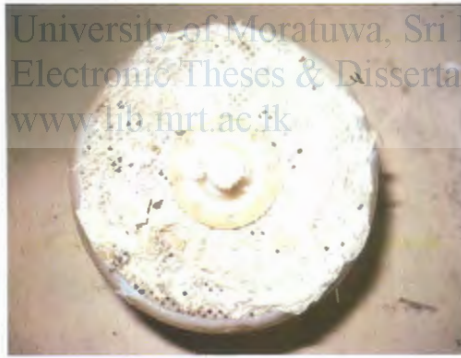
Figure 4-8 : Water Meter Blocked Incidents due to Sand and Solvent Cement

The major problem being faced with meter management is meter blockages and defective meters. Meter blockages are mainly occurred as shown in figure 4 – 8 due to clogging by sand, debris in the water or deposition of excess solvent cement or physical tampering; do not record any water flow. In the end of year 2007 Colombo city recorded 4% defective meters which was reduced to 2% at the end of the year 2008 by implementing a special meter replacement programme. Normally defective meters contribute to a considerable amount of NRW as once consumers get aware about their defective meters, they use water freely and result in high wastage and pay less amount of monthly bill. However it is difficult to quantify the amount because once defective meter is replaced consumer usage become normal.

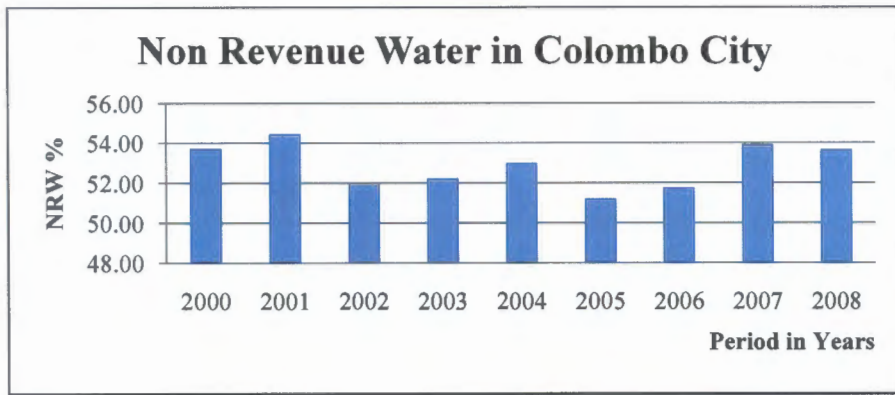
Figure 4-9 : Non Revenue Water in Colombo City from 2000 to 2008

NRW %	Year								
	2000	2001	2002	2003	2004	2005	2006	2007	2008
	53.74	54.49	51.95	52.25	53.04	51.25	51.79	53.95	53.68

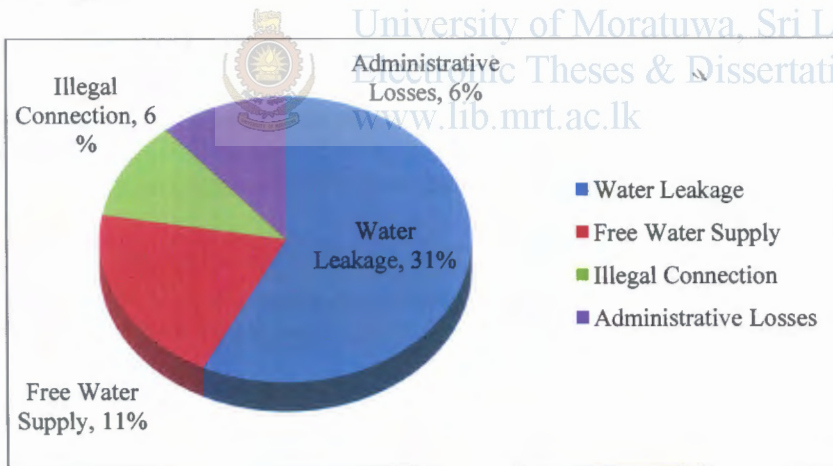
Figure 4-10 : Composition of Non Revenue Water in Colombo City

Frequent studies carried out by the consultants and experience in the operational staff and the NRW section, the composition of NRW in Colombo City is expressed as in Figure 4-10

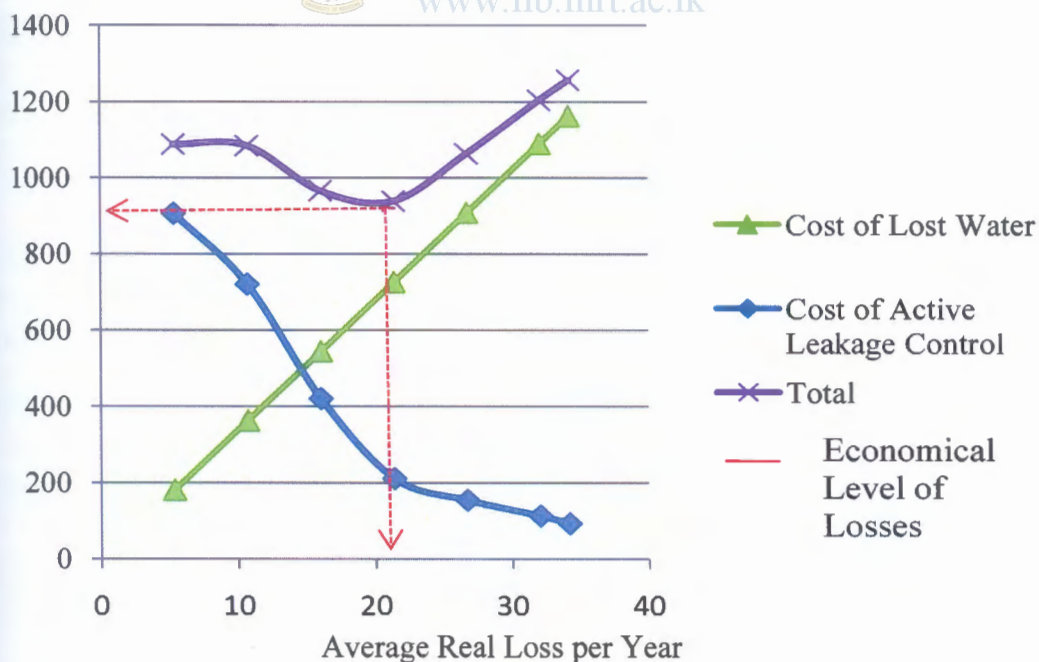
Figure 4-16 : Ecumenical Analysis of Leakage Control in Colombo City without Pipe Replacement

Activities of the Active Leakage Control	Leakage levels						
	31%	30%	25%	20%	15%	10%	5%
Loan Installment for Capital Investment							
Staff costs	10	10	11	12	12	21	24
Equipment	0.8	2	4	10	19.2	72	90
DMA establishment	1	3	3	8	8	25	38
Training	13	15	18	38	50	100	125
Leak detection vehicles	0.0	0.2	0.4	1.1	1.3	2.6	4.0
Leakage repair	70	84	120	144	330	500	625
Total	93.72	114.11	155.21	212.12	420.72	720.98	905.98

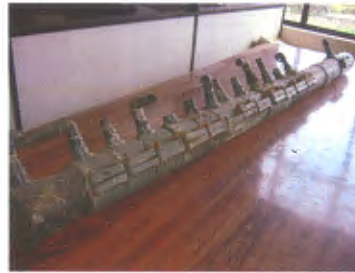
Figure 4-19 : Bundle pipes in Colombo City

This is common to the old distribution systems. This increases number of joints and leaking possibility is very high. Normally these service pipes were laid at shallow depths and have higher possibility of damages. Further if the workman ship is poor, dripping is a common outcome. Hence it is important to replace bundle pipe with common lines.

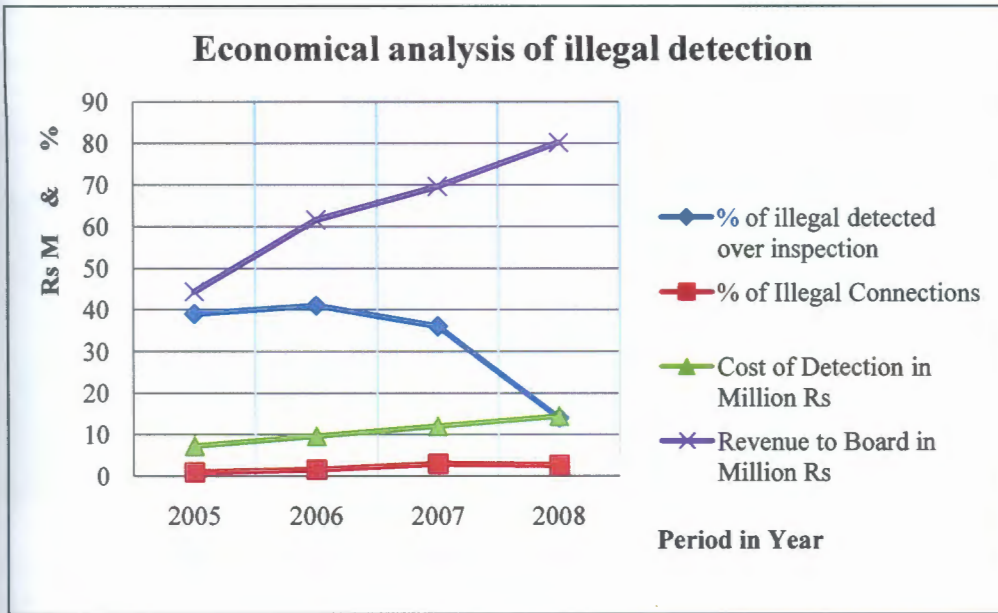
Figure 4-20 : Economical analysis of illegal detection in Colombo City

By reviewing of above data it is clear that the investment still signify to employ more gang to control illegal consumption in Colombo City. Initially with available resources only complaints were handled and nearly 40% of the complaints were successfully detected as illegal connections and with the increased of more gangs, complaints with suspected premises were checked. After further increases of staff, more premises were checked with plan programmes in addition to the normal complains, detection percentage was reduced but income is been increased by considerable amount when compared with the investment as clearly shown by figure - 4 -20.

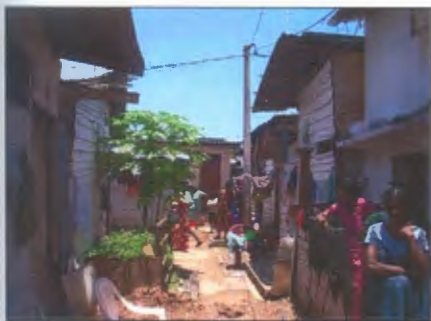
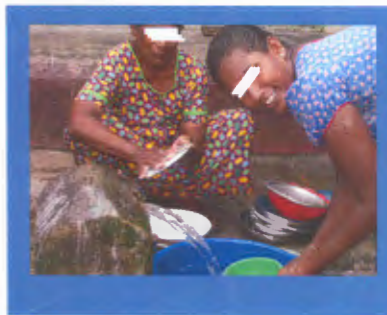
Figure 4-22 : Illustrates Low living standards and Water wastage Hygienic Problems in Colombo City Tenement gardens

Before starting this programme residents of the Tenement Garden in Colombo city were using water from common outlets and problems were observed as illustrated in figure 4-22. The wastage of water as shown, which is a common phenomenon, helps development of low pressures in the distribution system in Colombo City.

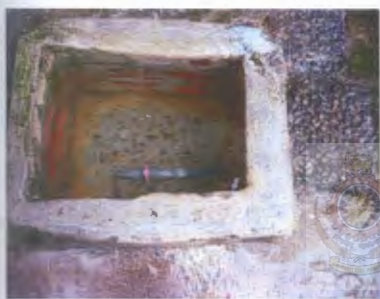
Figure 4-23 : Temporary Collecting pits in Tenement Garden due to low pressure

Due to the low pressures in some Tenement Gardens, water is collected in the ground level pits and consumed. This tends to huge wastage and more possibility of contamination as

shown in figure 4-23. www.lib.mrt.ac.lk
