Incident of Ground Collapse up to Daylight and Recovery Actions Taken in Shallow Ranwediya Tunnel in Sri Lanka

*Perumal¹ M, Wanigasekara¹ WADID, Isuranga¹ SNAMTK and Narangoda¹ SRAIB
¹Program Management, Design & Supervision Consultants (PMDSC), for Mahaweli Water Security Investment Program (MWSIP), Dambulla, Sri Lanka

Abstract

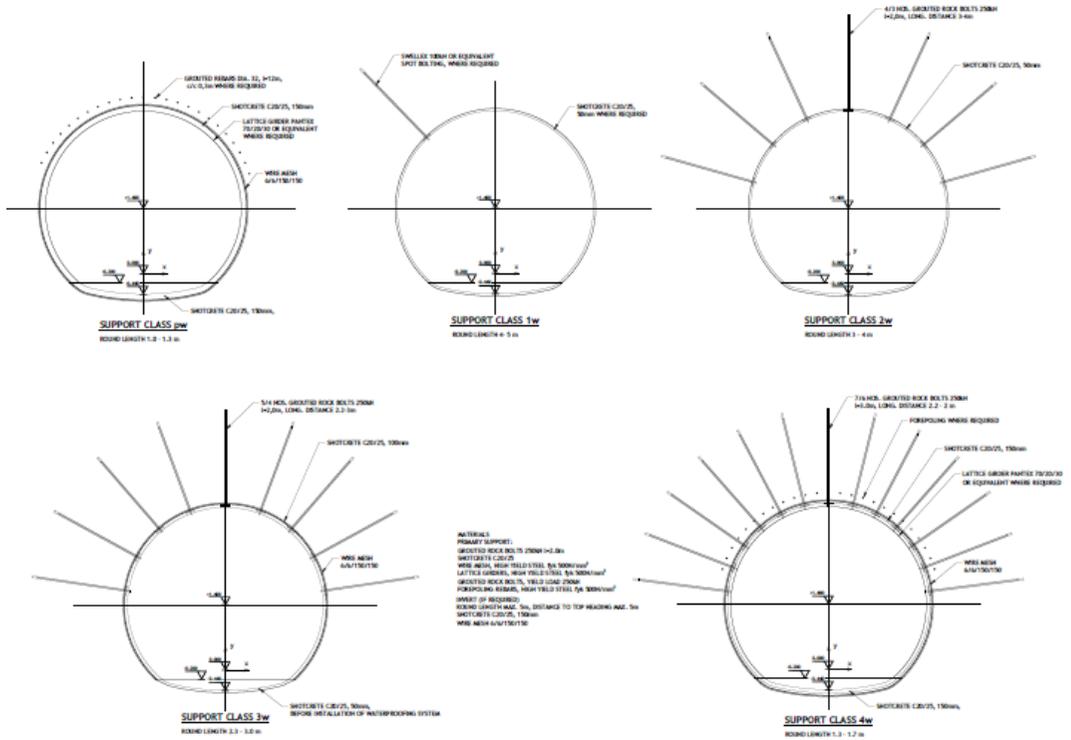
Figure 2 Design support classes

The tunnel was designed following the RMR [2] with five support classes including a portal support class that extended 10-15 m from the portal of both tunnel drives. The support classes were designed with RMR 0-30 as support class 4w, RMR 31-60 as support class 3w, RMR 61-80 as support class 2w and RMR 81-100 as support class 1w are shown in Figure 2.

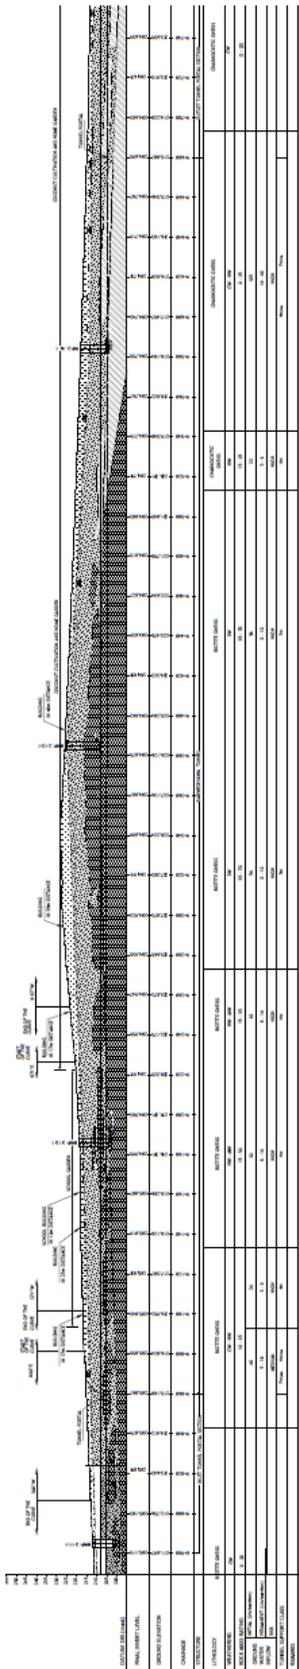
Figure 3 Predicted Geological long section of the Ranwedyawa tunnel at the design stage.

The tunnel was designed to run an initial 10m as the portal support class (pw) and follow with support class 4w over 155 m, support class 3w for a 240m length then run into a support class 4 and portal support class (pw) with 155 m & 10 m lengths respectively. This variation in the ground is shown in Figure 3.
