## 6.0 CONCCLUTION AND RECOMENDATIONS

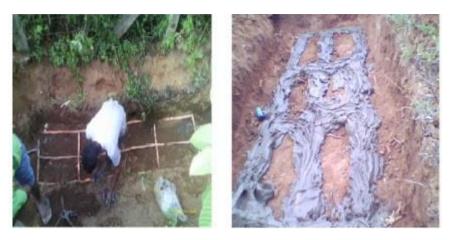
In the stage of lower erection, we do the basic crow foot grounding system. That is a standard design irrespective of tower location, keraunic level, soil condition etc. And further improvement done after any complain or damages reported. Therefore it is recommended to design the best suited grounding system, for a given tower site. Our analysis show that at tower sites on extremely high resistive grounds; rocks and sandy soil, the transient equipotentialization is more suitable for the safety of people and protection of equipment instead of attempting to achieve low ground resistance. Therefore ring conductor also recommended in such sites earth electrode (type B arrangement) should preferably be buried at a depth of at least 0.5 m for bare solid rock [17]. For the rocky areas we can use earth mesh with chemical compound that reduce the earth resistivity to arrange distributed earth as shown in Figure 6.1

Figure 6.1: Distributed earth with copper earth mesh (Source: Author)
